Technical Service Bulletin

91 SOS Emergency call function deactivated message in the cluster, DTC U153E00 stored in the telematics module

91 19 94 2055945/2 September 30, 2019. Supersedes Technical Service Bulletin Group 91 number 19-79 dated August 26, 2019 for reasons listed below.

Model(s)	Year	VIN Range	Vehicle-Specific Equipment
A4, A5, A6, A7, A8, Q5, Q7, and Q8	2019 - 2020	All	With ConBox Low

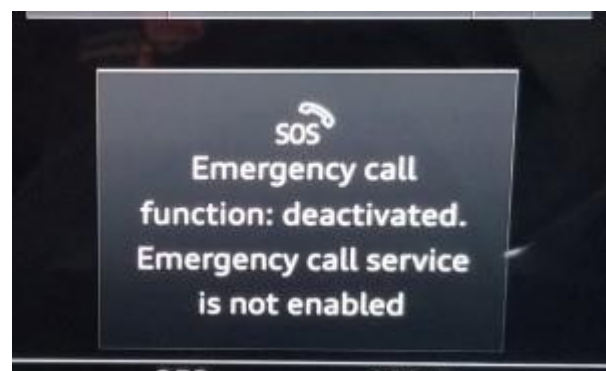
- The warning message “SOS Emergency call function deactivated” is seen in the instrument cluster (Figure 1 or 2).

Figure 1. SOS warning in the instrument cluster.

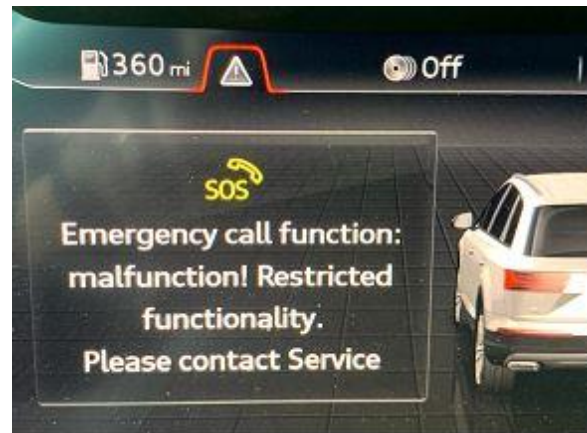
Figure 2. SOS warning in the instrument cluster.
