Technical Service Bulletin

Topic	EPB Warning light in DIP - Front door/s power latch system intermittent - DTC U112300 within Address 03 and Address 46
Market area	Bentley: worldwide (2WBE),Hongkong-Macau (5HK)
Brand	Bentley
Transaction No.	2055883/1
Level	EH
Status	Released for publishing
Release date	Sep 5, 2019

Bentayga

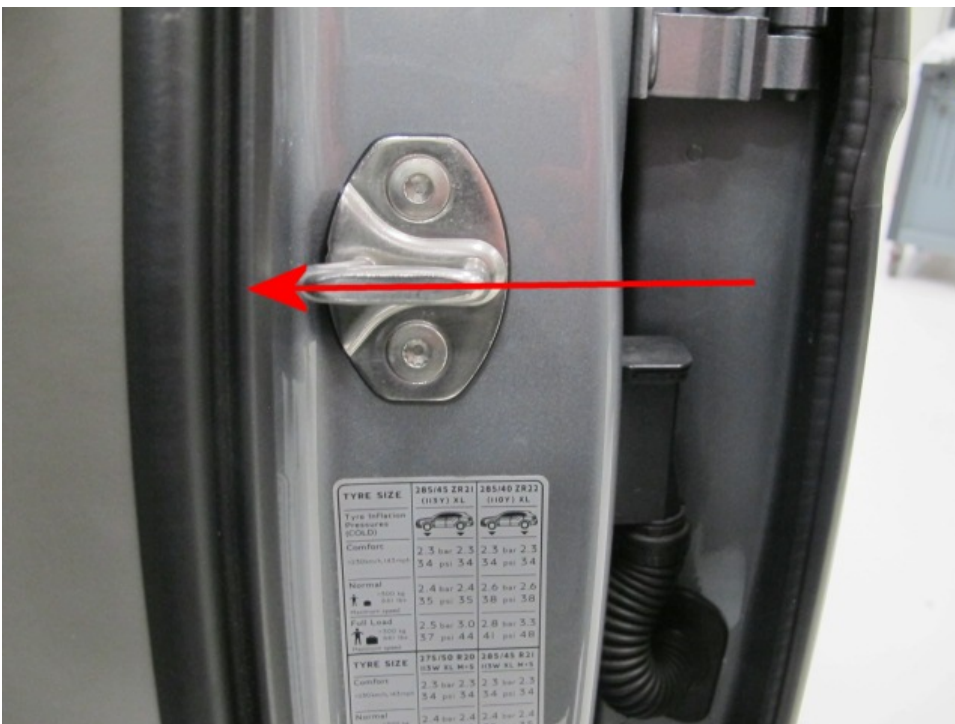
Figure 1

The front door/s power latching system sporadically does not work. The door remains in the first latch of the door lock and is not closed by the power latching system

The micro switch signal of the door lock is not recognised or too briefly

A counter-pressure of the door is required to clearly recognise the signal

- 1) Check whether the striker runs into the centre of the rotary latch of the door lock and correct it if necessary - Refer to Rep.Gr 57 - Door striker - To remove and fit

In addition, adjust the striker as far as possible (at least 0.5 mm) further inwards (Figure 1)
