EL18-024c

ITB18-041c

2019 QX50; AUDIO SYSTEM WILL NOT TURN ON AND/OR SCREENS FREEZE UP AFTER HANGING UP A PHONE CALL

APPLIED VEHICLE: 2019 QX50 (J55)

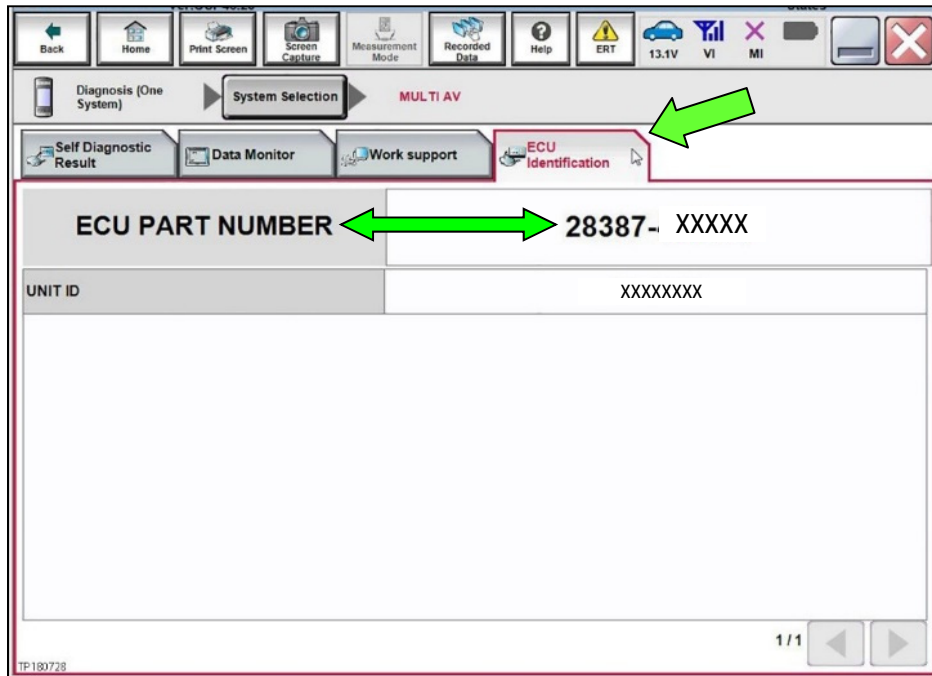
7. Select the **ECU Identification** tab.
8. When the screen in Figure 4 displays, confirm this bulletin applies as follows:
 - a. Write down the **ECU PART NUMBER** on the repair order.

NOTE: This is the current DCU part number (P/N).

- b. Compare the P/N written down to the P/Ns in the **CURRENT DCU PART NUMBER** column in **Table A** below.
 - If there is a match, proceed to step 9 on the next page.
 - If there is not a match, DCU updating does not apply. Refer to ASIST for further diagnosis.

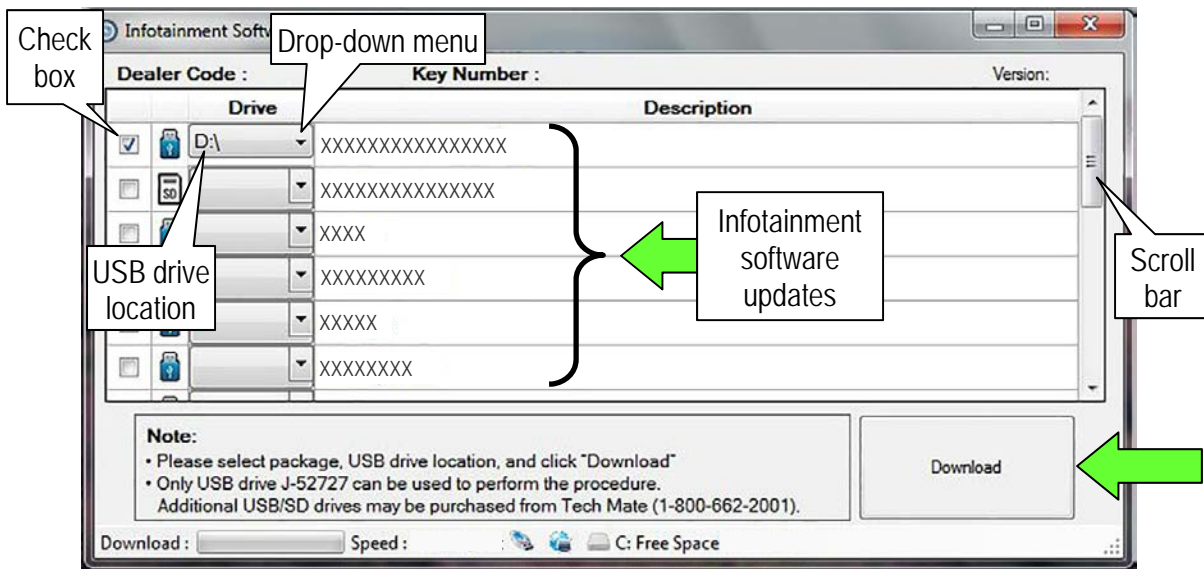
Figure 6

12. Select the check box next to the correct update software package based on **Table B** below (see Figure 6).

Failure to select the correct update software package may result in needing to replace the DCU.

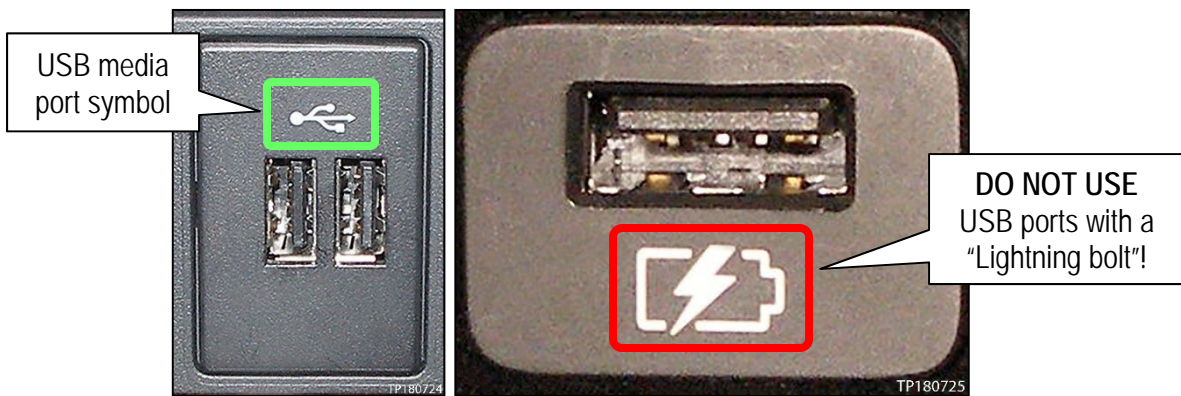
Figure 17

24. Insert the USB drive with infotainment update software into the vehicle's USB media port (see Figure 17).

Do not insert the USB drive into a charging port. If used, the update software and/or USB drive may become damaged. Only insert the USB drive in a USB media port.

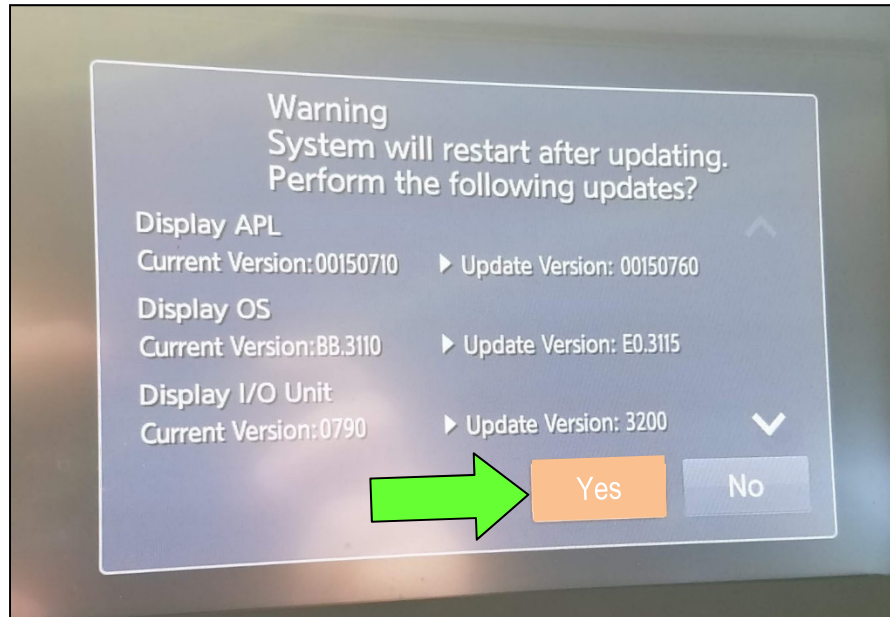
25. Wait approximately 10-30 seconds for the screen in Figure 19 or Figure 20 to appear.
- If the screen shown in Figure 19 appears, proceed to step 26 below.
 - If the screen shown in Figure 20 appears, then no software update is available. Refer to ASIST for further diagnostic information.

26. Select **Yes** to begin the software update.
