Technical Service Bulletin

48 Creaking or squeaking noises from steering column (sealing boot)

48 19 82 2034351/9 October 9, 2019. Supersedes Technical Service Bulletin Group 48 number 17-74 dated May 25, 2017 for reasons listed below.

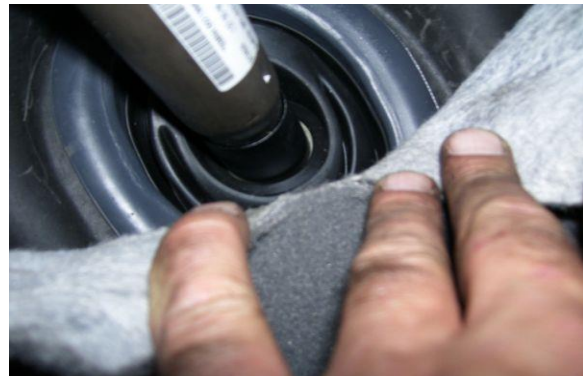
Insufficient lubrication of the intermediate steering shaft in the area of the sealing sleeve.

Figure 2. The sealing sleeve on the bulkhead.

1. Check the sealing sleeve for proper installation and fit (Figure 2).
2. To eliminate the noise, loosen the upper bolted connection of the steering intermediate shaft and the steering column. Pull the intermediate steering shaft out about 4 in (10 cm) and spray the special lubricant spray (**G052172M2**) in the area of the bearing ring and the black plastic sleeve. Push it in and pull it out a few times to distribute the spray on the intermediate steering shaft.

Do not lubricate the u-joints of the steering shaft.

3. Retighten the shaft with a new bolt on the steering column.
4. If the noise persists, replace the intermediate steering shaft.
