# Technical Service Bulletin

## PSS 91 Audi Smartphone Interface (ASI): Apple CarPlay or Android Auto display screen intermittently goes blank in FPK

91 19 97 2056232/1 October 2, 2019.

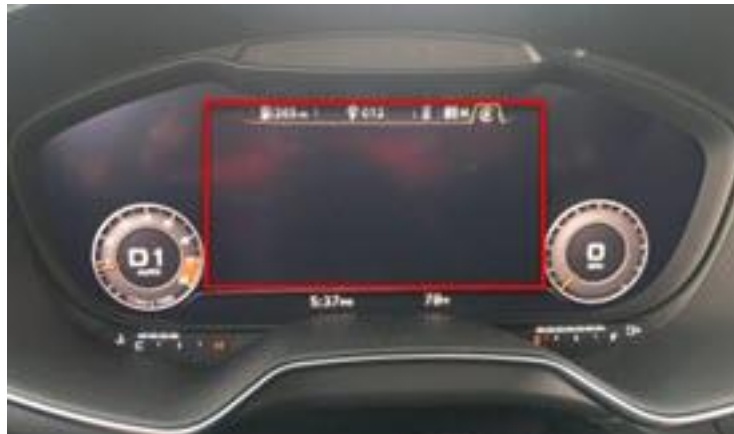
- The FPK (Free-Programmable Kombi/Cluster) screen goes blank intermittently when viewing the Audi Smartphone Interface (ASI) screen (Figure 1). This can occur while using Apple CarPlay or Android Auto.

Figure 1. FPK screen is blank.

This condition is a known MMI software issue and is currently in the analysis stage. Currently, there is no solution. Model Year 2019-2020 vehicles can have this issue with the factory-installed MMI software. Additionally, Model Year 2018 vehicles which received a recent MMI software update could also experience this issue. It's important to note that the issue is intermittent and does not always occur during a drive based on driving conditions. However, for some customers, this issue can occur during each trip each day.

Please inform the customer that the issue can occur when the vehicle speed drops below 20mph. Add the customer's information into the Pending Service Solution (PSS) system ([AccessAudi.com](http://AccessAudi.com) >> [App Links](#) >> [Service](#) >> [Pending Service Solution \(PSS\)](#) or <http://www.accessaudi.com/pssjct>).

1. Have the customer bring the car to a full stop in a safe manner and location.
2. Ask the customer to press the Park Aid button twice (Figure 2), once to trigger the parking sensors, and once to turn off the parking sensors. The vehicle must be stationary in order to complete this step.
