## Side windows may make noises when closing and opening, or reverse direction when closing.

Topic number	LI67.30-P-052837
Version	4
Design group	67.30 Side windows
Date	07-08-2014
Validity	MODEL 166.0 Up to VIN end no.: L 003467 Up to VIN end no.: M 003467 Up to VIN end no.: A 361392
Reason for change	Part number changed. Repair procedure changed.
Reason for block

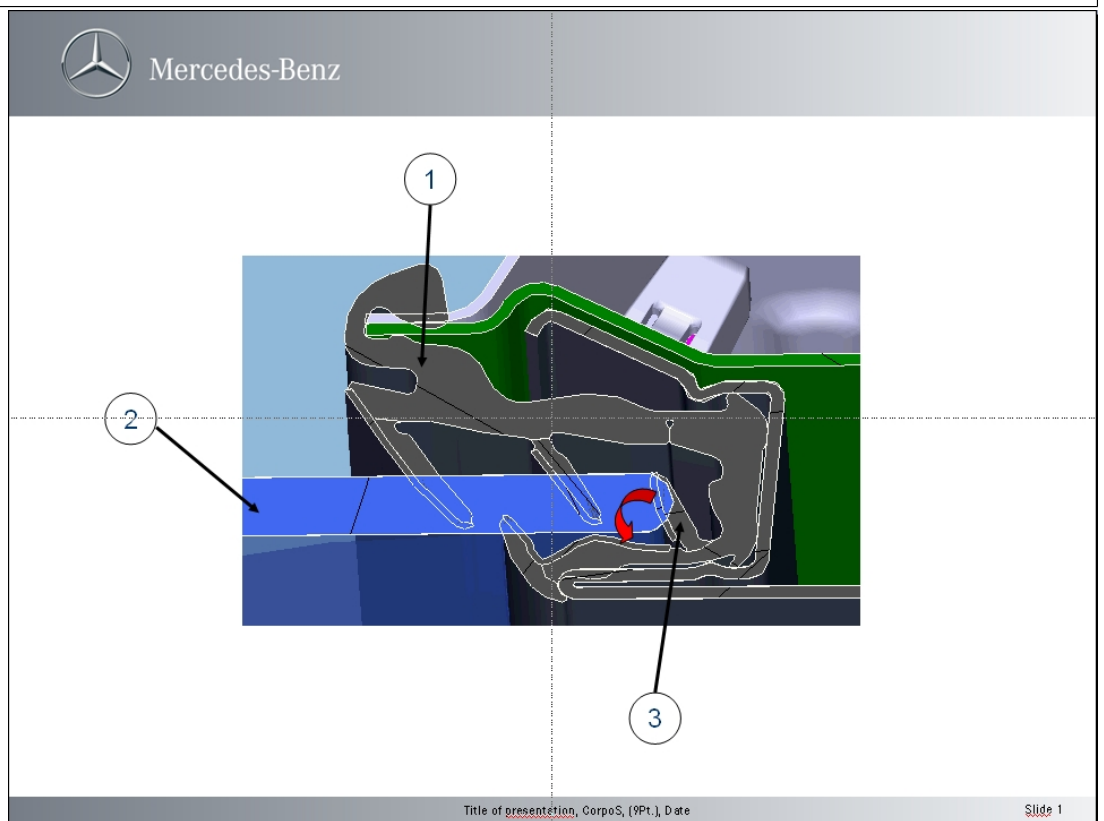
Bild1.jpg:

2. Window guide rails (see picture 1): Side window (2) can slip behind base lip (3) whereupon the base lip (3) folds over (red arrow).

Consequence: Window runs on bare rubber and the friction is too high, which causes noise and reversing windows.

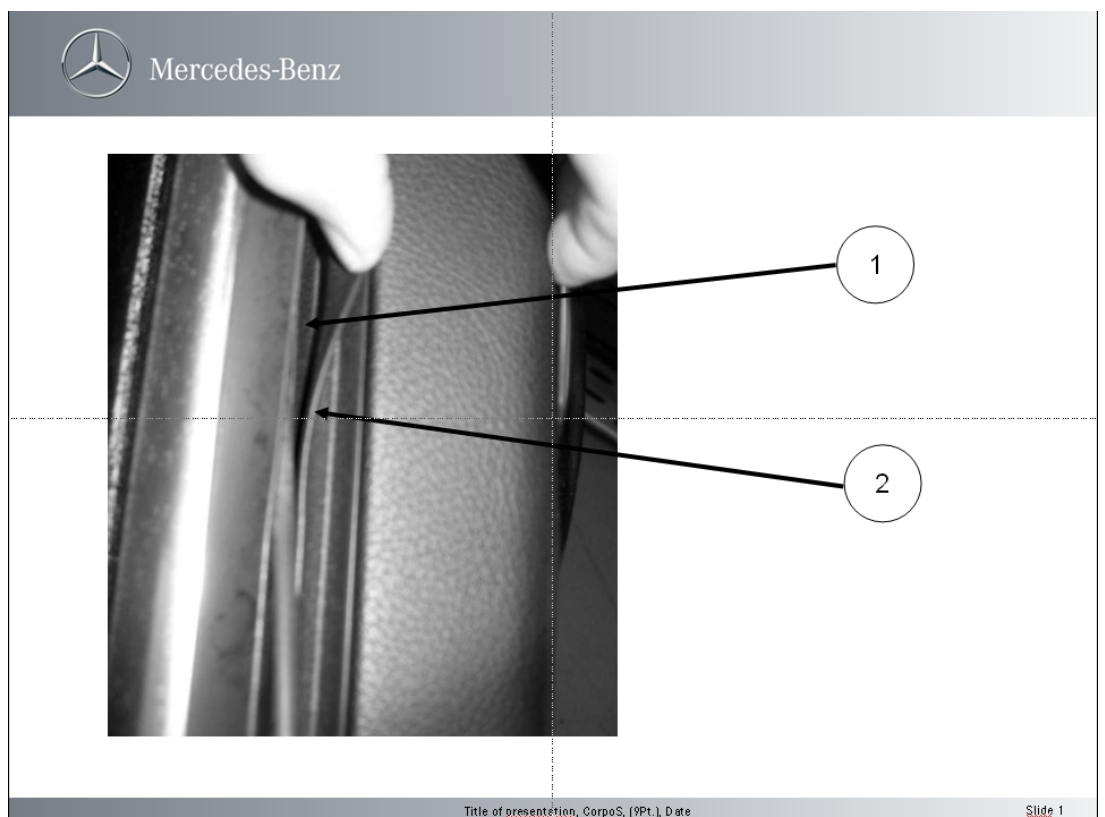
Bild3.jpg:

1. Interior window channel seal: Faulty anti-friction coating can lead to increased friction and folding down of the sealing lips.

Consequence: Friction is too high and results in noise and reversing windows.

1. Visually inspect upper (picture 3, item 2) and lower sealing lips (picture 3, item 1) of interior window channel seals:  
- If the sealing lip has folded down replace the affected interior window channel seal.

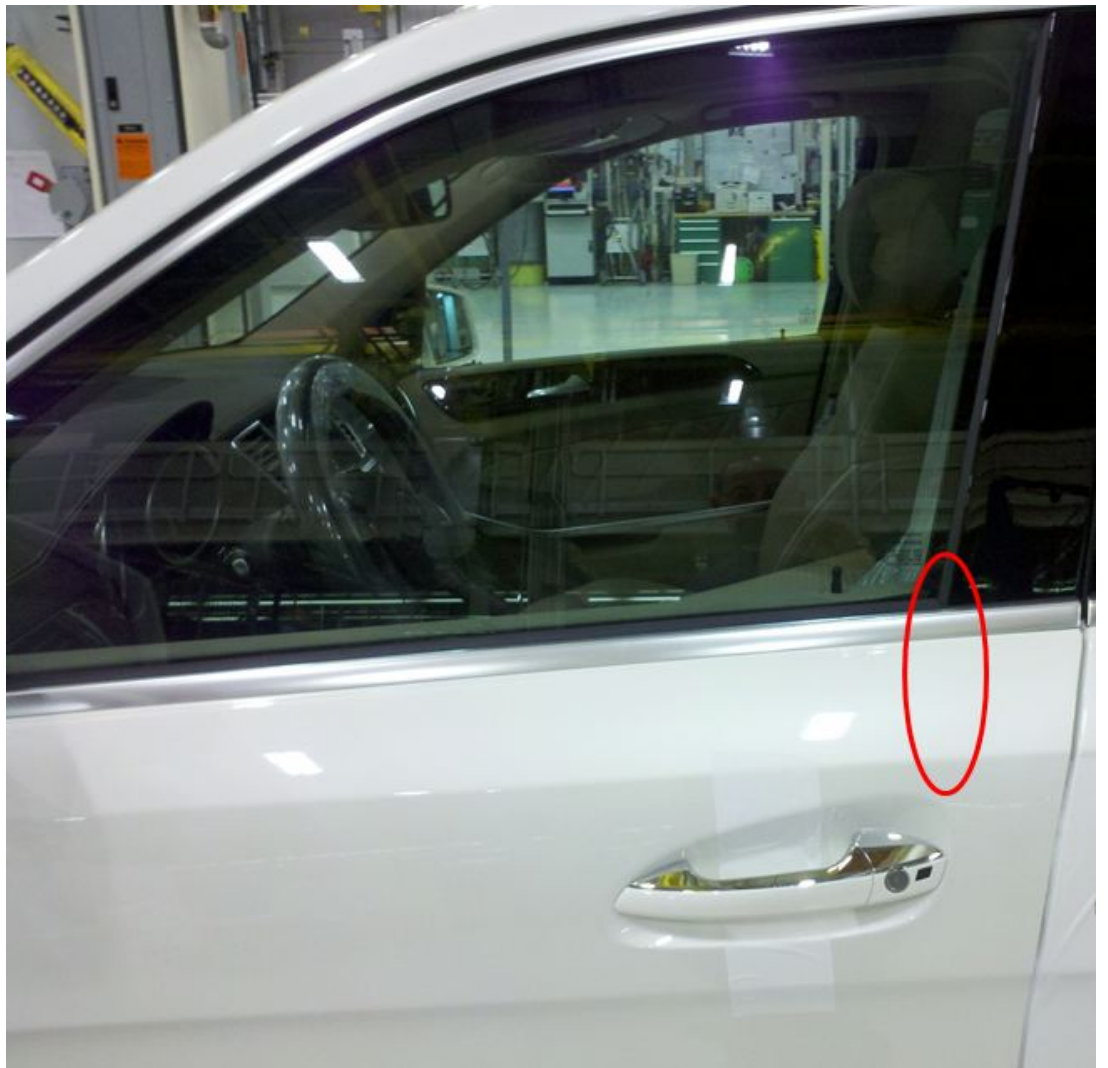
Bild 4.JPG:

3. On the front doors the lip may be folded over on the window guide rail below the beltline in the area of the B-pillar (see picture 4 and picture 5).

Consequence: Friction is too high and leads to noises.

3. Visual inspection to check whether the lip is folded over on the window guide rail.

- To do this, remove beltline trim strip.

- If the lip is folded over, the window guide rail must be replaced.
