# Technical Service Bulletin

## 91 MIB MMI: Text messages cannot be viewed or sent using Bluetooth

91 19 93 2037087/4 September 27, 2019. Supersedes Technical Service Bulletin Group 91 number 18-12 dated October 2, 2018 for reasons listed below.

Model(s)	Year	VIN Range	Vehicle-Specific Equipment
All	2014 - 2022	All	With MIB1, MIB2, and MIB2+

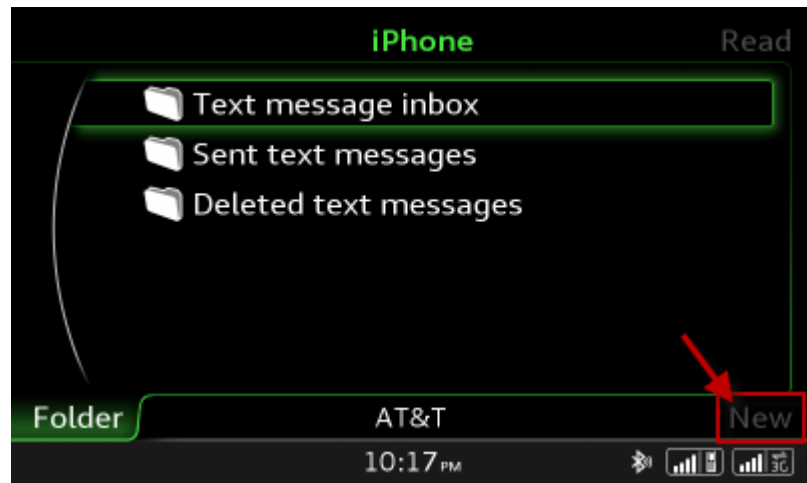
- Customer cannot enable text message support via the MMI system.
- The option to send new text messages cannot be accessed through the Messages function in the MIB MMI telephone menu.
- Additionally, the option to send text messages using “New” is greyed-out in the Messages menu (Figure 1).
- Text messages which were previously received before pairing to the MMI cannot be displayed.

Figure 1. “New” option is greyed out.

Explain to the customer that the condition is related to the features of the mobile phone's operating system, and it is not a limitation of the MMI system. Ask Apple device owners to update to iOS13 or newer if possible.

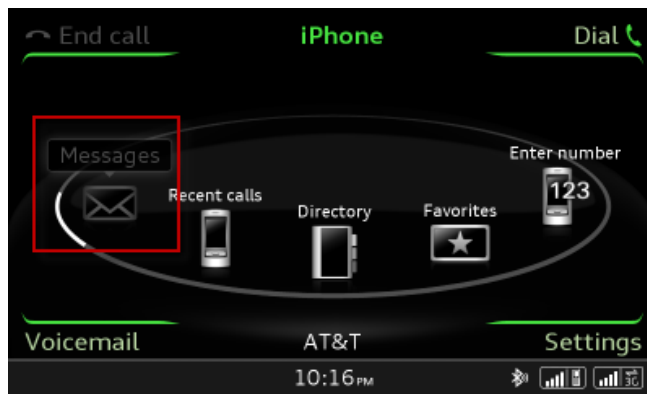
Figure 2. Messages menu greyed out.

1. If incoming messages cannot be received or if the "Messages" menu is greyed-out (Figure 2), explain to the customer that the "Show Notifications" option must be enabled with the following steps.

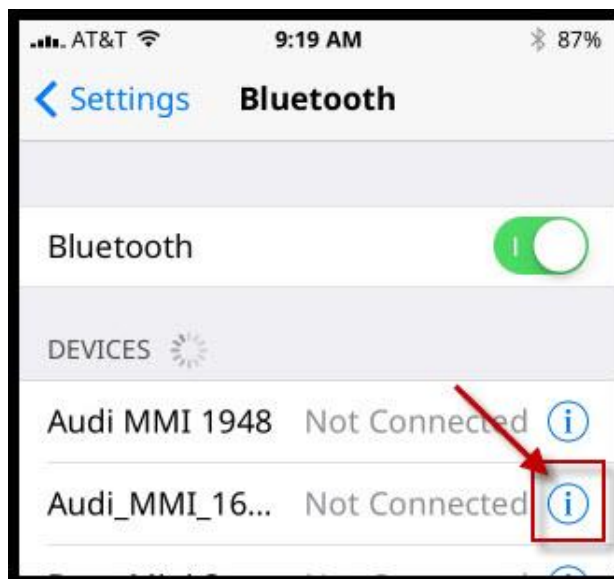
Figure 3. "i" next to the Audi MMI pairing.

2. In iOS, under *Settings >> Bluetooth*, select "i" next to the MMI Bluetooth pairing name (Figure 3).

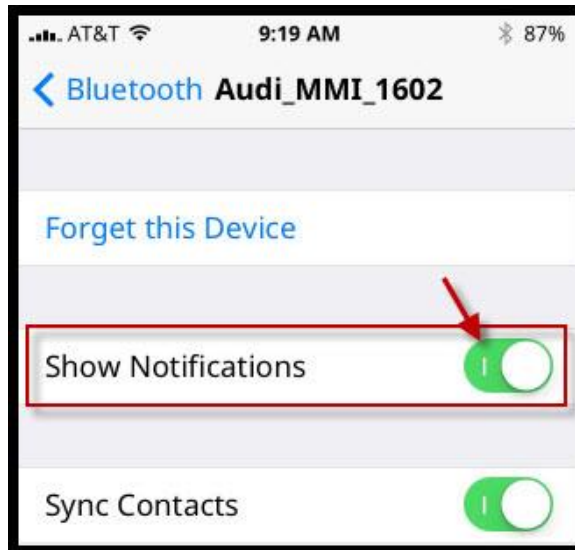
If this option is not available, it is possible that the wrong vehicle pairing was selected (check the MMI system for correct vehicle pairing name), the phone does not support MAP, or the vehicle does not have the MIB High system.

Figure 4. “Show Notifications” option in iOS.

3. Ensure that the “Show Notifications” option is enabled (Figure 4), which will allow the MMI system to access new text messages that are received while the iPhone is bonded to the car.

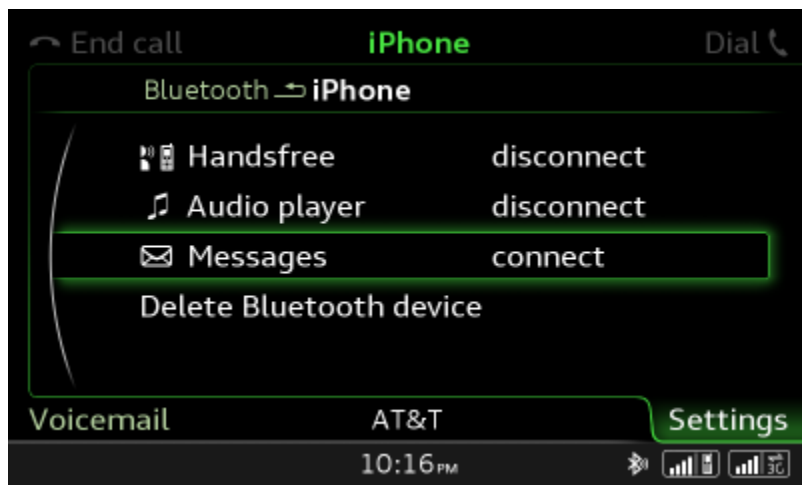
Figure 5. Messages Connect option for MIB1.

4. For MIB1 MMI (A3), if the Messages option is still greyed-out, manually force the connection in the MMI:
  - Go to the Bluetooth device list in the MMI (*Telephone >> Bluetooth >> Device List*). Select the phone from the list, then select “Messages” to connect the MMI to the iPhone using MAP (Figure 5).

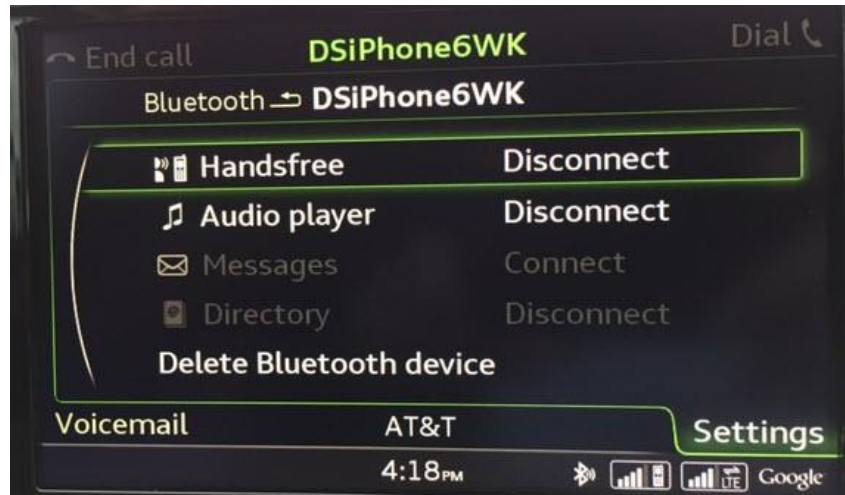
**Figure 6.** Messages Connect option is greyed-out and not accessible for MIB2.

For MIB2, MIB2+, & MIB3, if the Messages function or “Messages Connect” option is greyed-out and not accessible (Figure 6), the Bluetooth service will need to be stopped and restarted:

- Either in the MMI or in the phone’s Bluetooth menu, turn the Bluetooth radio off and back on. This forces the phone and MMI to reconnect with the new Bluetooth settings with the MAP function enabled.
