## Solution K05913580 Friday, October 4, 2019 3:49:02 PM CEST

Title	13 Liter Engines ONLY - Engine Coolant Pump Housing Leak; Coolant Found Around The Oil Cooler Duct Cover Or In Between The Coolant Pump Housing And Oil Cooler Housing - Model Years 2019 And 2020
Mack Models	
Mack Model	TE - TerraPro, AN - Anthem, GR - Granite, PI - Pinnacle
Volvo Models	
Volvo Model	VN, VNL, VNR, VNX, VAH, VHD
Engine family	
Engine family	13L Engine, MP8
** SOLUTION **	
Cause	Vehicles built between 1 March 2018 and 28 May 2019 and equipped with a 13 liter engine may experience coolant leakage found on the front right side of the engine. It has been found that some coolant pump housings were manufactured out of specification.
Solution	Vehicles affected by this issue will show coolant runoff on the front rights side of the engine. The likely area coolant will be found is highlighted below:

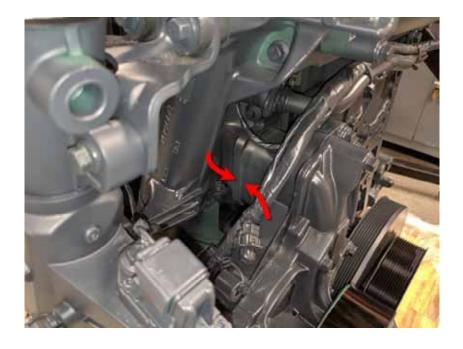
The joint between the coolant pump housing and oil cooler duct cover should be checked:

If a vehicle presents with a coolant leak in the area shown and the source of the leak is traced to the surfaces between the oil cooler duct cover and the coolant pump housing:

- Replace the coolant pump cover.
- Replace the seal between the oil cooler duct cover and the coolant pump.

**Note:** Ensure the seal is properly seated when reconnecting the housing and duct cover. If the seal is improperly seated, leakage may persist after repairs are complete.
