SIB 17 06 17

COOLANT LEAK FROM LOW TEMPERATURE COOLING CIRCUIT (N63R)

This Service Information Bulletin (Revision 4) replaces SI B17 06 17 **dated June 2019**.

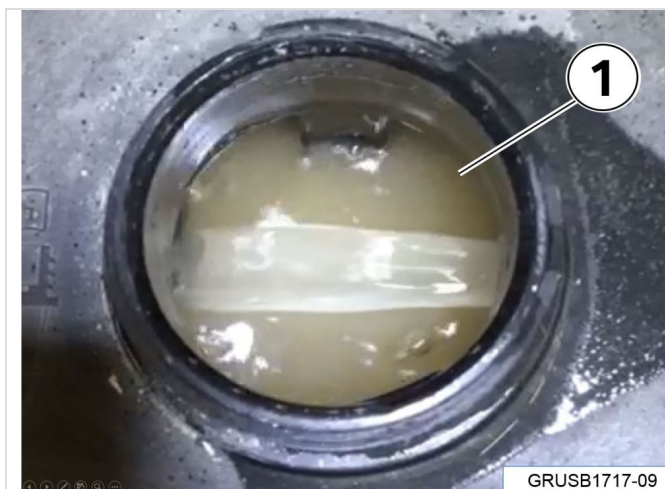
Coolant leaking from the engine compartment. Traces of coolant leaking from the expansion tank of the low temperature cooling system.

Coolant in the low temperature cooling circuit may also have an acrid smell and discoloration (1).

Aluminum corrosion in the charge air intercoolers, or in the radiator for the low temperature cooling is causing an unfavorable chemical reaction to the coolant.

Replace the radiator and both charge air coolers for the low temperature cooling circuit. Allow all the coolant in the system to drain during repairs (do not clamp off hoses).
