Technical Service Bulletin

SUBJECT:		No: TSB-19-42A-008	
POPPING NOISE WHEN OPENING OR CLOSING TAILGATE		DATE: September 2019	
		MODEL: 2020 Outlander Sport	
CIRCULATE TO:	<input type="checkbox"/> GENERAL MANAGER	<input checked="" type="checkbox"/> PARTS MANAGER	<input checked="" type="checkbox"/> TECHNICIAN
<input checked="" type="checkbox"/> SERVICE ADVISOR	<input checked="" type="checkbox"/> SERVICE MANAGER	<input checked="" type="checkbox"/> WARRANTY PROCESSOR	<input type="checkbox"/> SALES MANAGER

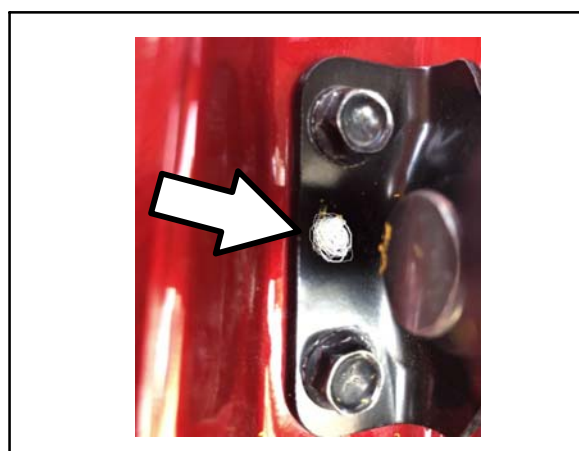
1. **BEFORE performing this procedure**, verify that the adjustment has not already been done at the port.
 - Look for the white round grease pencil mark on both tailgate brackets, as shown.
 - If no mark is seen, proceed with the procedure below.
