SIB 51 29 19 GROANING NOISE FROM TAILGATE HINGE

2019-09-25

E-Series	Model Description
F16	X6 Sports Activity Coupe
F86	X6 M Sports Activity Coupe

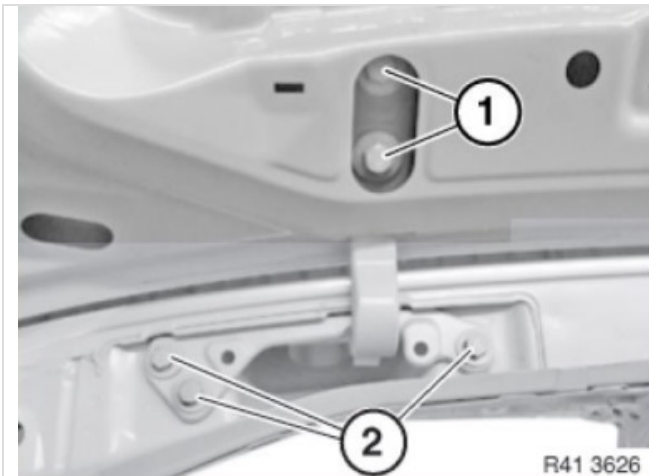
A groaning noise is present from the area of the tailgate hinge when opening and closing the tailgate.

Improper tightening of the tailgate hinge.

1. Ensure that the tailgate is correctly adjusted, using ISTA repair instruction **REP 41 00...** “**Gap dimensions, body**”.
2. Re tighten the tailgate hinge screws (1 & 2) on both sides of the vehicle as shown to the left.
 - Refer to ISTA for tightening torque specification.
