JLRTB02001NAS1 TECHNICAL BULLETIN

12 SEP 2019

INFORMATION			
SECTION:			
01-03			
SUBJECT/CONCER	N:		
ailgate Does Not	Open Fully		
AFFECTED VEHICL	E RANGE:		
MODEL:	MODEL YEAR:	VIN:	ASSEMBLY PLANT:
E-PACE (X540)	2018-2020	Z00381-Z78385	Graz (Austria)
MARKETS:			
IORTH AMERICA			
CONDITION SUMM	ARY:

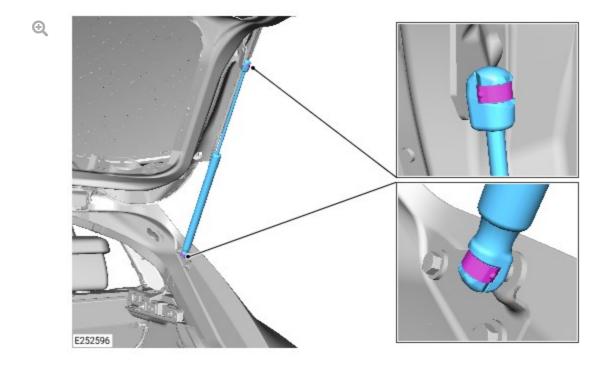
The tailgate does not open fully.

Incorrect specification tailgate struts have been installed to the vehicle. A new service part is now available with improved opening performance. **Suggested customer concern code** -

Repeat this step to the other side of the vehicle.

Renew the tailgate strut with the new higher specification tailgate strut.
