Service Bulletin

Bulletin No.: 19-NA-186

Subject: Speedometer and Tachometer Reading Inaccurately

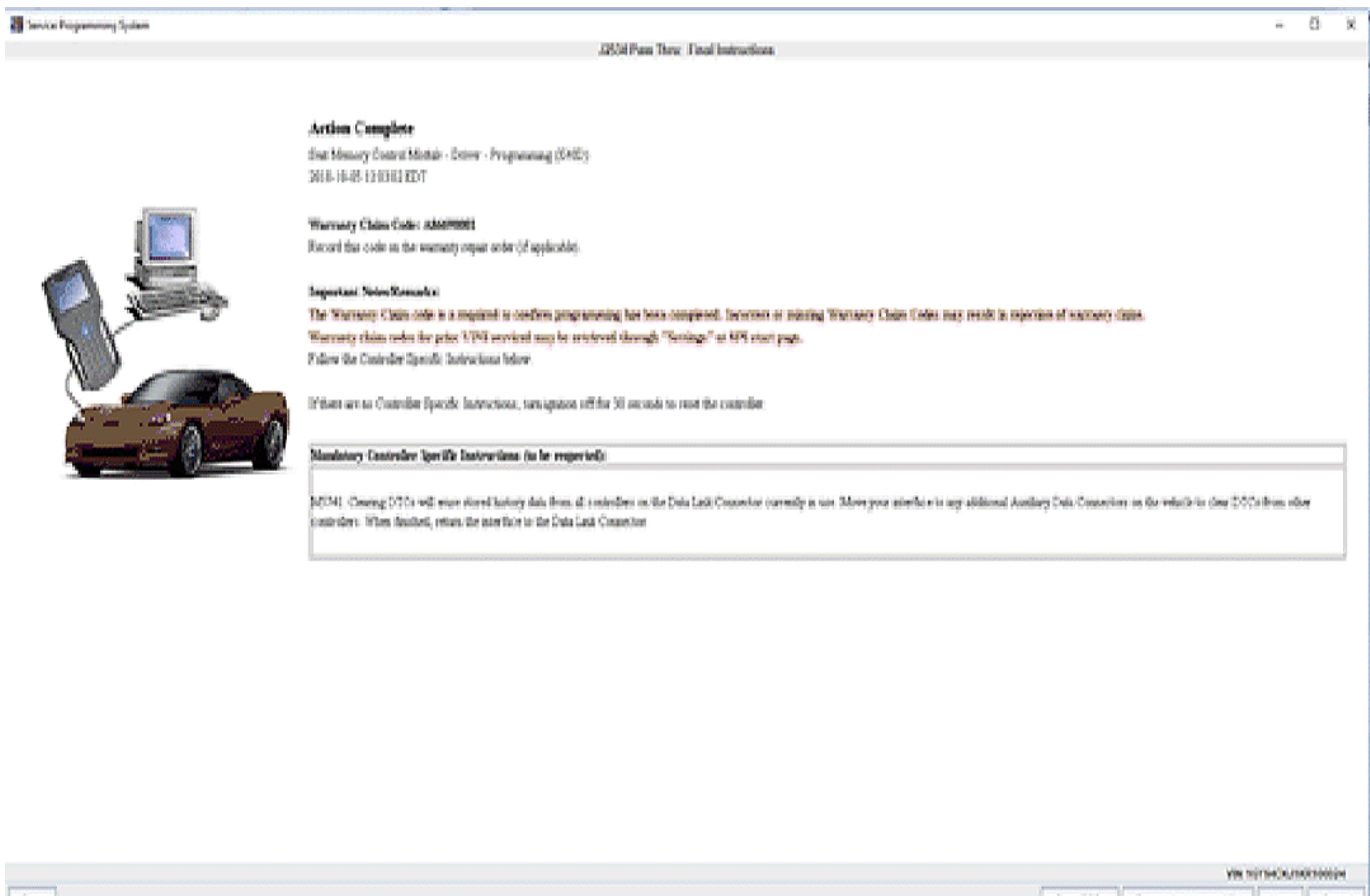
5164843

M6991: You are attempting to reprogram with the same calibration.
This is not allowed for the selected ECU. Please record Warranty Claim Code: A86690002

- Record SPS Warranty Claim Code on job card for warranty transaction submission.
