Service Bulletin

Bulletin No.: 17-NA-222

Subject: Turbocharger Whine Noise

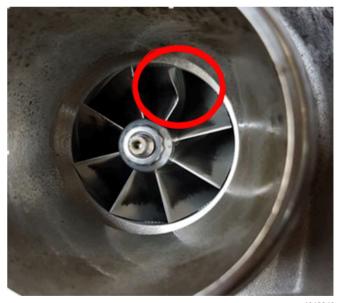
4818843

Involved Region or Country	North America and N.A. Export Regions		
Additional Options (RPOs)	Equipped with 2.8L Diesel Engine (RPO LWN)		
Condition	Some customers may comment on a whine noise during acceleration, in gear, or Neutral.		
Cause	This condition may be caused by a bent turbocharger compressor blade.		
Correction	Replace the turbocharger.

If you encounter a vehicle with the above concern, inspect the turbocharger compressor blades.

If one of the blades is bent as illustrated above, replace the turbocharger. Refer to *Turbocharger Replacement* in SI.

If none of the blades are bent, continue diagnosis referring to SI.
