Technical Service Bulletin

19 Water pump/thermostat housing revised repair procedure

19 19 99 2052657/3 October 16, 2019. Supersedes Technical Service Bulletin Group 19 number 18-96 dated November 21, 2018 for reasons listed below.

Model(s)	Year	VIN Range	Vehicle-Specific Equipment
All	2013 - 2019	All	EA888 Evo2 Engine
All	2015 - 2019	All	EA888 Gen3 Engine

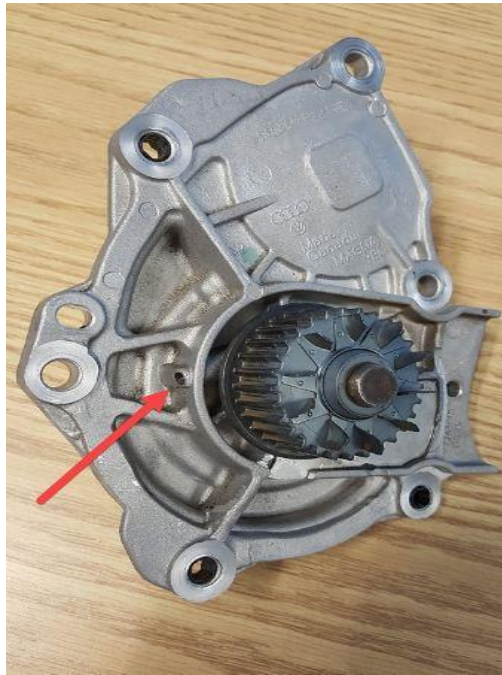
The water pump should only be replaced if there is a leak from the control/weep hole (Figure 1). All other replacements are unauthorized i.e. combination replacement with the thermostat housing.

Figure 1. Control/weep hole leak.

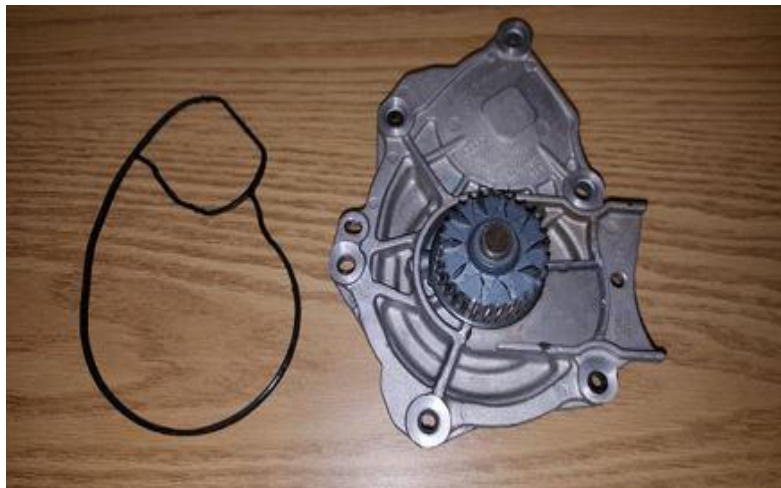
Figure 2. Water pump replacement required parts.

Do not replace the thermostat housing and the water pump at the same time. Regardless of which part is replaced, the seal must be replaced as well (Figure 2 and 3).

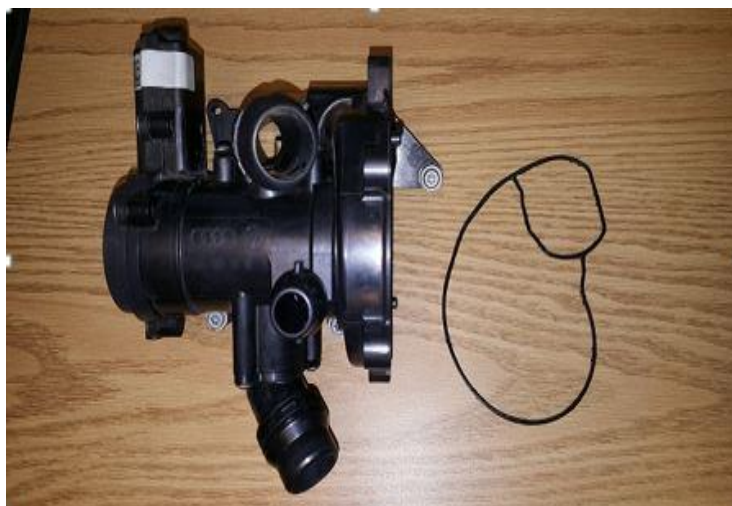
Figure 3. Thermostat housing replacement required parts.
