#### 87 Faint high-frequency noise in the instrument panel area during A/C operation

87 19 00 2056182/2 October 22, 2019. Supersedes Technical Service Bulletin Group 87 number 19-97 dated September 20, 2019 for reasons listed below.

| Model(s) | | Year | VIN Range | Vehicle-Specific Equipment | |
|---|---|---|---|---|--|
| | RS3 | 2017 – 2020 | All | Not Applicable | |

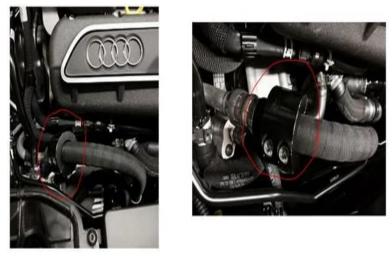
Figure 1. Balance weight positioning on the low side refrigerant line.

Install balance weight part number 5Q0 820 899 on the refrigerant line (Figure 1). Install the balance weight using 2 bolts part number WHT 003 121. Apply medium strength thread locking compound to the bolts such as locking fluid D 185 410 A2.

2. Tighten the bolts to 13 Nm (+/- 3

Nm).

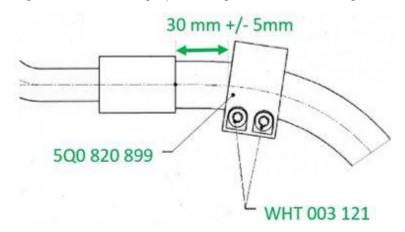
Figure 2. Specification for the positioning of the balance weight.
