# Technical Service Bulletin

## 91 Rearview camera intermittently inoperative, DTC 02203 is stored in the rearview camera control module

91 19 03 2041430/7 October 22, 2019. Supersedes Technical Service Bulletin Group 91 number 19-92 dated September 27, 2019 for reasons listed below.

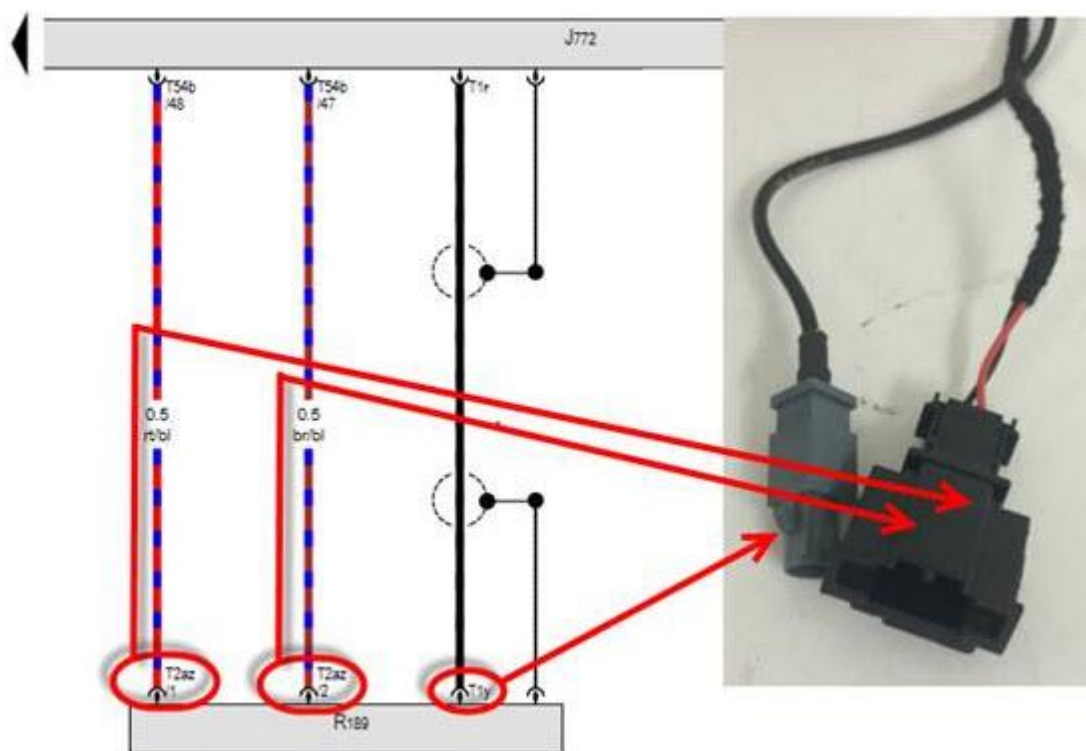
An issue with the wiring harness may cause the condition.

Figure 1. Check the wiring of the R189 reverse camera at connector T2az and T1y.

1. Before proceeding, confirm that the DTC and one of the fault symptoms listed in the *Condition* are logged in the rearview camera system control module, J772 (address word 006C). If the DTC is not listed with one of the fault symptoms, this bulletin does not apply.
2. Check the wiring of the R189 reverse camera at connector T2az and T1y (Figure 1). Repair any loose connectors or pins, corrosion, or any other physical damage.

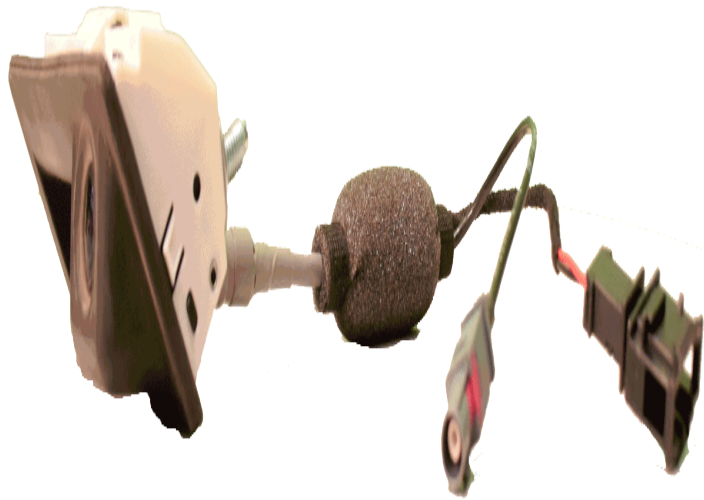
*Figure 2. Reverse camera harness to be replaced.*

If no problems are found with the wiring or connections of the rearview camera, continue to step 3 to replace the rearview camera harness (Figure 2).

3. Remove the original reverse camera from the vehicle. Follow applicable steps in the Elsa repair manual for the specific vehicle.
