SERVICE BULLETIN

APPLICABILITY: 2017-18MY Impreza
 2018MY Crosstrek
 2018MY Legacy and Outback
 2018MY BRZ*

NUMBER: 15-211-17R

SUBJECT: Reprogramming File Availability for Additional Optimization of Harman Gen 3 Audio and Navigation Head Units

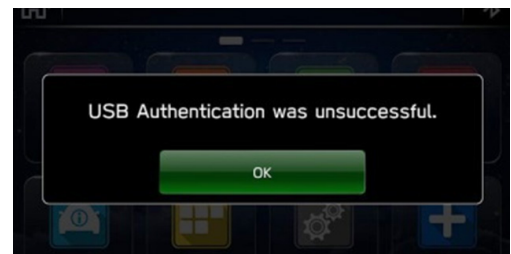
CAUTION: NEVER attempt to install this software on any 2019 MY vehicles as they are equipped with Gen 3.1 Audio/Navigation systems. This update is ONLY for models equipped with Gen 3.0 Audio/Navigation systems. Should an attempt be made to install any of these files into a Gen 3.1 head unit, the authentication error screen to the right will be displayed.

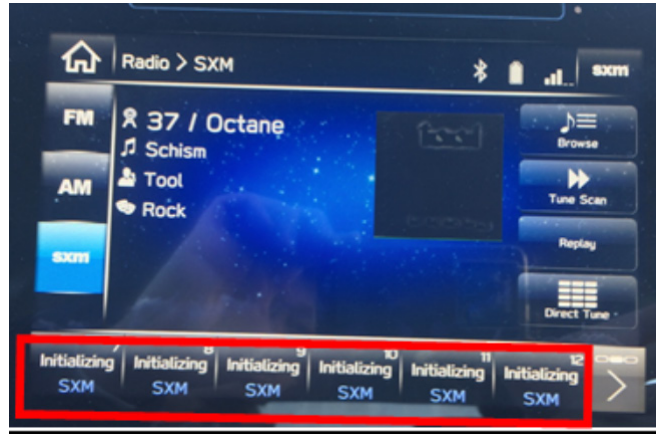
- On 2018MY Legacy / Outback models with Navigation (High) head units, the update corrects a condition where the head unit remains powered even after the ignition is OFF and the driver door is opened.
- Update for a condition where the SXM presets become lost and only “Initializing” appears as shown below.

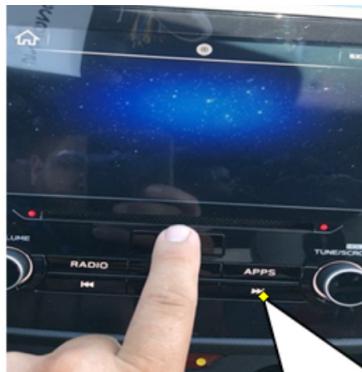
- Update for condition where only the star field background is displayed (without icons) after the HOME button is pressed.

Background shown, but no icons

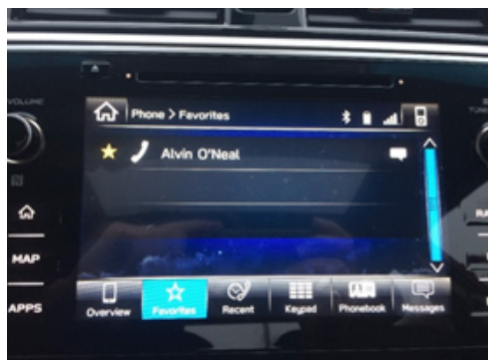
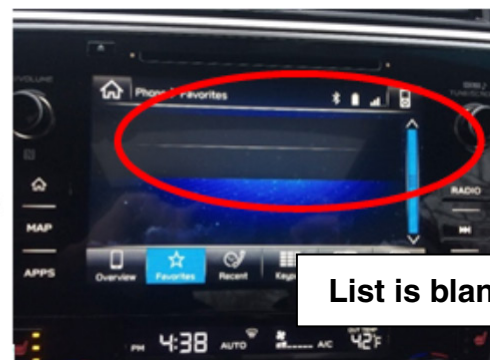
- Update for a “Pop” or “Crackling“ sound concern when listening to AM radio.
- Update for a concern of the head unit continually resetting itself.
- Update for a concern of after selecting a contact to be a “Favorite” and the “Favorite” list display is blank.

List is blank

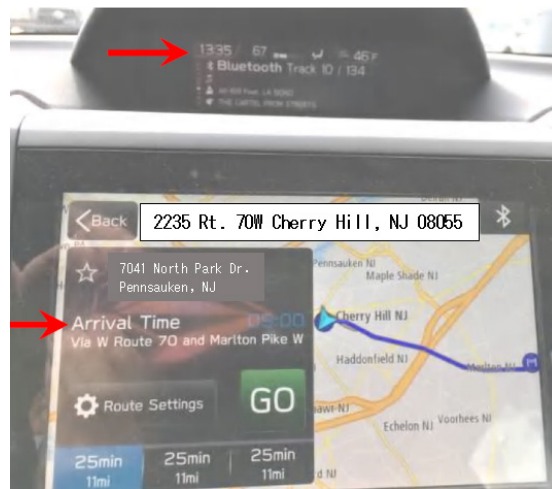
- 2) Time of day displayed in the MFD is incorrect and the arrival time displayed in Navigation unit is also incorrect.

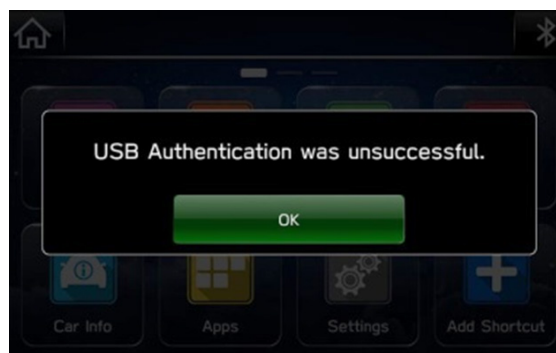
NOTE: If an attempt is made to install the wrong “grade” file into the wrong grade head unit (EXAMPLE: “Base” update file into a “Mid” or “High” head unit), the USB Authentication error screen below will be displayed:
