## The intake manifold pressure sensor has a malfunction

Topic number	LI54.18-P-056664
Version	2
Design group	54.18 Cable harnesses
Date	02-06-2014
Validity	Models 172, 204, 207, 212 with engine 271.8 (evo) Only vehicles up to production date 11/2011 are affected. Up to chassis end numbers: 204xxx xA 651830 204xxx xF 808353 204xxx xR 213247 204xxx xL 160434 207xxx xF153320 212xxx xA 556108 212xxx xL 050892 172xxx xF 031052
Reason for change	Fault code adjusted
Reason for block

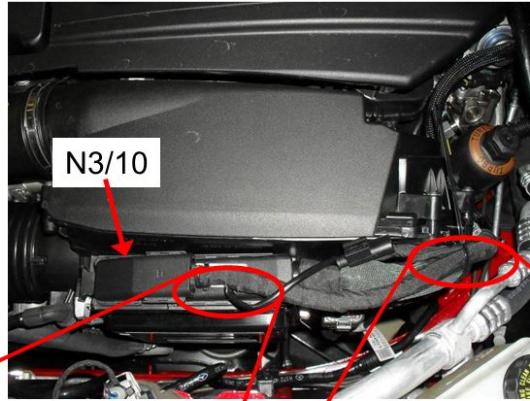
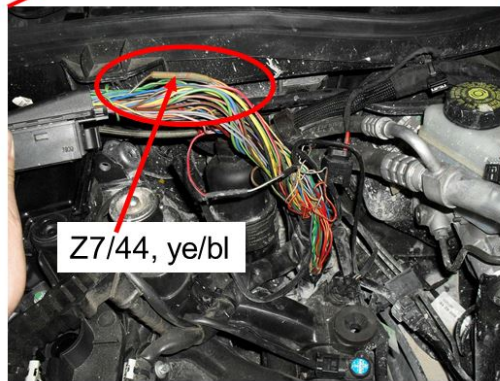
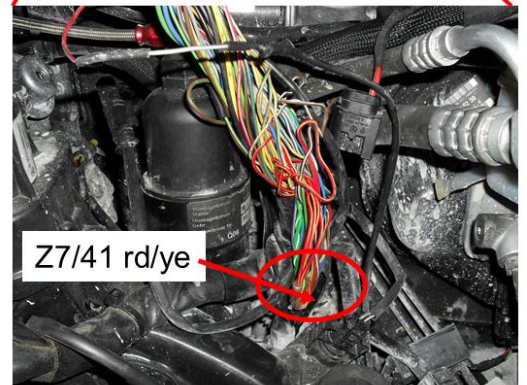
position Z-Connector.  
JPG:

Possible transition resistances in engine wiring harness.

- Check engine compartment wiring harness for chafe marks and repair if necessary.
  - Check ground connections of engine control unit and clean/repair if necessary.
- If no noticeable problems are found, perform the following work:
- Cut the Z-connector sleeves (Z7/41, Z7/44, see Figure 1 for location) out of the wiring harness and repair using a solder connector; insert an extension piece with solder connectors if necessary.
