Technical product information

Topic	Active engine mount replacement
Market area	Bentley: worldwide (2WBE),Hongkong-Macau (5HK)
Brand	Bentley
Transaction No.	2055760/1
Level	EH
Status	Approval
Release date

Bentayga

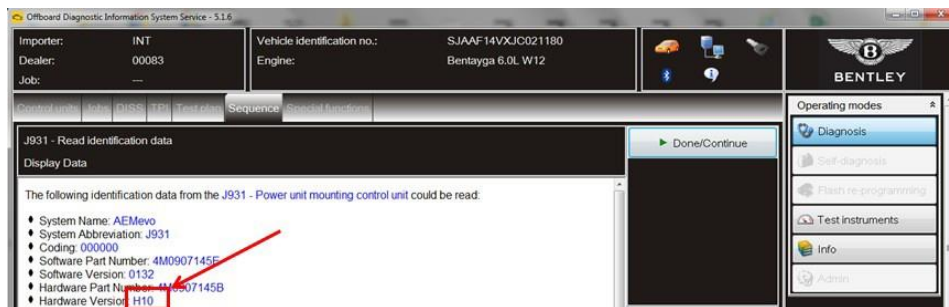
- Ensure that both active engine mounts are now fitted with part numbers 4M0199255/6 BH
- Check and confirm the Hardware version number of address 00BA *Assembly Mounting*, the hardware version must be H10.

■ Figure 1 shows the Hardware version number to be H10

- Should the Hardware version number not be H10, you must replace the Active engine mount control module with part number 4M0 907 145 E.
