Passenger-side wiper arm strikes vent grille of water collector

Topic number	LI82.30-P-058874
Version	1
Design group	82.30 Windshield wipers
Date	04-10-2014
Validity	X204 as of 03.02.2014 up to 2049XXXG308033
Reason for change	
Reason for block

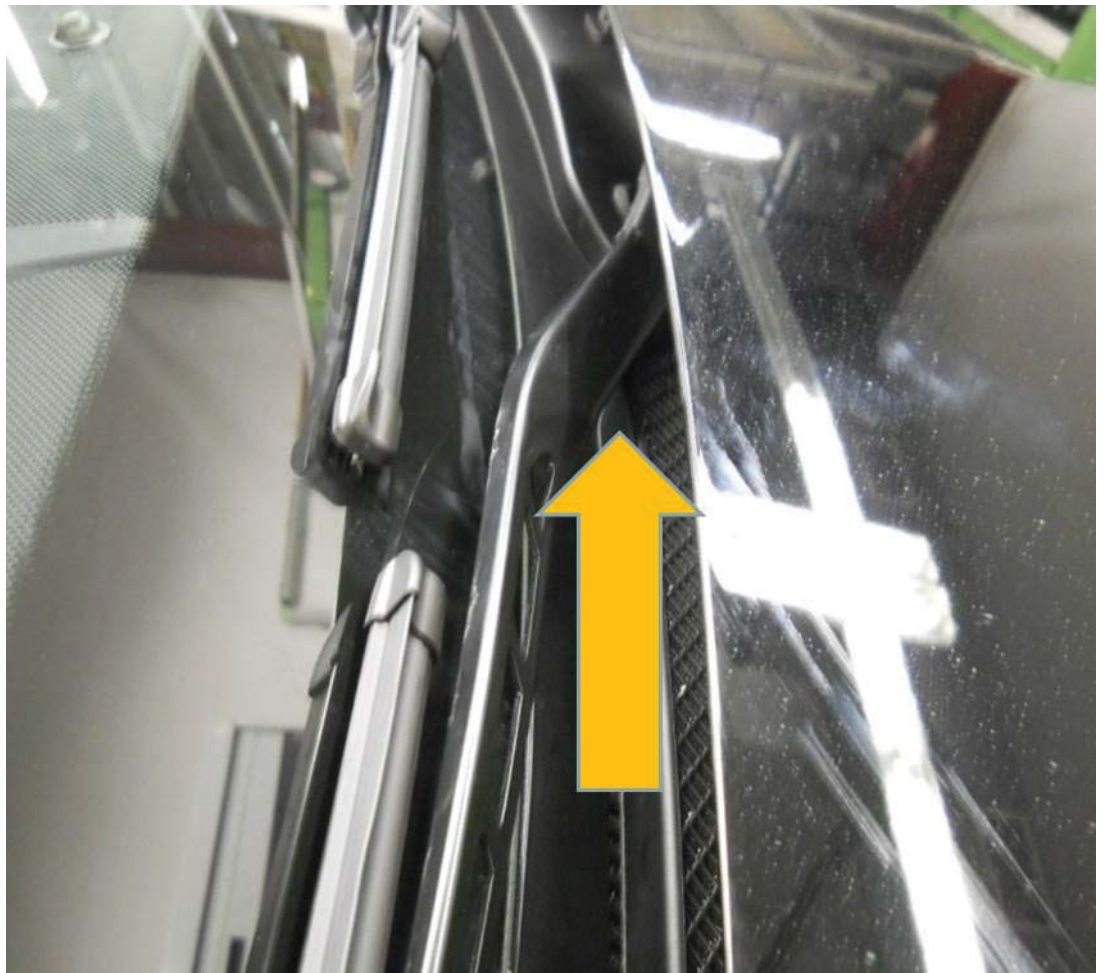
Bild 1.jpg:

Passenger-side wiper arm strikes vent grille of water collector (Figure 1).

Attachments	
File	Designation
Bild 1.jpg	Collision of passenger-side wiper arm with vent grille of water collector

Passenger-side wiper arm set too low.

With the implementation of the new wiper system from February 2014, the wiper arm must be positioned further up due to the modified geometry, otherwise it collides with the vent grille of the water collector.

Loosen wiper arm, adjust by 1-2 teeth and retighten.

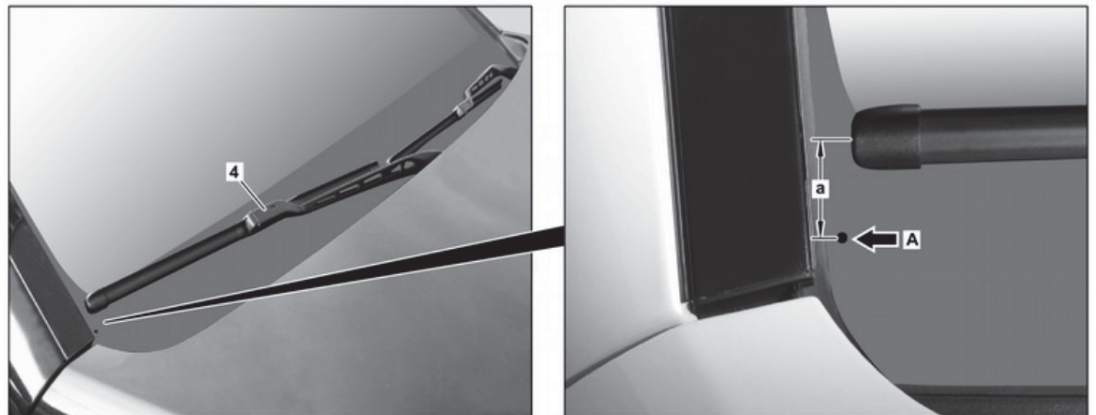
Bild 2.JPG:

Attachments	
File	Designation
Bild 2.JPG	Rest position of blade tip of passenger-side wiper arm 21 mm above marking

For correct setting see Figure 2: A - Marking on windshield, a = 21 mm
