SERVICE BULLETIN

Classification: AT18-003d	Reference: NTB18-058d	Date: October 9, 2019
------------------------------	--------------------------	--------------------------

2013-2017 SENTRA AND VERSA SEDAN, AND 2014-2017 VERSA NOTE; ENHANCED DIAGNOSTIC LOGIC FOR CVT

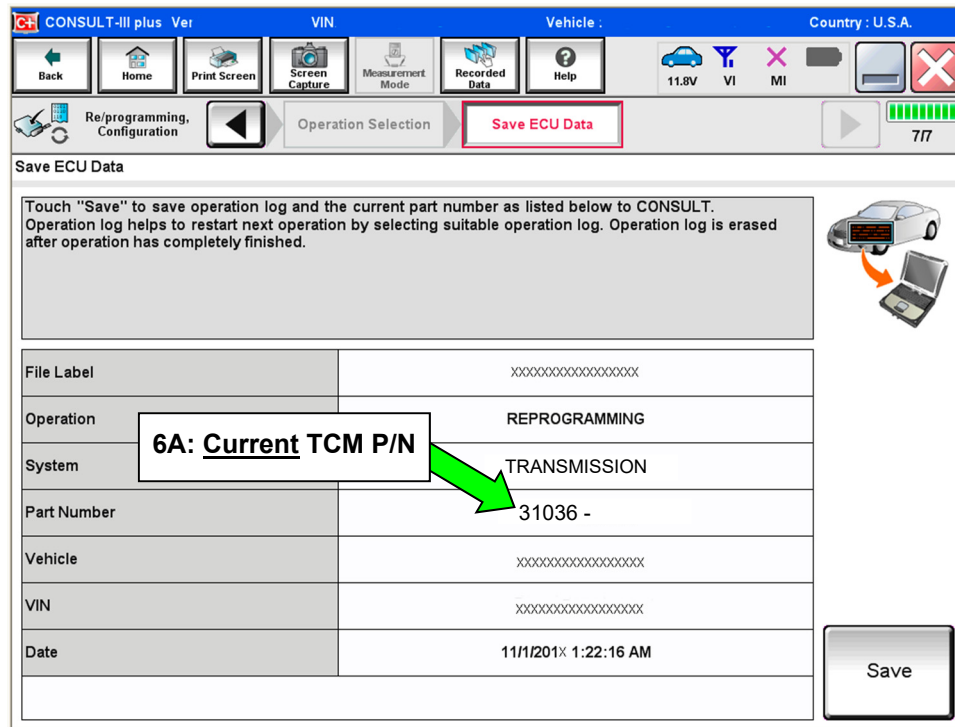
Figure 2

6. When you get to the screen shown in Figure 2, confirm this bulletin applies as follows:
- A. Find the TCM **Part Number** and write it on the repair order.

NOTE: This is the current TCM Part Number (P/N).

- B. Compare the P/N you wrote down to the numbers in the **Current TCM Part Number** column in **Table A** on the next page.
- If there is a match, this bulletin applies. Continue with the reprogramming procedure.
 - If there is not a match, this bulletin does not apply. Refer to ASIST for further diagnostic and repair information.

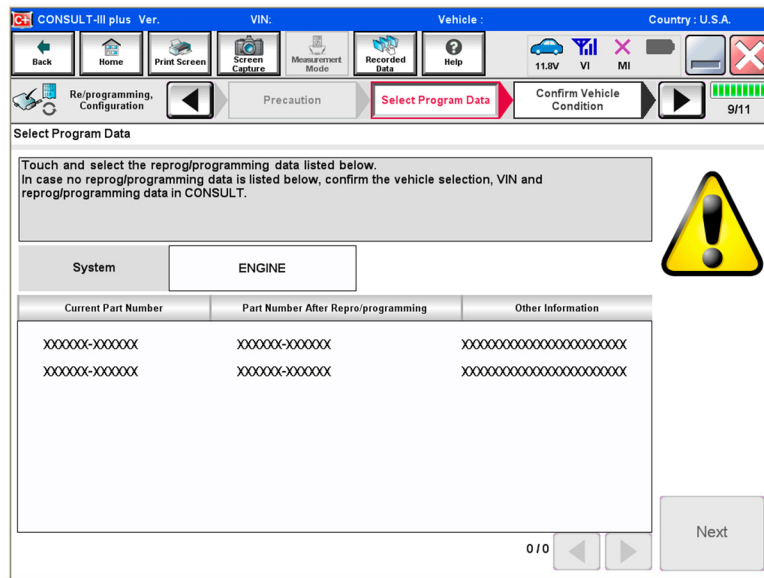
- In some cases, more than one new P/N for reprogramming is available.
 - If there is more than one new P/N, the screen in Figure 3 displays.
 - Select and use the reprogramming option that **does not** have the message “Caution! Use ONLY with NTBXX-XXX”.
- If you get this screen and it is blank (no reprogramming listed), it means there is no reprogramming available for this vehicle.

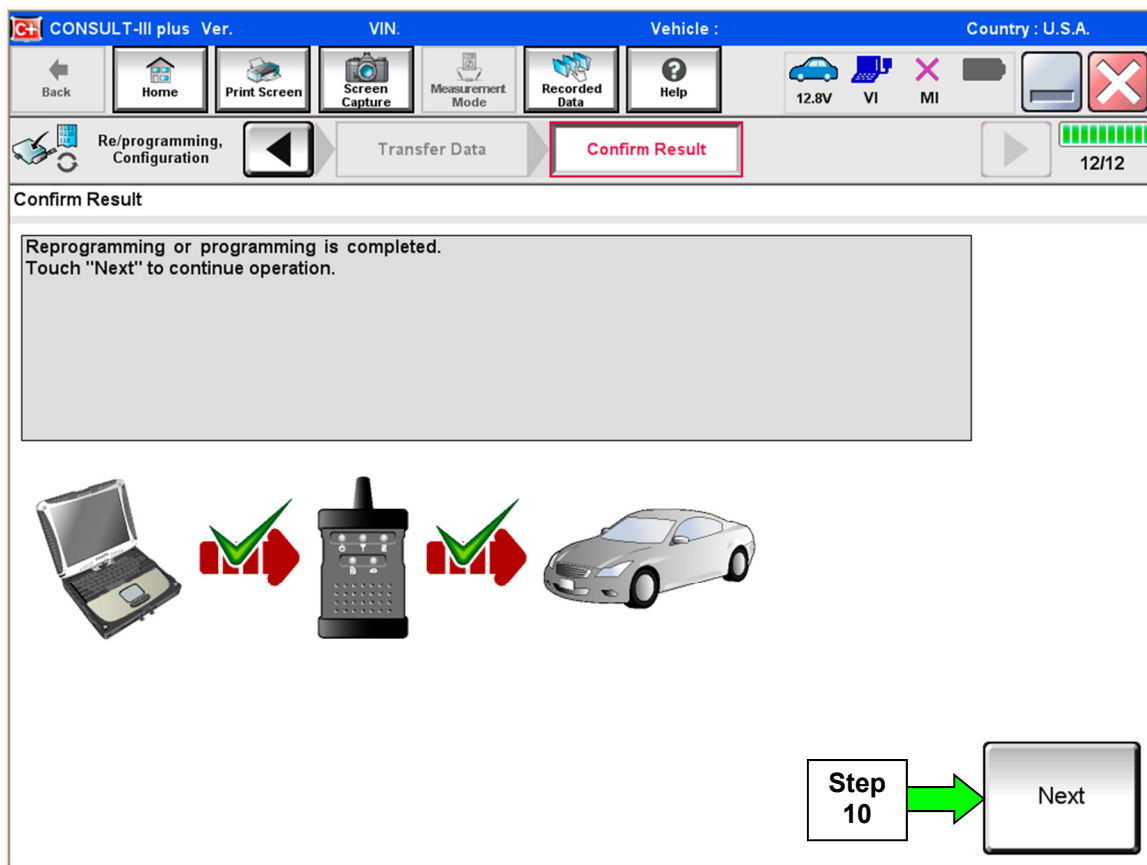
8. When the screen in Figure 5 displays, reprogramming is complete.

NOTE: If the screen in Figure 5 does not display (indicating that reprogramming did not complete), refer to the information on the next page.

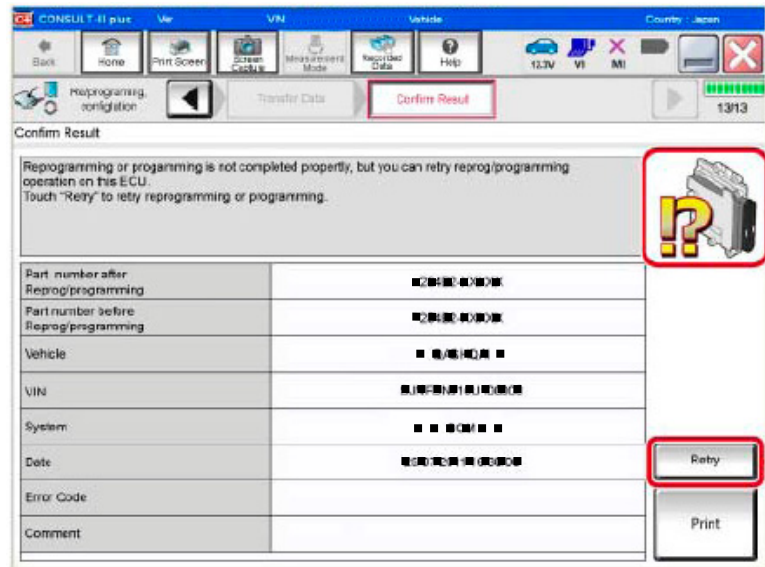
Figure 6

If reprogramming does not complete and the “!?” icon displays as shown in Figure 6:

- Check battery voltage (12.0–15.5 V).
- Ignition is ON, engine OFF.
- External Bluetooth® devices are OFF.
- All electrical loads are OFF.
- **Select retry and follow the on screen instructions.**
- “Retry” may not go through on first attempt and can be selected more than once.

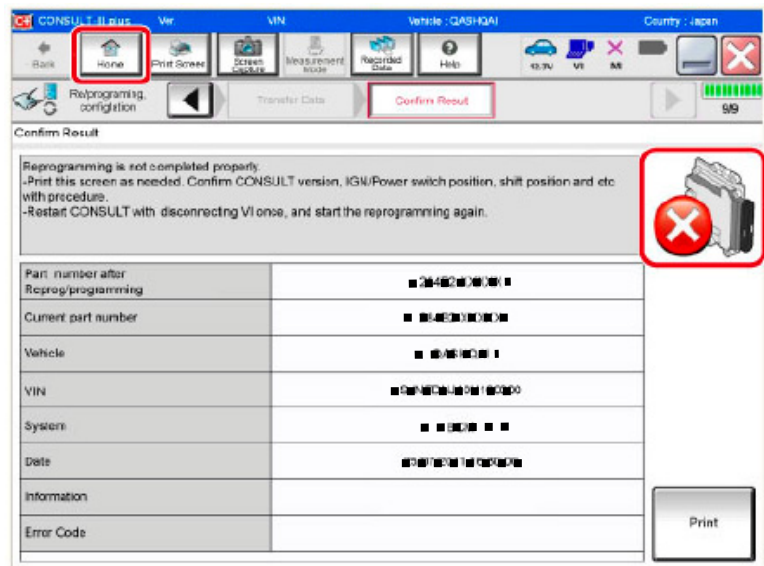
Figure 7

If reprogramming does not complete and the “X” icon displays as shown in Figure 7:

- Check battery voltage (12.0 – 15.5 V).
- CONSULT A/C adapter is plugged in.
- Ignition is ON, engine OFF.
- Transmission is in Park.
- All C-III plus / plus VI cables are securely connected.
- All C-III plus updates are installed.
- **Select Home, and restart the reprogram procedure from the beginning.**

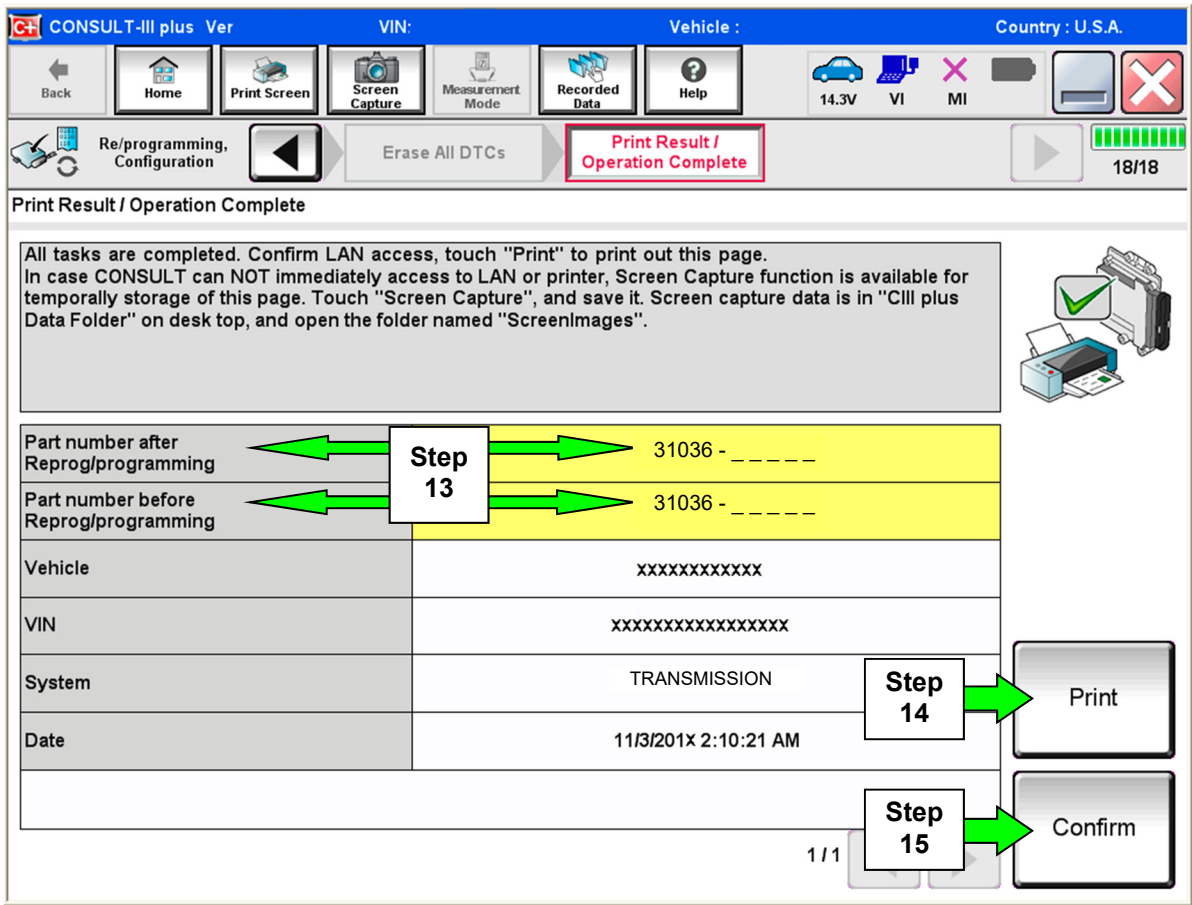
- 11. Follow the on-screen instructions to **Erase All DTCs**.
- 12. When the entire reprogramming process is complete, the screen in Figure 8 will display.
- 13. Verify the before and after part numbers are different.
- 14. Print a copy of this screen (Figure 8) and attach it to the repair order for warranty documentation.
- 15. Select **Confirm**.
