# SERVICE BULLETIN

Classification: EC18-028b	Reference: NTB18-062b	Date: October 24, 2019
------------------------------	--------------------------	---------------------------

## 2018 ARMADA AND TITAN; MIL ON WITH DTC P0138 AND/OR P0158

- APPLIED VEHICLES:** 2018 Armada (Y62)  
2018 Titan (A61)  
2018 Titan XD (A61)
- APPLIED ENGINE:** VK56VD (gasoline V8)

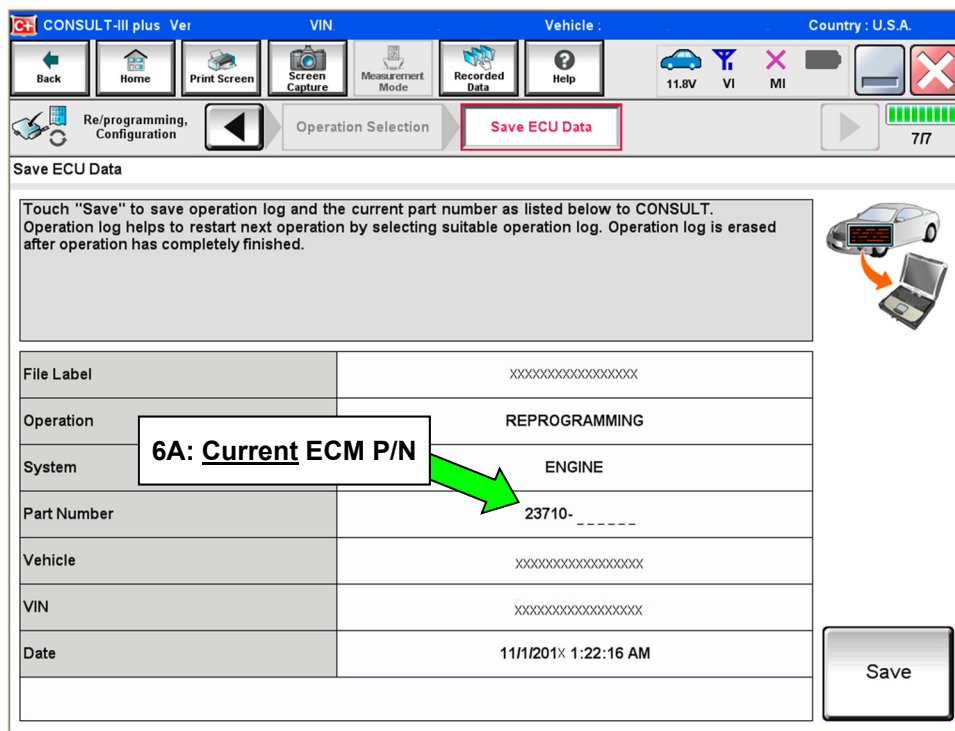
6. When the screen in Figure 2 displays, confirm this bulletin applies as follows.

A. Find the ECM **Part Number** and write it on the repair order.

**NOTE:** This is the current ECM Part Number (P/N).

B. Compare the P/N you wrote down to the numbers in the **CURRENT ECM PART NUMBER** column in **Table A** below.

- If there is a match, this bulletin applies. Continue with the reprogramming procedure.
- If there is not a match, reprogramming does not apply. Refer to ASIST for further diagnosis.

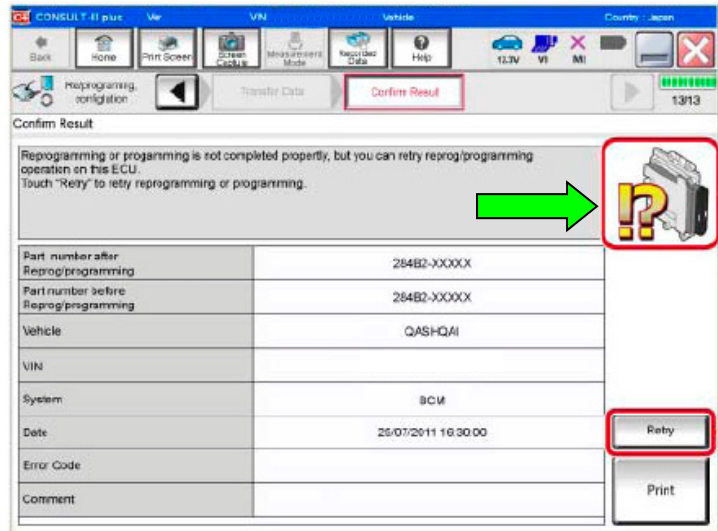
Figure 6

If reprogramming does not complete and the “!?” icon displays as shown in Figure 6:

- Check battery voltage (12.0 - 15.5 V).
- Ignition is ON, engine OFF.
- External Bluetooth® devices are OFF.
- All electrical loads are OFF.
- **Select retry and follow the on screen instructions.**
- **“Retry” may not go through on first attempt and can be selected more than once.**

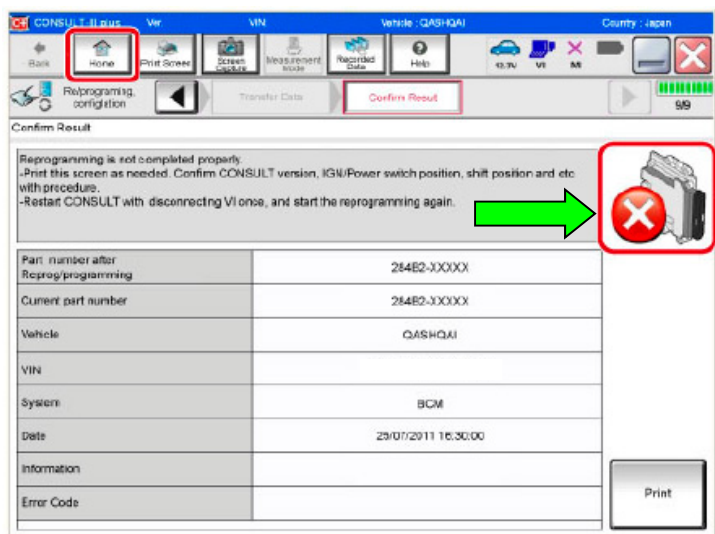
Figure 7

If reprogramming does not complete and the “X” icon displays as shown in Figure 7:

- Check battery voltage (12.0 - 15.5 V).
- CONSULT A/C adapter is plugged in.
- Ignition is ON, engine OFF.
- Transmission is in Park.
- All C-III plus / VI cables are securely connected.
- All C-III plus updates are installed.
- **Select Home, and restart the reprogram procedure from the beginning.**
