### PIP5495K Check Engine Light On With P0299 Or P0234

Brand:	Model:	Model Years:	VIN:		Engine:	Transmissions:
			from	to		
Buick	Encore	2013 - 2019	All	All	1.4L LUV or LUJ	All
Chevrolet	Cruze	2011 - 2016	All	All	1.4L LUV or LUJ	All
Chevrolet	Sonic	2012 - 2019	All	All	1.4L LUV or LUJ	All
Chevrolet	Trax	2013 - 2019	All *See Note	All * See Note	1.4L LUV or LUJ	All

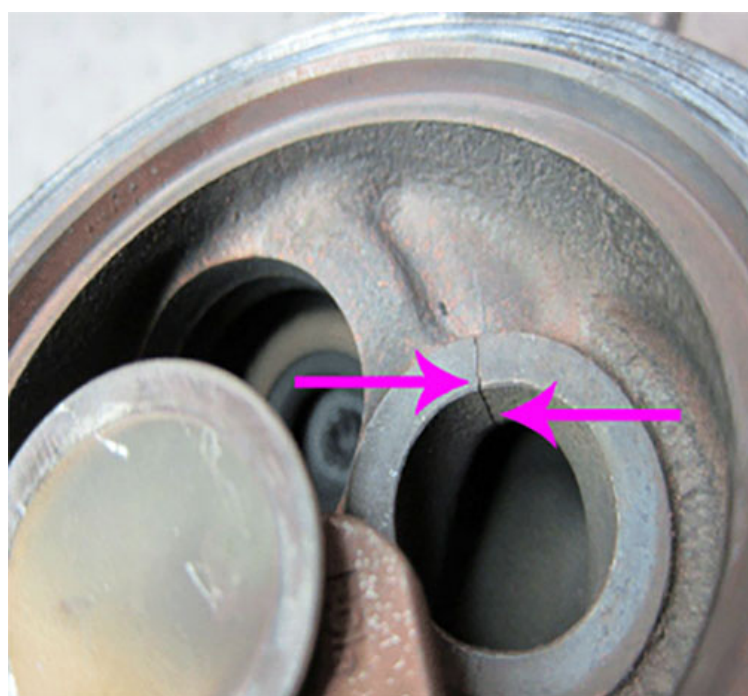
Crack(s) at the wastegate valve port (this is normal and does not affect performance)

**Wastegate solenoid valve port broken (replace solenoid valve - released for service)**

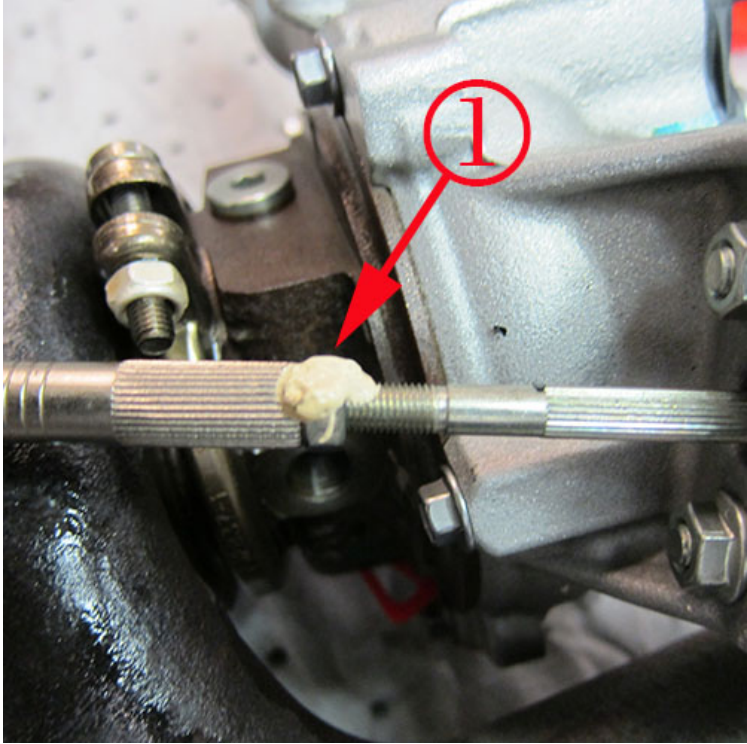
Wastegate actuator clip missing (replace wastegate actuator clip - released for service)

If the tamper paint seal is broken or missing, check the vehicle for any additional sign of modification to the induction, exhaust, or engine calibrations as this may indicate an attempt to adjust the wastegate arm to modify the powertrain operation.

If found, review the powertrain warranty status with your service manager prior to performing repairs

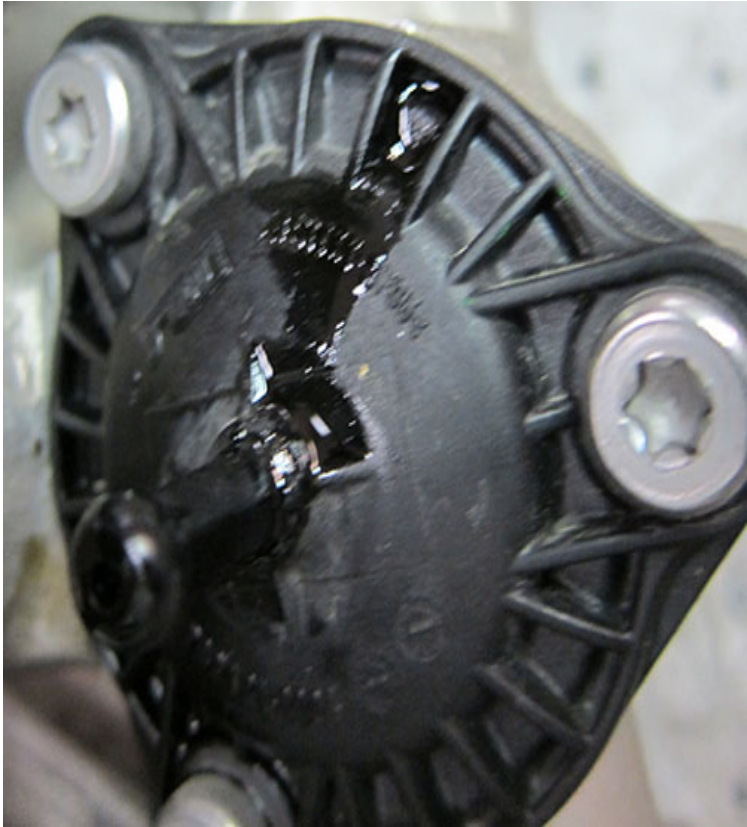
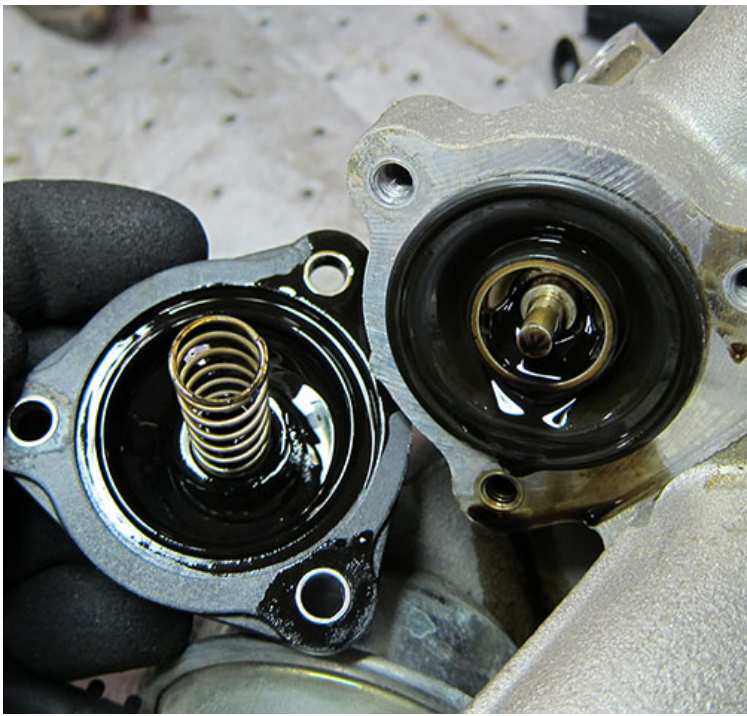
Bypass (recirculation) valve cover port broken or water/oil found inside the valve (clean the components, if necessary replace bypass (recirculation) valve assembly - released for service)

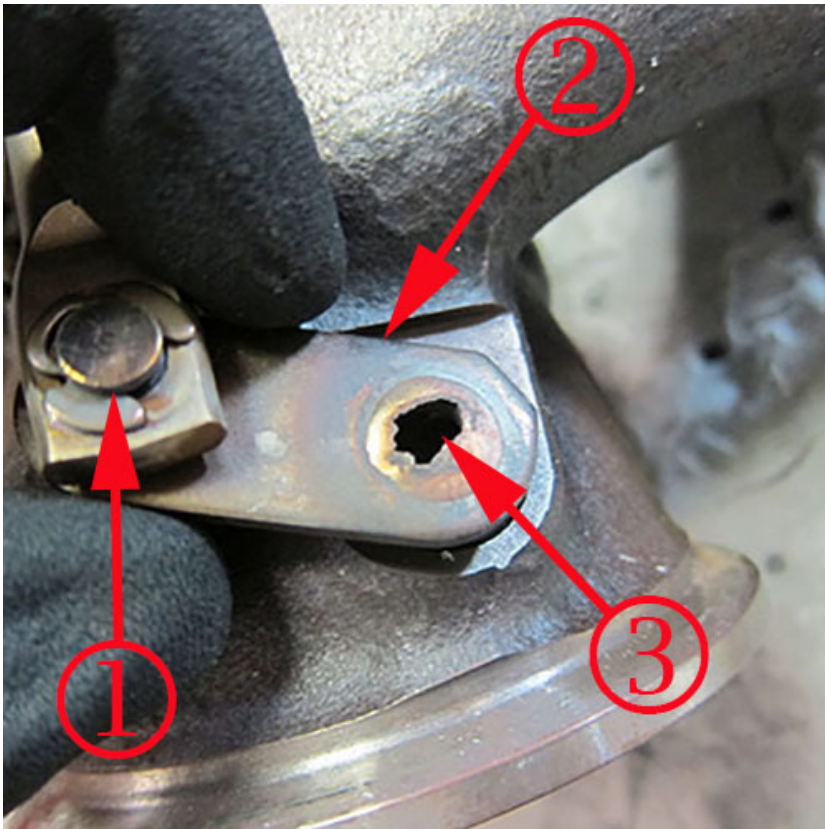
Disconnected wastegate lever arm (crank) (2) from the shaft (3).

Disconnected wastegate lever arm pin (1) from the lever arm (crank) (2).

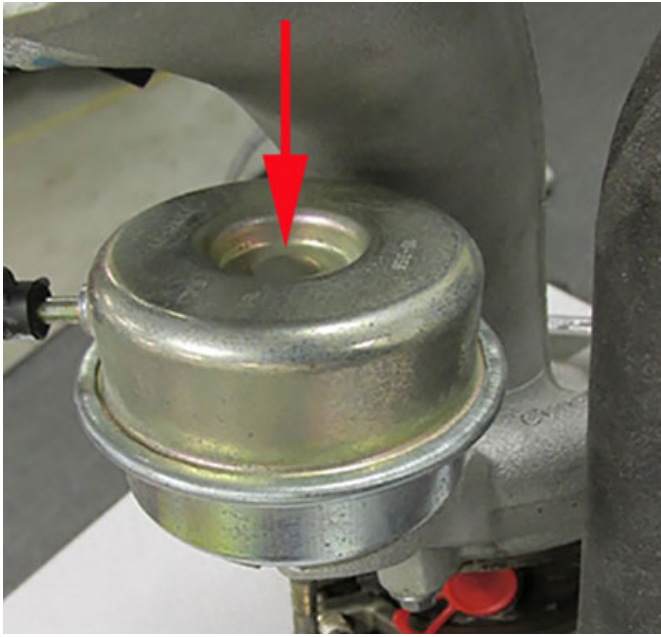
Original equipment actuator is found on 2011 and 2012 model years.

The original equipment wastegate actuator found on 2011 and 2012 model years shown below, has a recessed stop at the head of the actuator.

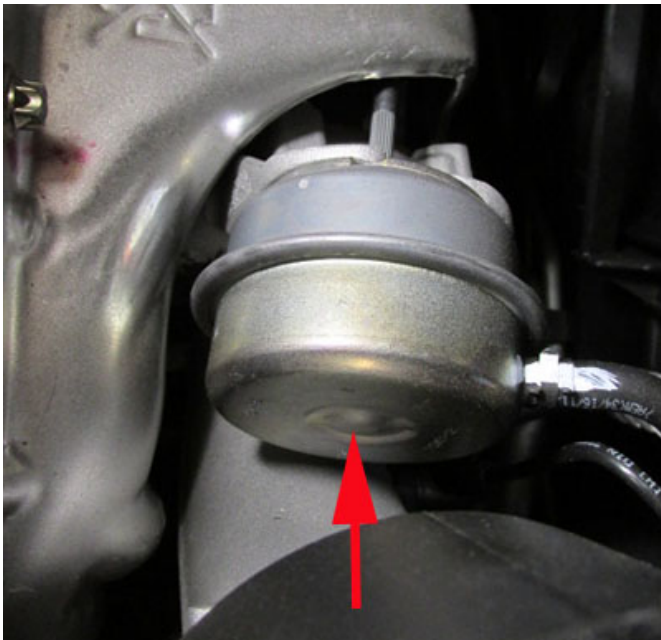
Updated design.

The updated design actuator shown below has a stop that is not recessed and allows 5mm more travel in the closed direction.

With this updated design, it is very unlikely that an insufficient preload issue exists.

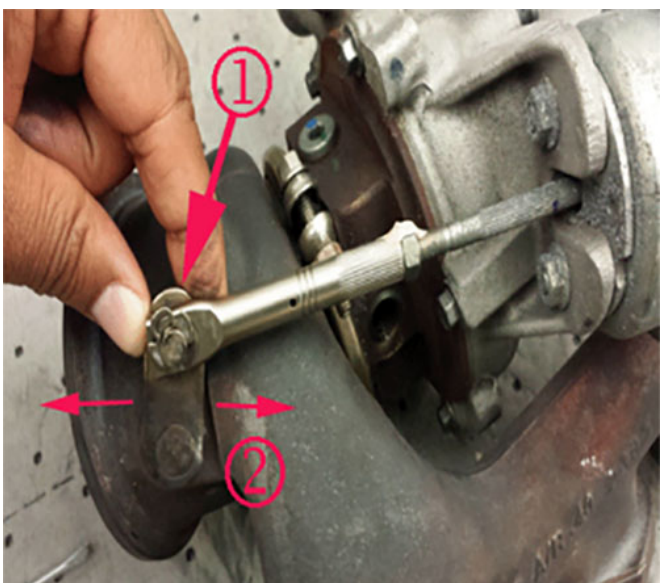
Wastegate Preload Inspection.

Wastegate lever arm (1) moves with little effort in the direction as shown (2) while the actuator rod remains static, see picture below "Wastegate Preload Inspection".

If the lever wiggles with little effort while the actuator rod remains static, the pre-load is insufficient and the turbocharger must be replaced.

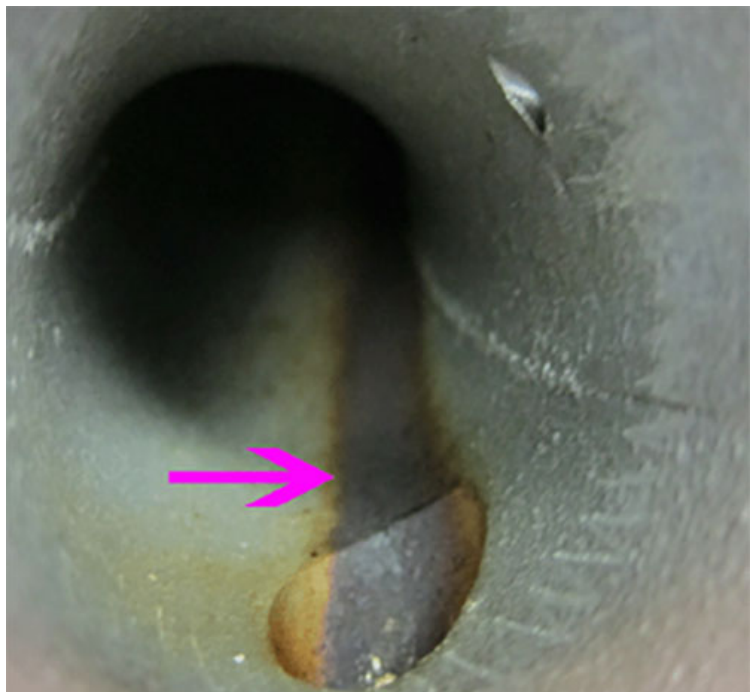
Notice: The view shown below indicates NORMAL oil staining in the turbocharger outside air inlet. This dry stain does not represent an oil leak.

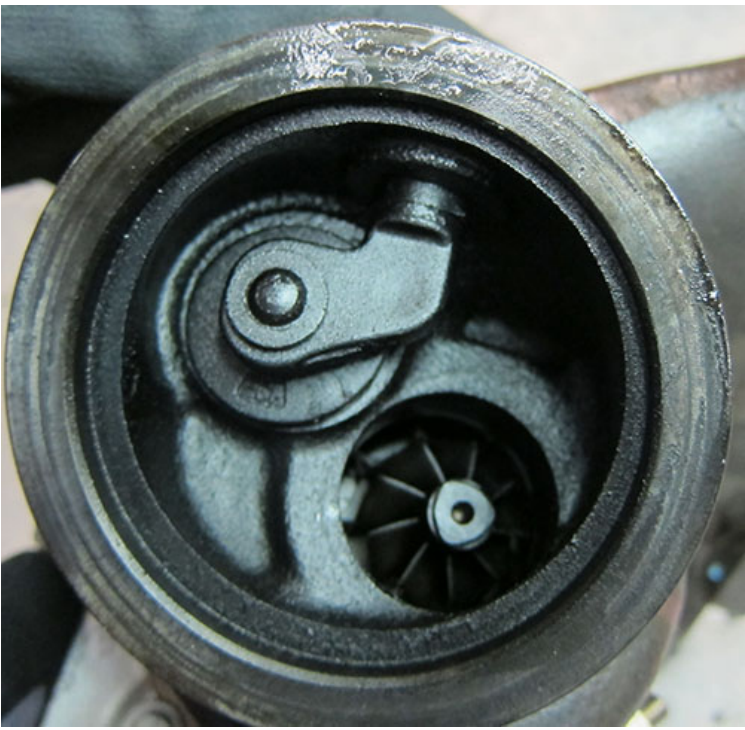
Inspect for the presence of oil in the exhaust system.

If oil is present in the exhaust system, then inspect the turbocharger turbine and compressor wheels to be sure that they are not broken off.

It is very unlikely that the turbocharger will leak oil internally if the turbine and compressor wheel shaft is not broken.

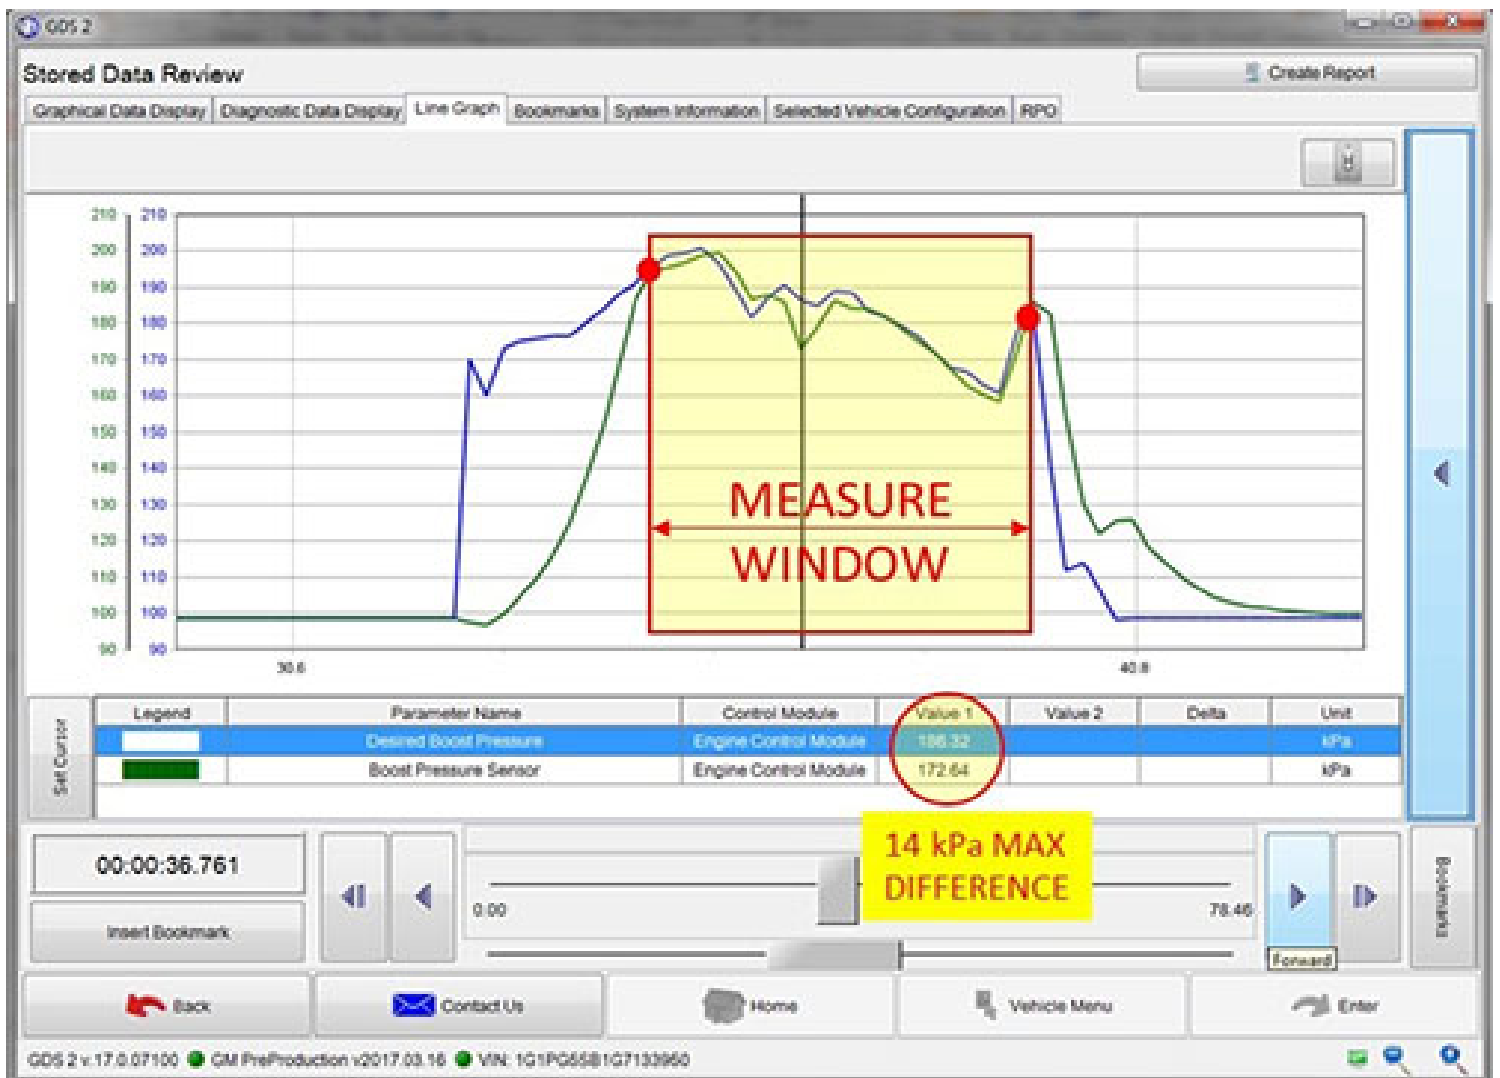
**Example of normal turbocharger wastegate operation:**

In this example, notice that the measure window begins once the Boost Pressure Sensor reading (Green) meets the Desired Boost Pressure reading (Blue) and ends when the APP is released per the testing instructions.

The Boost Pressure Sensor reading (Green) closely tracks the Desired Boost Pressure reading (Blue) indicating normal Turbocharger operation.

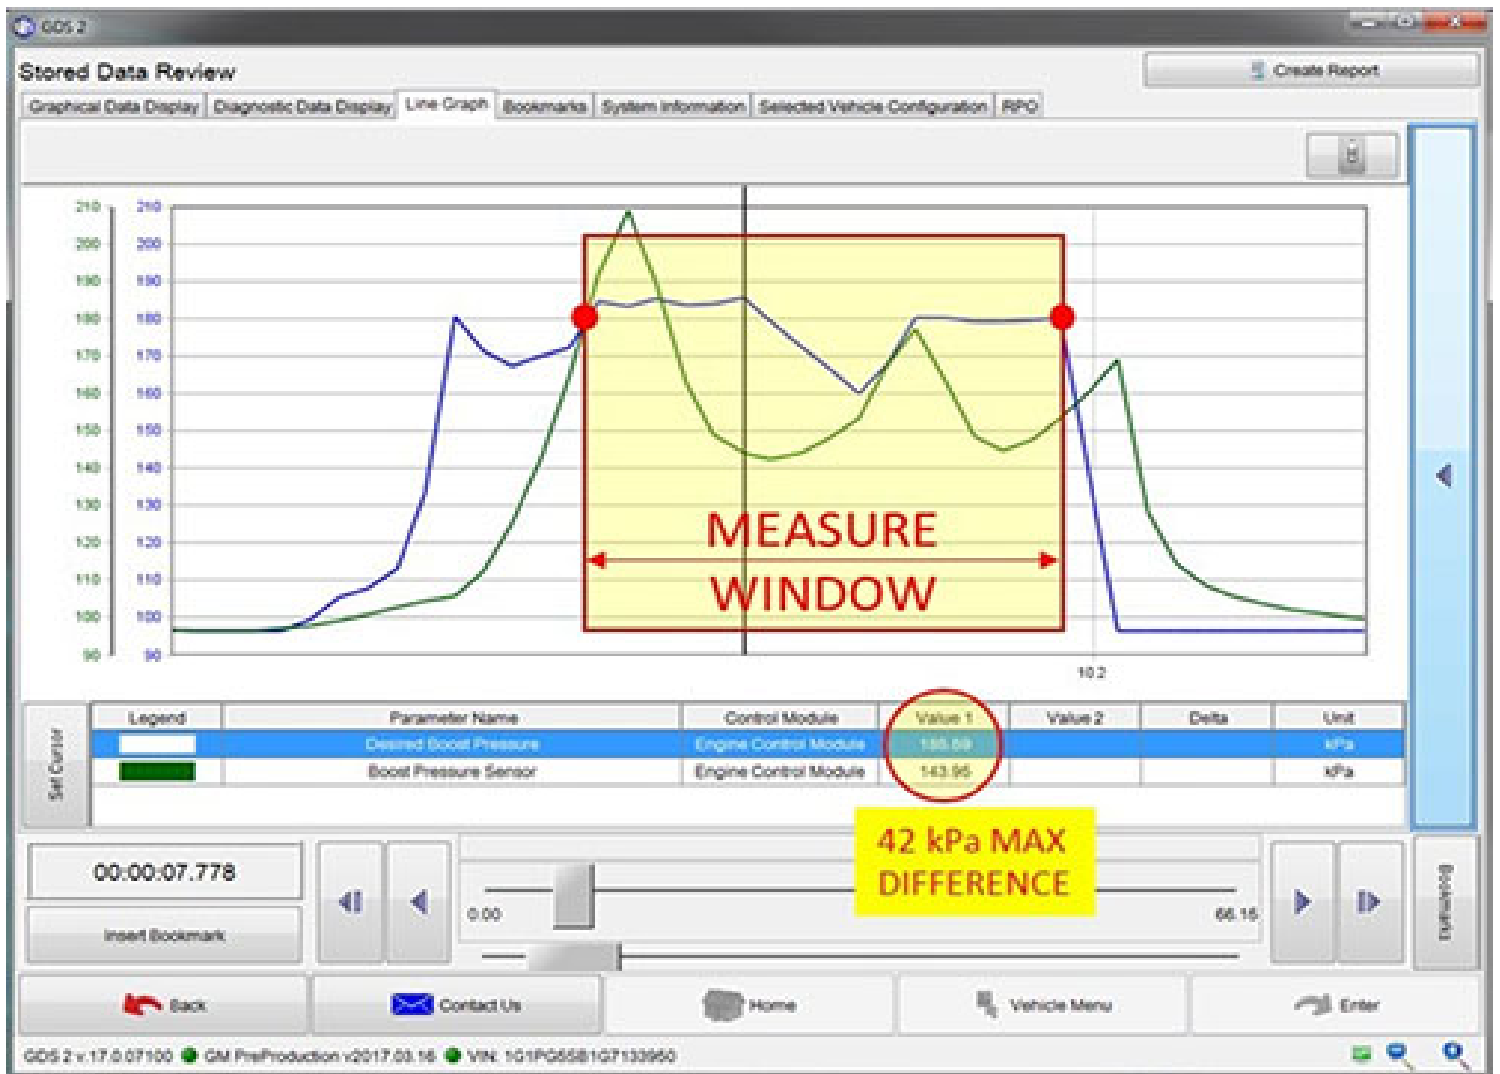
**Example of a malfunctioning turbocharger wastegate:**

In this example, notice that the Boost Pressure Sensor reading (Green) moves thru and well above the Desired Boost Pressure reading (Blue).

As the abnormally high pressure is corrected by the management system, the Boost Pressure Sensor reading (Green) over reacts and dips well below Desired Boost Pressure reading (Blue).

A difference of 14 KPA (2 PSI) between the Boost Pressure reading (Green) and the Desired Boost Pressure Sensor reading (Blue) Indicates a Malfunctioning Turbocharger.

9. Utilize the Print Screen Function to take a screen shot of GDS2 showing the line graph.
10. Replace the turbocharger if the difference within the Measured Window is more than 14 KPA (2.0 PSI) as shown in the examples.
