Preliminary Information

PIT5288H RKE / Passive Entry And Start / No Audio / SWC / Touch Screen / Display Blank/ Rear Wiper And Rear Power Windows Inoperative / Dead Battery / Service Tire Pressure System / SES MIL DTC B3101 B144C C0710 C0544 P0106 P0107 P2122 P2123 P2127 P2128 P2138 U0028 U0029 U0077 U0126 U0151 U0415 U1548 U1549 U154A

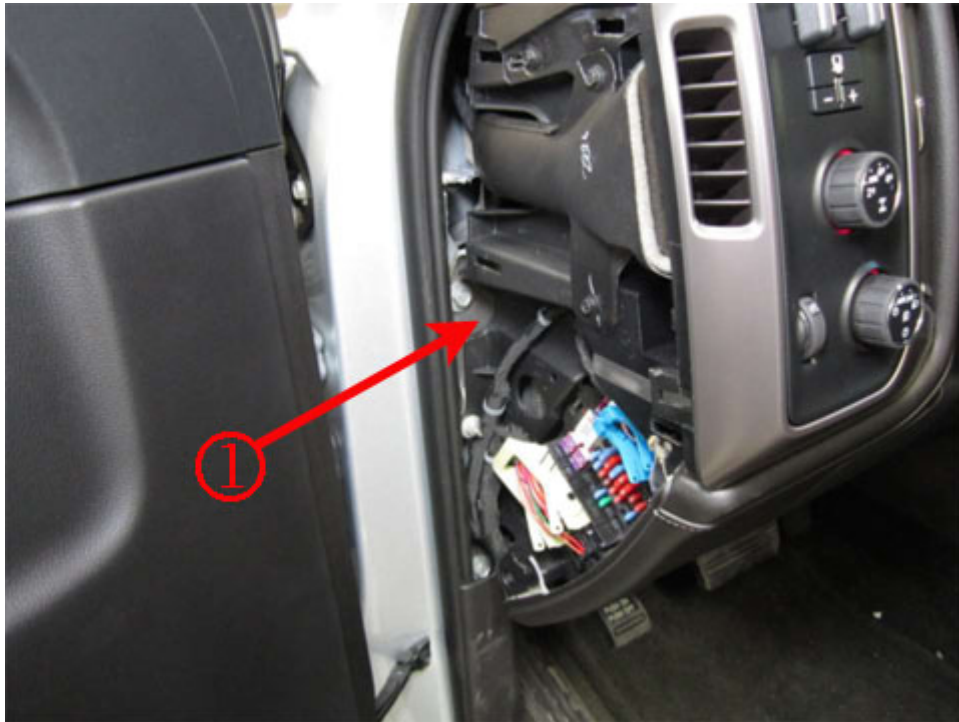
These concerns could be caused by the dash harness being pinched between the left I/P dash mounting bracket (1) and the body. Shown below, is the left I/P mounting bracket (1) as seen when the I/P fuse block cover is removed from the end of the dash. This picture is for reference only and the wiring must be inspected from under the dash.

To repair this concern, loosen the left I/P dash mounting bracket bolts and pull the harness free. Open the harness and repair any damaged wires as necessary.

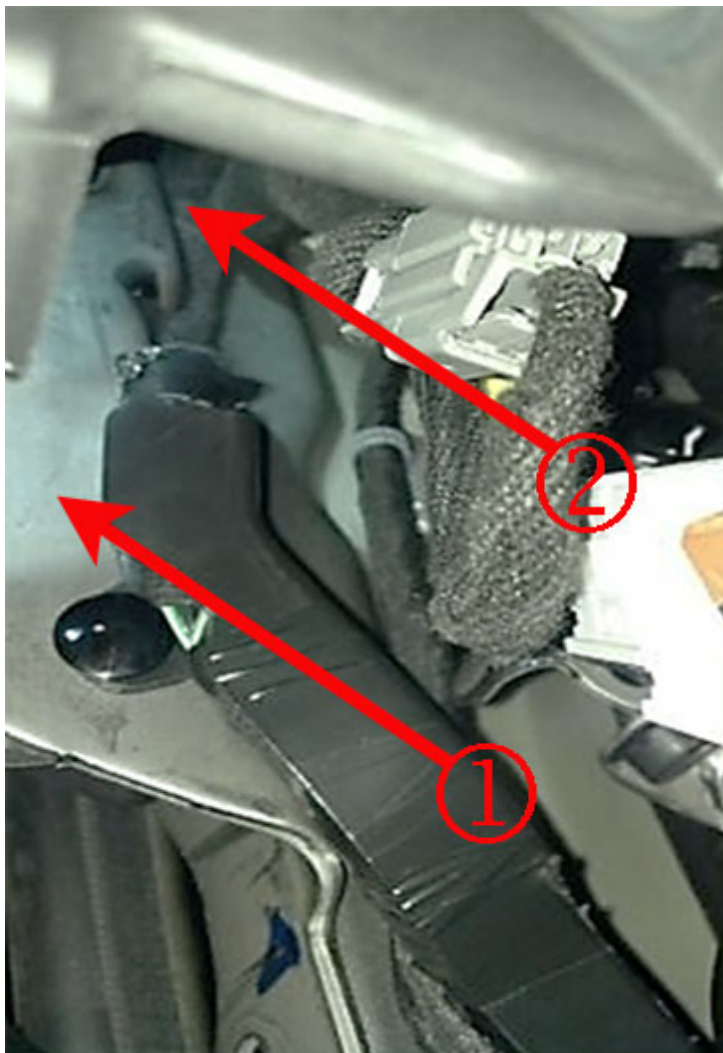
As shown below, the wiring harness (2) is pinched at the upper portion of the I/P mounting bracket (1). In many cases, the complete harness may not be pinched and it can be difficult to see that the harness is damaged. When inspecting for a pinched harness, make sure the harness can be moved freely away from the bracket to body interface.

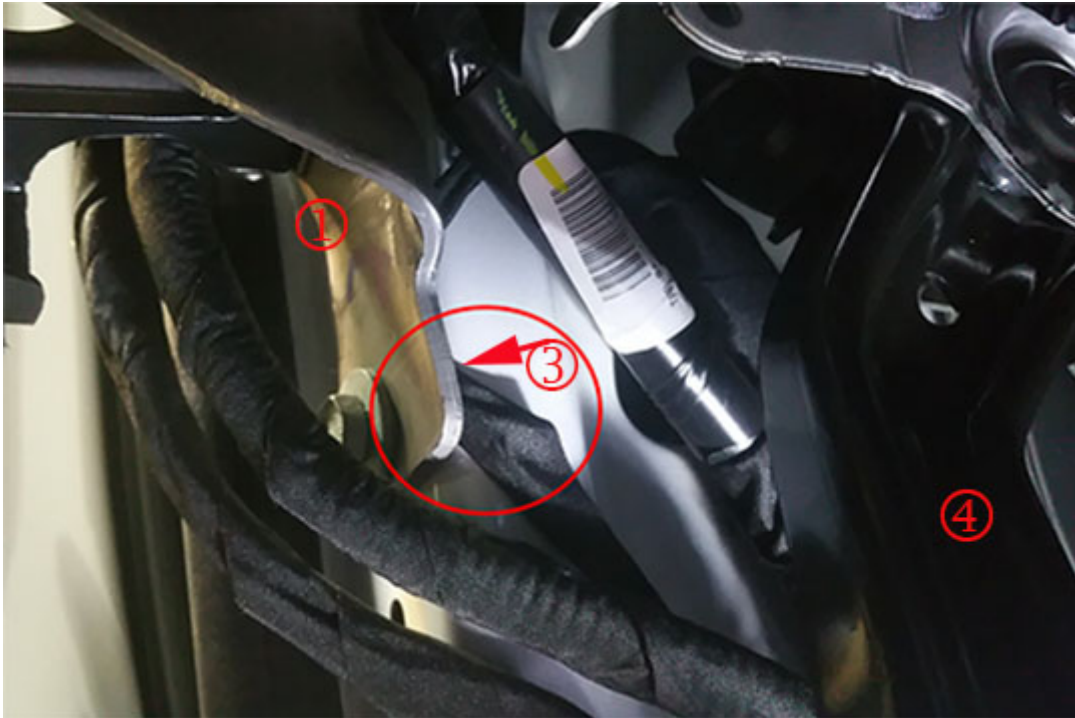
As shown below, the wiring harness (3) is pinched at the lower portion of the left I/P mounting bracket (1). For reference only, call out (4) is the parking brake pedal.
