Steering column clicking or cracking noise

Topic number LI46.10-N-058722

Design group 46.10 Steering wheel, casing tube, steering shaft, stee-

Validity Model 906 with code (XM0) Facelift

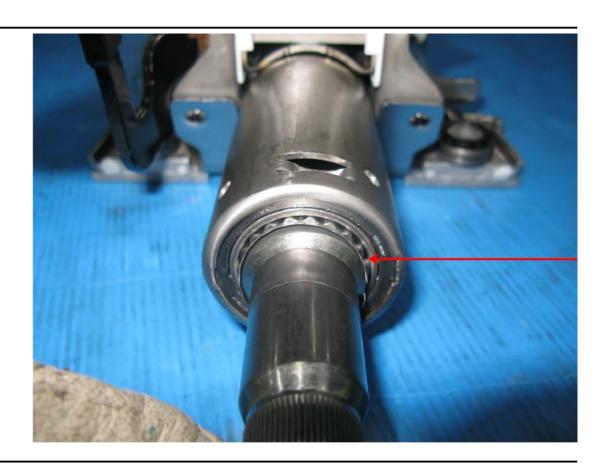
01.JPG:

Steering column clicking or cracking noise.

Steering column bearings (see Figure 01).

Attachments	
File	Designation
01.JPG	Steering column bearing

Do not replace any parts.

After a certain time or running-in period (approx. 650 miles, depending on operating conditions), the shape of the tolerance ring adapts itself to the movements of the inner bearing race and the noise disappears.
