Model series 246/176/117 center stowa- ge compartment closes/opens with difficulty

Topic number	LI68.20-P-058749
Version	1
Design group	68.20 Center console
Date	03-18-2014
Validity	Model series 246/176/117 up to production date 30.6.2013 only with automatic transmission (code 429)
Reason for change	
Reason for block

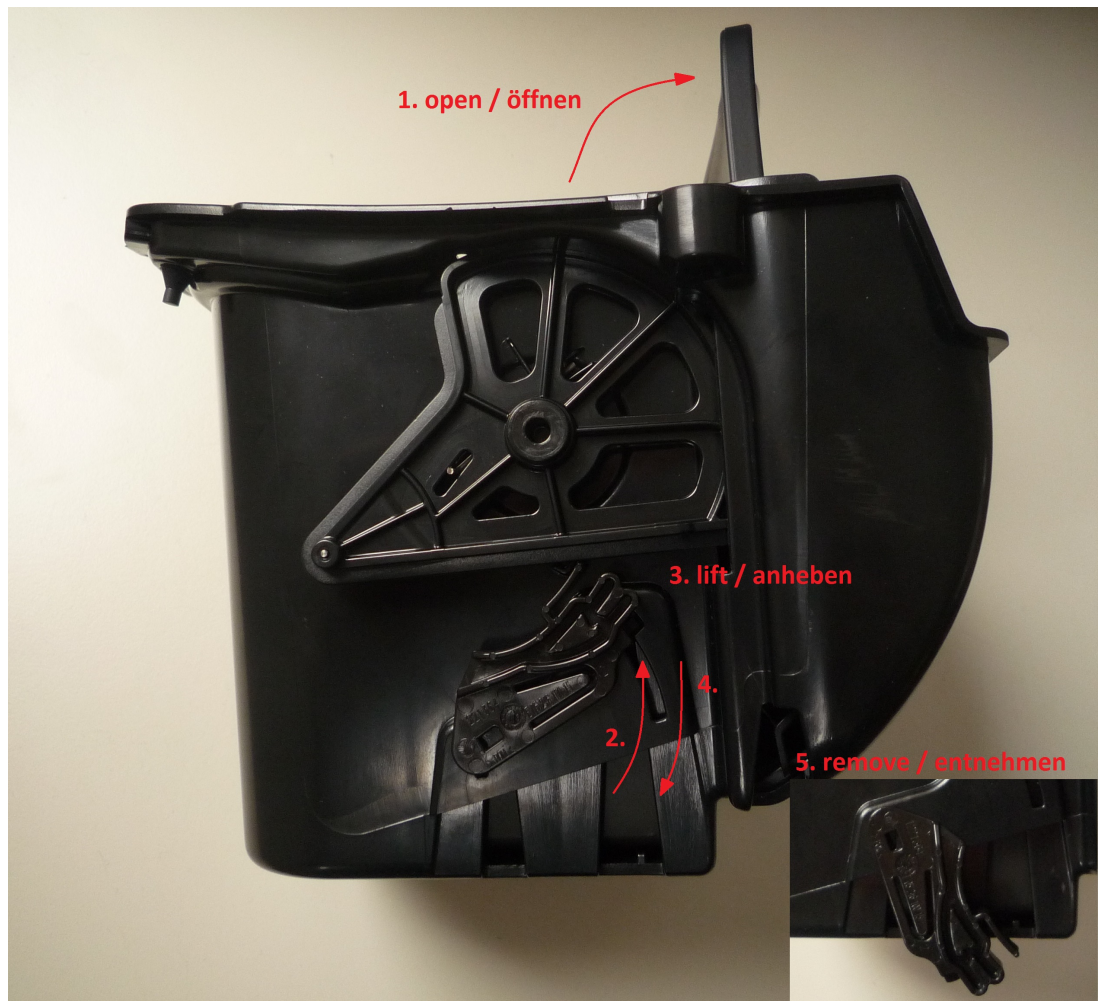
Ausbau Betätigungshebel - Führungsschiene
A176 766 00 00.jpg:

The center stowage compartment does not close or open smoothly.

The kinematics of the guide rail for the lid jams.

Remove operating lever/ guide rail at side (see picture).

Install new operating lever/ guide rail (A176 766 00 00) in the reverse order.
