Date: July 2013
Action No.: C1A – 13 07 01
Group: 07

SUBJECT: **Model 166.057**
Model Year 2013
Update Injector Coding

This Customer 1 Action has been initiated because the injector coding may not meet current specifications in the subject vehicles. Dealers will update injector injection quantity adjustment to correct this condition at the next workshop visit.

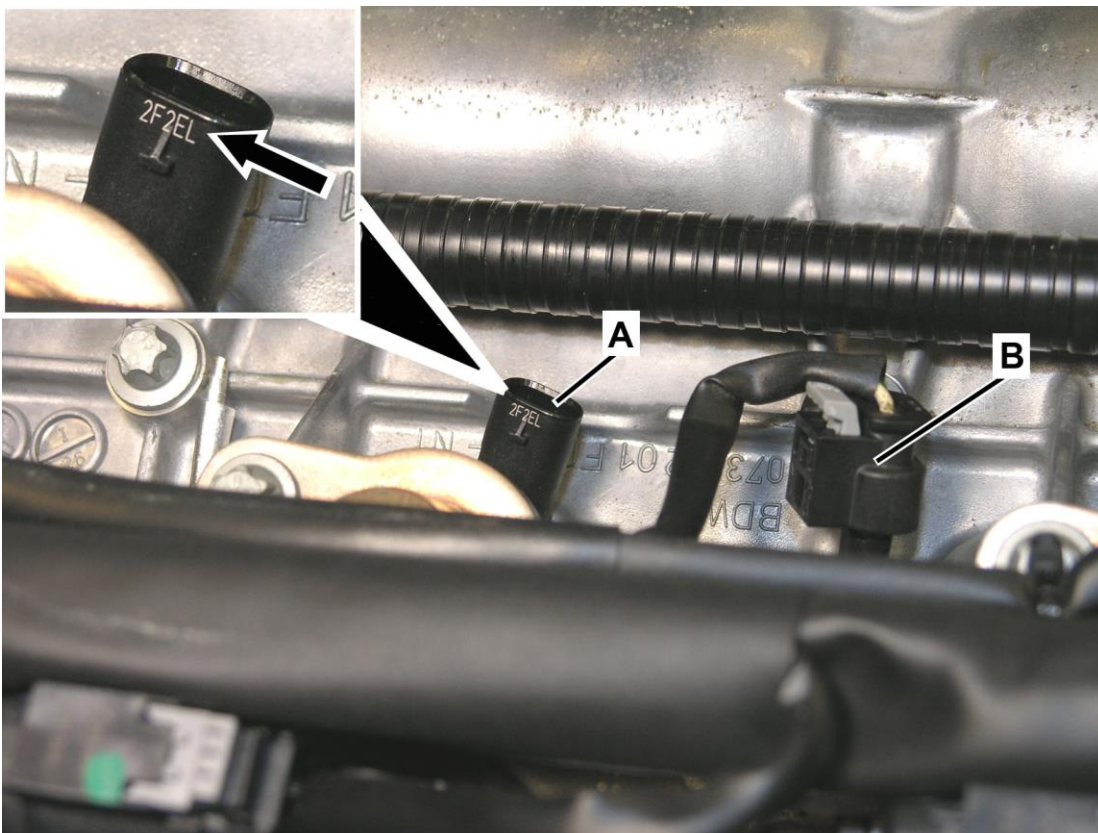
Figure 4

Injector code (arrow, Figure 4) can be read by disconnecting engine harness connector (B) from injector (A).

- Use DAS/Xentry 05/06-13 with all associated patches or higher.
 - Follow the steps exactly as described in DAS/Xentry.
 - Connect battery charger (battery voltage >12.5V).
6. Update injector injection quantity adjustment: Control units / ME-SFI motor electronics 'MED 177' for internal combustion engine 'M276' / Control unit adaptations / Configuration / Manual adjustment / Injector quantity adjustment.
 7. Follow on-screen instructions.
