## Water ingress - retractable hardtop front section

Topic number	LI77.30-P-056644
Version	1
Design group	77.30 Vario roof, soft top - complete
Date	07-25-2013
Validity	SLK - BR172
Reason for change	Damage code for retractable hardtop front section adjusted. New damage code is 79201 04 for Vario roof front section - Leaking. Published worldwide.
Reason for block

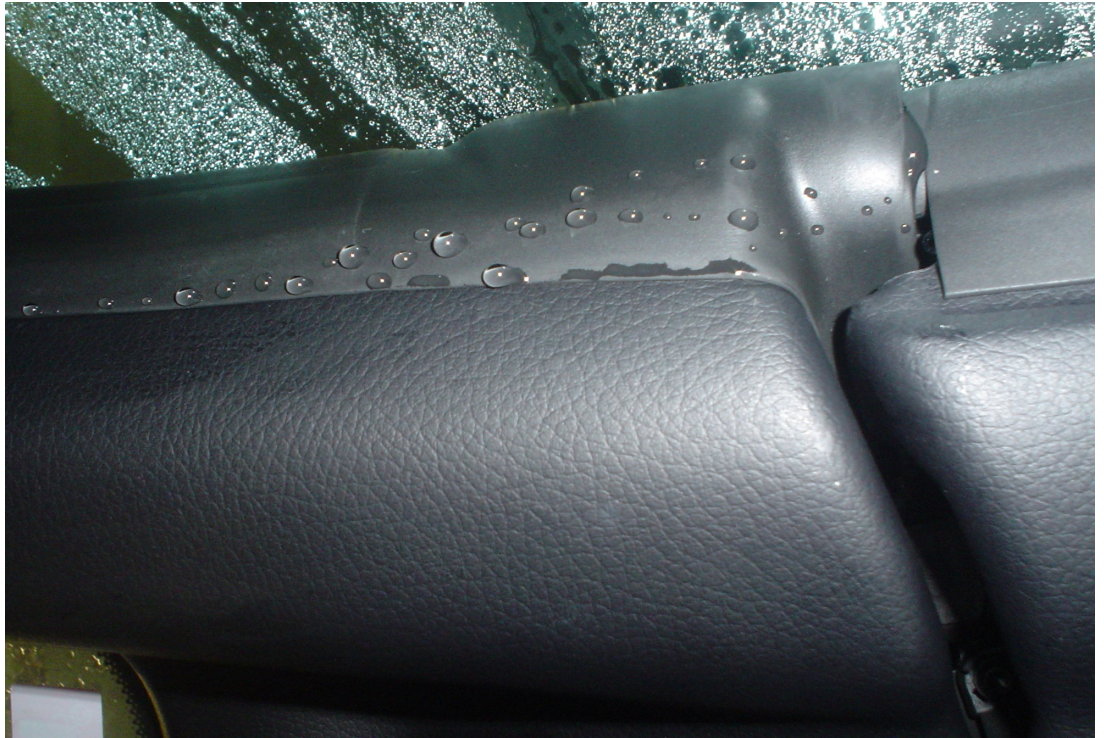
Abb.1.jpg:

- Partial water entry in the area of the side seals to the A-pillar (for area see Fig. 1) when accelerating/braking the vehicle.
- Water entry in rear area of side seals (see Fig. 2 and Fig. 3).
- Water entry in area of rear pivot/mounting for front section of retractable hardtop (see Fig. 4 and Fig. 5)
- Water entry in side area of headliner (see Fig. 6).

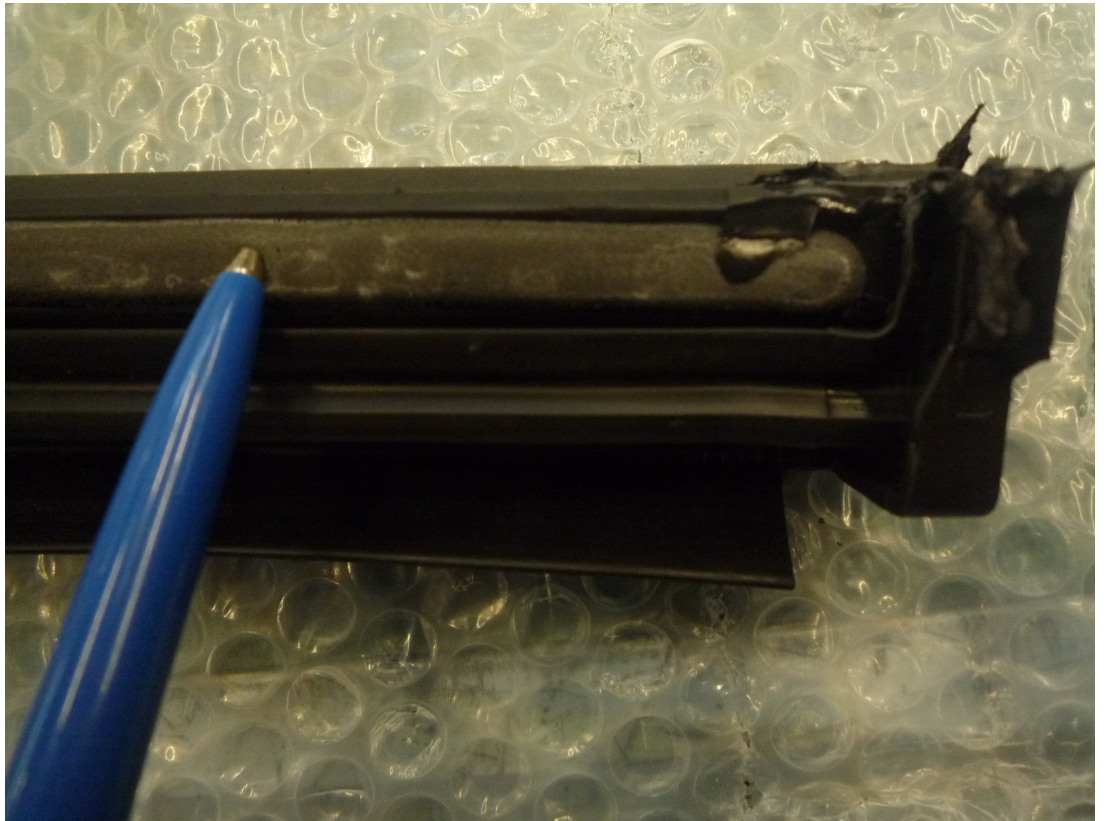
Abb.7.jpg:

In order to localize the water entry after the rain test, the side seal on the side on which the complaint was registered must be removed. Then the seal should be checked for any damage. The polyurethane foam bead (see Fig. 7) of the side seal is not wet/moist.

- Polyurethane foam bead wet/moist: In the event that the polyurethane foam bead (see Fig. 7) of the side seal is found to be wet/moist, then following operation steps should be performed to check the front section of the retractable hardtop.

- Side seal damaged: In the event that the side seal is damaged, then this has to be replaced in accordance with WIS document "AR77.50-P-4200W". Special care should be paid here to the correct butyl routing.

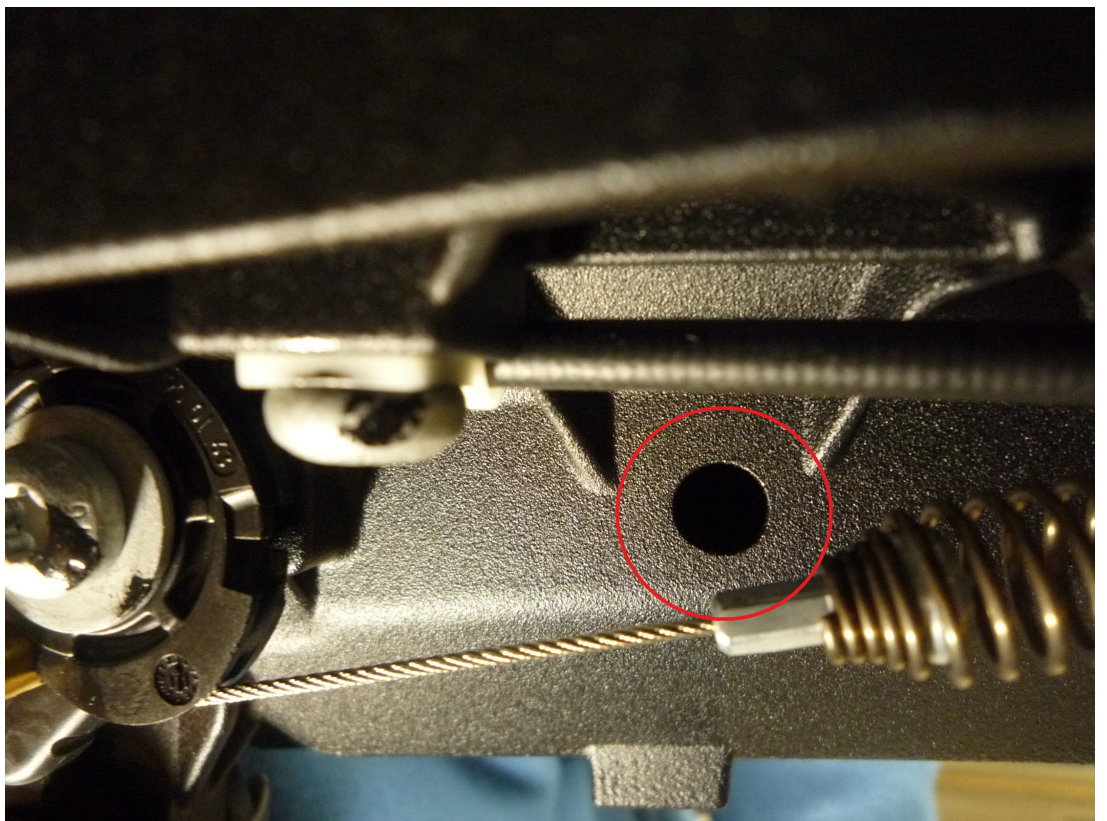
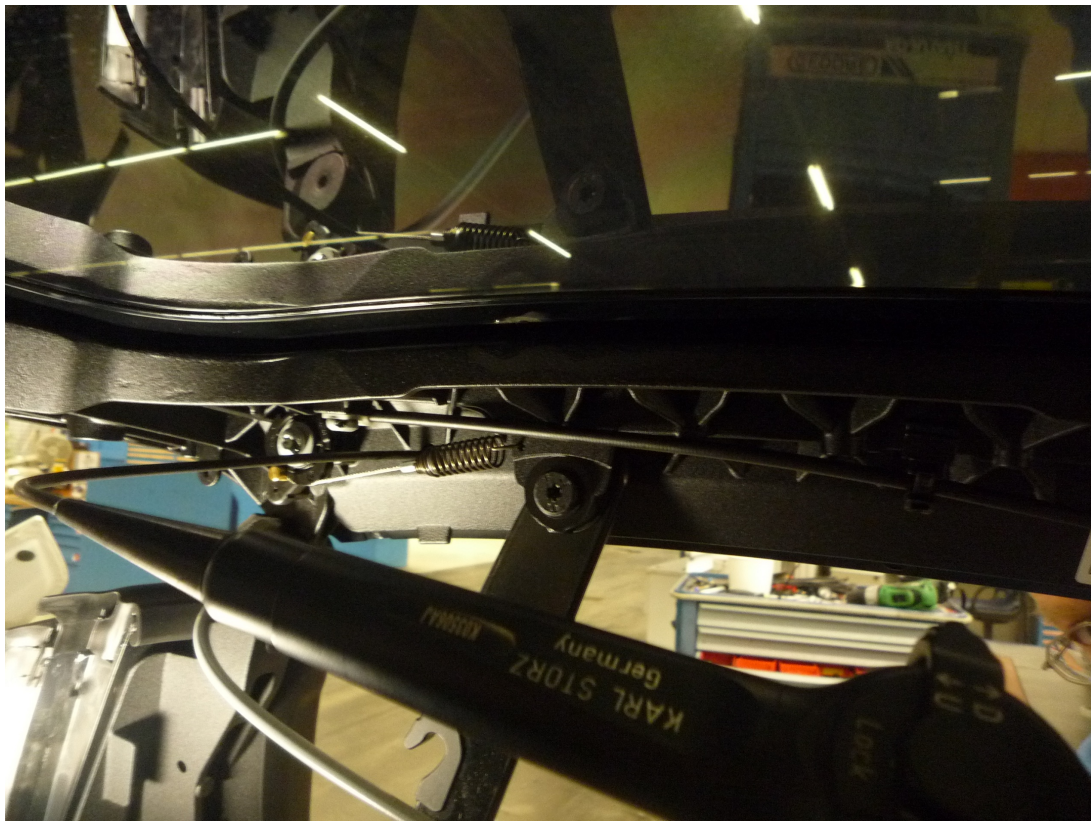
The endoscope can be used to check the interior of the side panel for any water entry. Access for the endoscope here is through the previously made hole in the rear area of the magnesium frame (see Fig. 8 and Fig. 9). It is important here to check the entire panel for any water entry or drops of water.

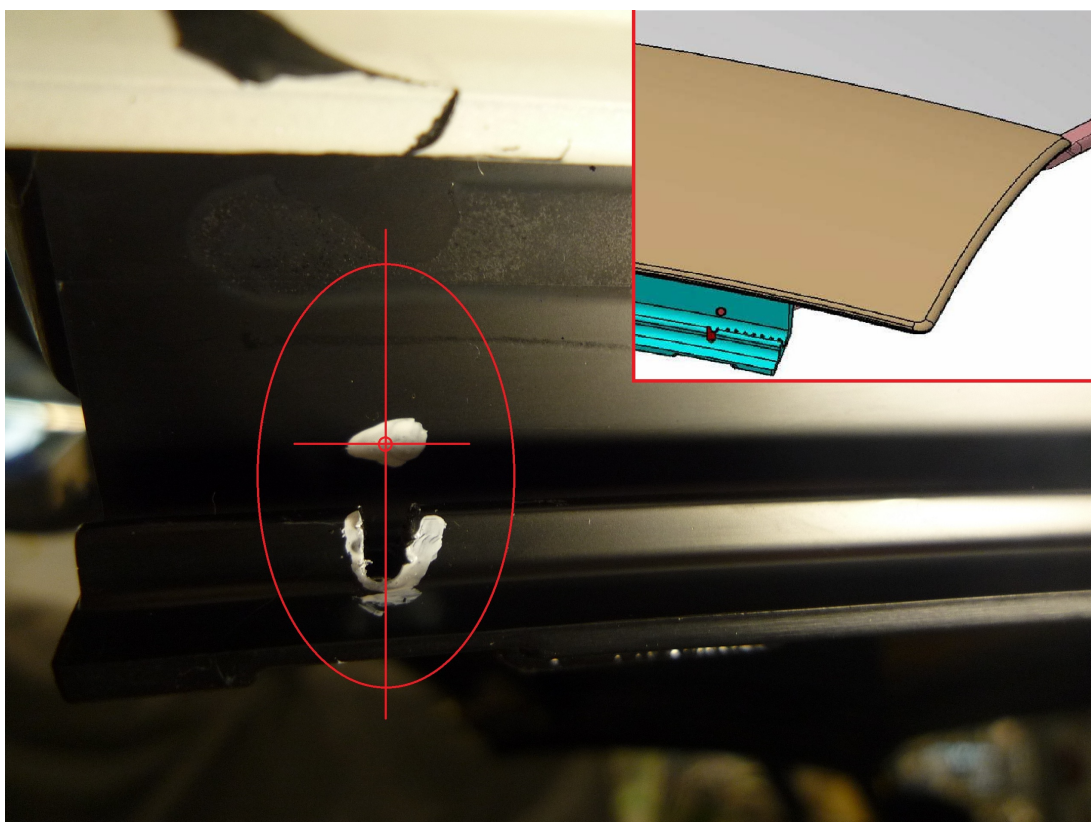
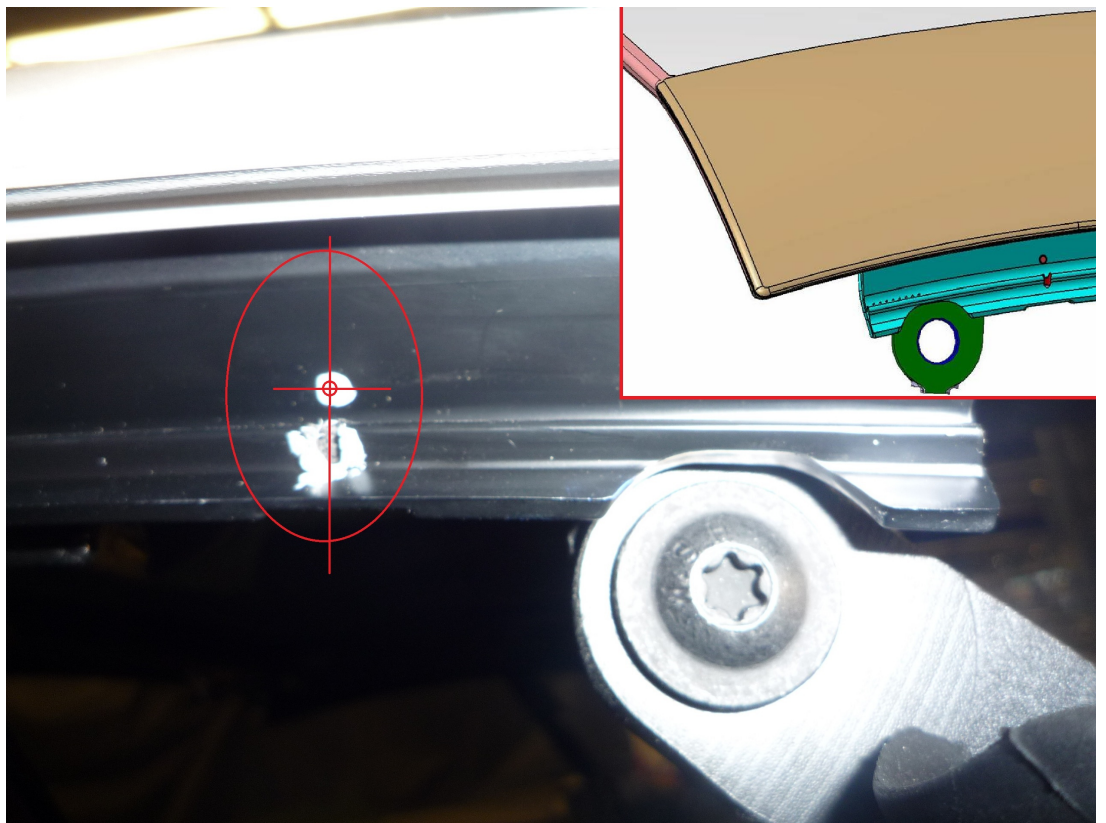
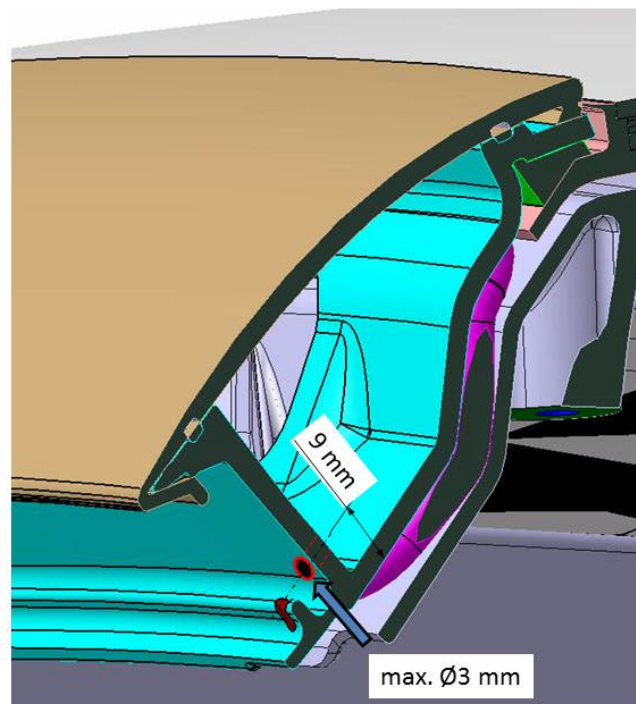
A drill bit with a max. diameter of 3 mm is to be used at the corresponding positions (see marked areas in Fig.10, Fig. 11 and Fig. 12) to drill water exit holes (note dimensions in Fig. 13). These water exit holes can be used to check whether water escapes and therefore whether there is any water located in the side panel (a piece of wire can be used here to help force water out of the 3 mm water exit holes).

**Important!**The drill bit diameter must not be larger than 3 mm and the marked areas in Fig. 10, Fig. 11 with the dimensions from Fig. 12 must be maintained, because the holes are in the dry area.

If this test should reveal that there is no water in the side panel, then the water exit holes are to be sealed again using 4 mm butyl cord. No excess butyl may protrude here beyond the hole to ensure that this does not stick to the seal later on.

If, in one of these cases, water entry is detected in the side panel on the front section of the retractable hardtop, then this is to be replaced in accordance with WIS document "AR77.50-P-3100W". Corresponding pictures (water exit from water exit holes, other water entry points) are to be included with the warranty claim.
