# Service Campaign Bulletin

Campaign No. 2013070001, July 2013

SUBJECT: **Model 906, Model Year 2013**  
**Rework Seal Seam on Emergency Exit Window**

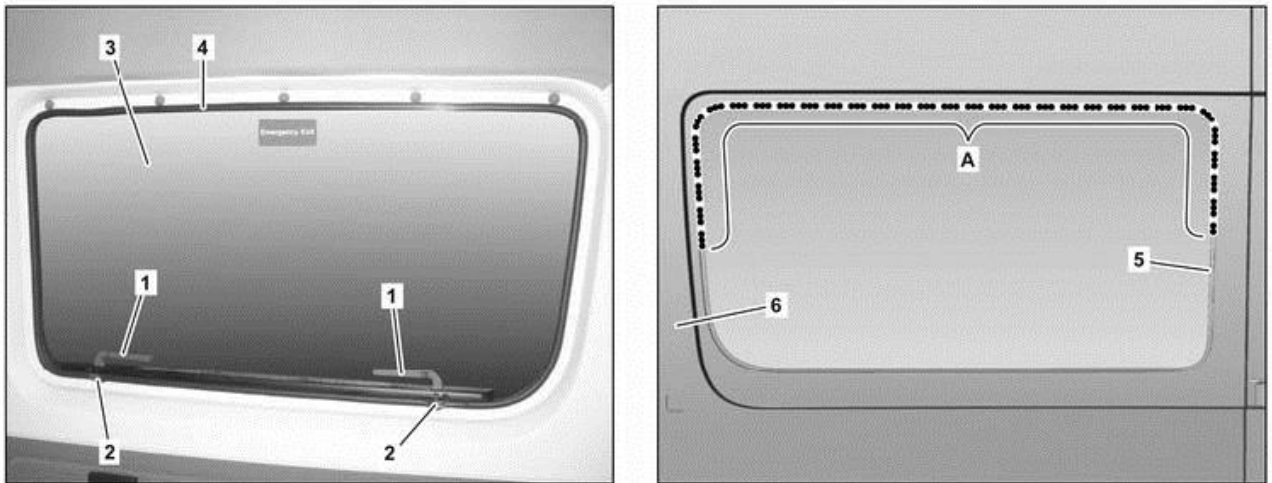
**Figure 1**

This Sprinter Service Campaign has been initiated because Daimler AG (DAG), the manufacturer of Mercedes-Benz and Freightliner Sprinter vehicles, has determined that due to a factory process change the seam seal on the Emergency Exit window may be incomplete which could allow moisture to enter the interior of the vehicle. An authorized Sprinter dealer will rework the Emergency Exit window seal seam at the next workshop visit.

1. Move locks (1, Figure 1) to upright (unlock) position to open.

2. Remove retainer (2, Figure 1) pieces from holes.
3. Open window (3, Figure 1) and support window with (under hoist type) jack stand.

- **Do not open window (3, Figure 1) more than 90° angle otherwise the window (3) could get damaged.**
  - Be careful not to damage exterior paint when positioning jack stand near vehicle.
4. Pull off seal (4, Figure 1) at the top and the sides (area A, Figure 1) from the window flange.
  5. Complete the existing sealing seam between sidewall paneling (6, Figure 1) and inner part of sidewall (5) at the sides and top (area, A).

7. Allow sealing seam to dry for approx. 20 minutes.
8. Re-install seal (4, Figure 1).
9. Close window (3, Figure 1).
10. Close locks (1, Figure 1).
11. Insert new retainers (2, Figure 1).
