Title **Vehicles With An Automated Manual Transmission Model F (AMT-F) With Crawler Gearbox - Diagnostic Trouble Code (DTC) P10C7-97 Crawler Gear Engagement System Blocked Shift To Neutral Position; Vehicle Stuck In Limp Mode Or Will Not Shift Into Gear**

Cause Chassis equipped with an AMT-F may log DTC P10C7-97, accompanied by the vehicle going into limp mode or possibly not being able to engage a gear. **These symptoms may be intermittent.**

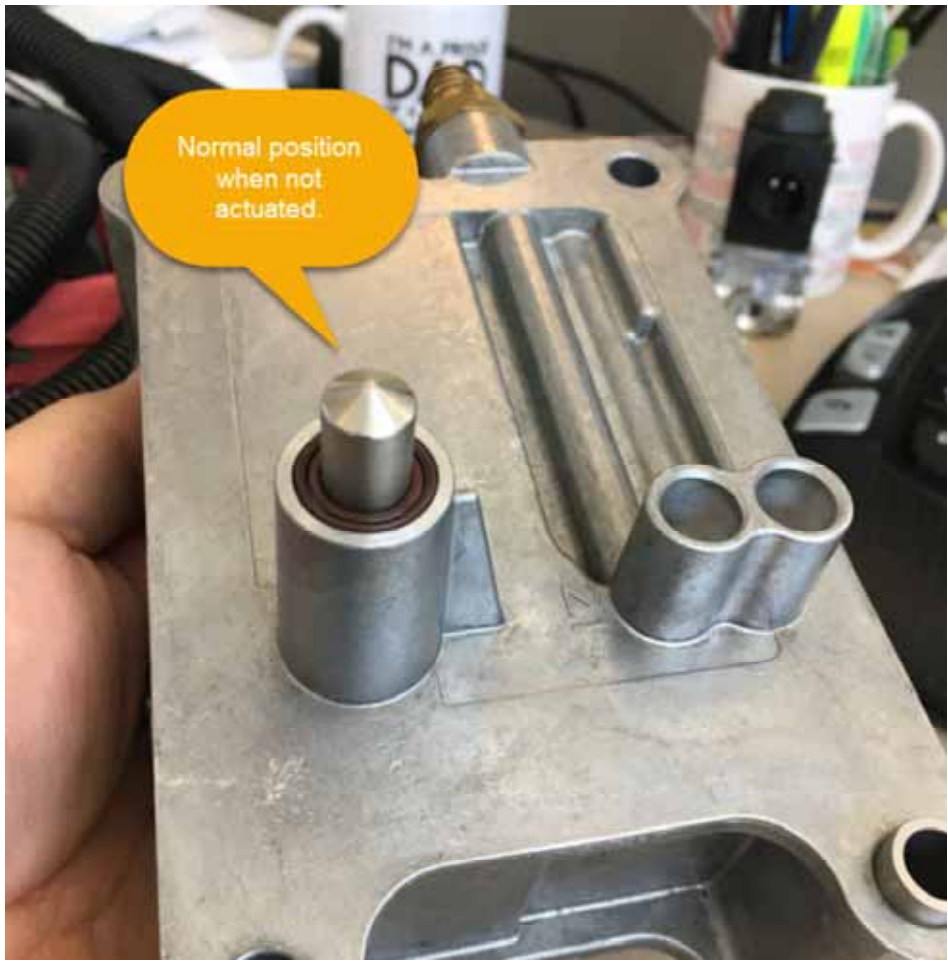
2.2.1.2. If the crawler shifter moves easily manually: Use a rubber tipped air blower to put air to the two ports inside the gearbox to shift the unit with air pressure.
