# Technical Service Bulletin

SUBJECT:			No: <b>TSB-19-42A-002REV</b>
<b>POWER WINDOW AUTO OPEN/CLOSE FUNCTION INOPERATIVE - REVISED</b>			DATE: <b>October 2019</b>
			MODEL: <b>2019-2020 Eclipse Cross, Outlander, Outlander PHEV</b>
<b>CIRCULATE TO:</b>	<input type="checkbox"/> GENERAL MANAGER	<input checked="" type="checkbox"/> PARTS MANAGER	<input checked="" type="checkbox"/> TECHNICIAN
<input checked="" type="checkbox"/> SERVICE ADVISOR	<input checked="" type="checkbox"/> SERVICE MANAGER	<input checked="" type="checkbox"/> WARRANTY PROCESSOR	<input type="checkbox"/> SALES MANAGER

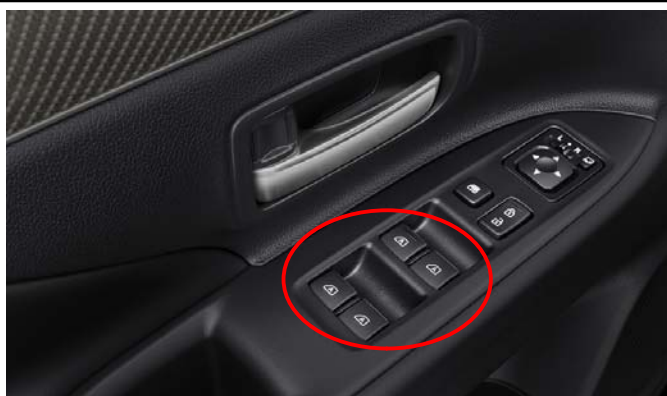
### Driver's Door Power Window Switches

The power window auto open/close function may become inoperative after *any of the following operations*:

<i>Operation</i>	<i>Probability of Inoperation</i>
<i>Passenger or rear window switch is operated in the opposite direction abruptly (within 0.04 seconds) while the window is moving up or down.</i>	<i>High</i>
<i>The window switch is stopped just before it reaches the fully closed or fully open position.</i>	<i>Medium</i>
<i>The switch is operated to the open position when the window is already in the fully open position.</i>	<i>Medium</i>
<i>The switch is repeatedly operated ON-OFF in a short time span.</i>	<i>Low</i>

Starting with 2019 model year in affected vehicles listed below, the power window system calculates the window position from the current flows to the motor. This creates a gap between actual and calculated window position when the motor moves by inertia even after the motor current stops. This gap becomes greater after the power window switch is *operated in any of the ways described above*. As a result, the auto open/close function becomes inoperative and the normal entrapment prevention while the window is closing may not work properly.
