Technical Service Bulletin

Mazda North American Operations
Irvine, CA 92618-2922

Subject: POOR HEATER PERFORMANCE AND/OR DTC P011A:00 STORED	Bulletin No.: 07-007/19
	Last Issued: 11/04/2019

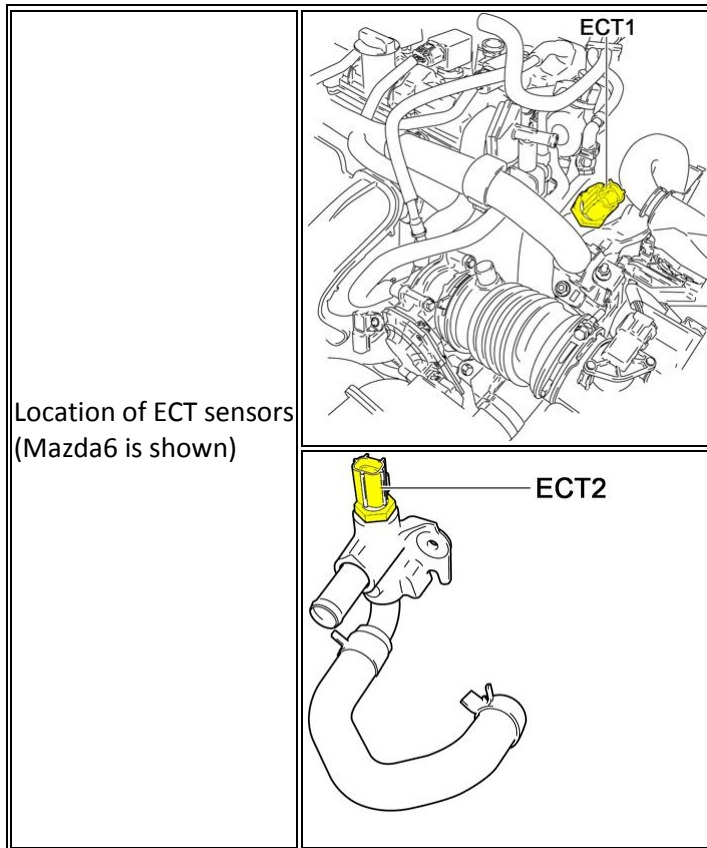
NOTE A: DTC P011A:00 (ECT sensor No.1/No.2 performance problem) is for 2013-2016 (US spec) / 2017 (Mexico spec) CX-5 and 2014-2016 Mazda6 only.

The purpose of having two ECT sensors is to mutually monitor their performances. If two temperature values detected by the sensors are different beyond the specified value, the DTC P011A:00 is set.

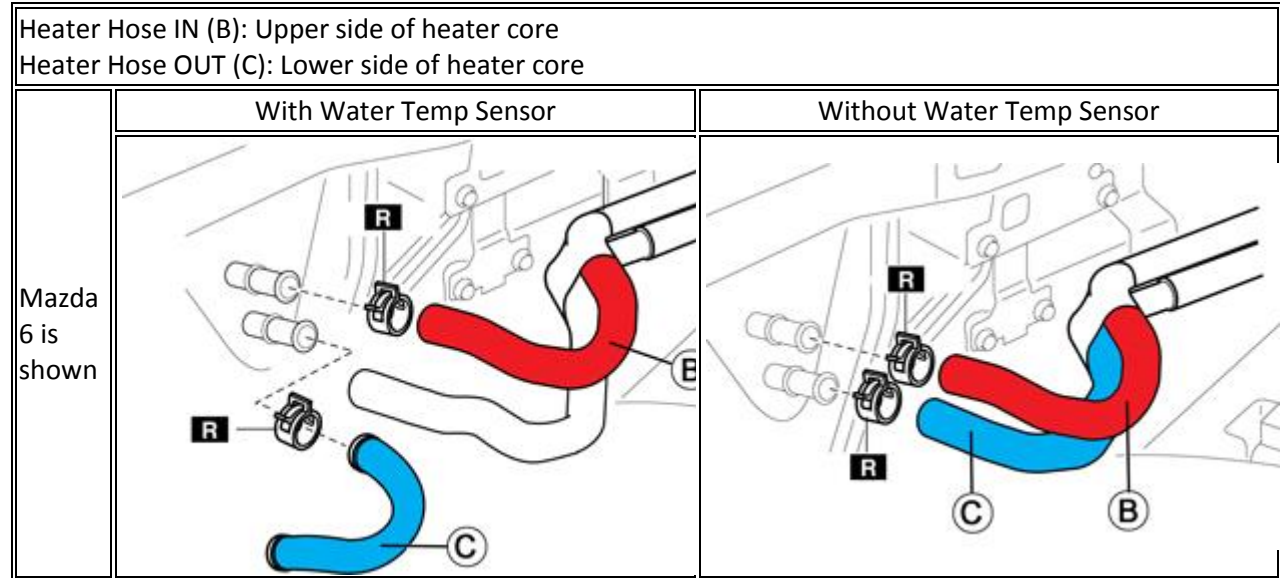
NOTE C: Inspect heater hose IN and OUT for temperature difference.

Using a thermal temperature gun or thermocouple, measure the heater hose IN and heater hose OUT temperature. If there is an obvious difference in temperature between both hoses, the heater core may be plugged.

NOTE: When doing this inspection, turn the HVAC blower fan OFF. If ON, the heater core radiates heat, so the temperature difference between IN and OUT hoses will generate heat even if the heater core is not plugged.

If the heater core was determined to be plugged by the diagnosis procedure, replace the heater core with a new one and replace the contaminated engine coolant twice.
