Subject: BODY VIBRATION WHEN ENGINE IDLING IN (D)RIVE AND (R)EVERSE	Bulletin No.: 01-017/19
	Last Issued: 11/14/2019

- 2014-2018 Mazda3 (2.0L A/T)
- 2014-2018 Mazda3 (1.5 A/T Mexico spec)
- 2017-2018 CX-5 (2.0L A/T Canadian spec)
- 2018-2019 CX-5 (2.0L A/T Mexico spec)

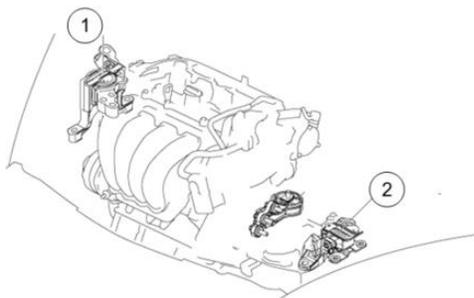
1	No.3 engine mount
2	No.4 engine mount

Some customers may complain about a vibration through the driver and passenger seats at idle in (D)rive and (R)everse when the engine rpm drops down to 550.

1.5L	The No.3 and No.4 engine mount rubber hardening during vehicle usage at high ambient temperatures which decreases the damping force.
2.0L	Components of the No.3 engine mount rubber melting inside the mount at high ambient temperatures which creates deposits on the engine mount plate that restrict engine mount plate movement.

Mass production change has not been determined at this time, but modified No.3 and No.4 engine mounts have been newly established as service parts. Their material and spring characteristic have been changed. Customers having this concern should have their vehicle repaired using the following repair procedure.

Mazda3 (1.5L)	Replace both No.3 and No.4 engine mounts with modified ones according to the instructions on MGSS (ENGINE MOUNT DISASSEMBLY/ASSEMBLY [SKYACTIV-G 1.5]).
Mazda3 and CX-5 (2.0L)	Replace the No.3 engine mount with a modified one according to the instructions on MGSS (MOUNT DISASSEMBLY/ASSEMBLY [SKYACTIV-G 2.0, SKYACTIV-G 2.5]).
