Subject: ENGINE NO START (KEY NOT DETECTED)	M-Tips No.: MT-004/19
	Last Issued: 11/20/2019

2014-2020 Mazda3
2014-2020 Mazda6
2016-2020 CX-3
2013-2020 CX-5
2016-2020 CX-9
2016-2020 MX-5
2020 CX-30

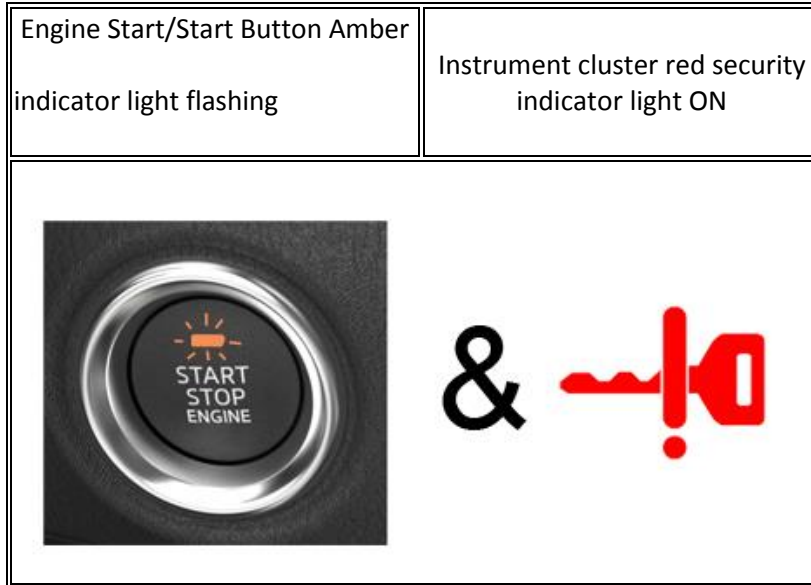
- Intermittent engine no start
- Instrument cluster red security indicator light ON
- Engine Start/Start Button Amber indicator light flashing
- Battery discharge
- Electrical relay buzzing noise
- **DTC B13D3:94 (Communication error with remote transmitter) stored.**
