Service Bulletin

Bulletin No.: 19-NA-236

Subject: Binding and/or Clunking Noise Heard While Operating the Front Door Windows

Brand:	Model:	Model Year:		Breakpoint:		Engine:	Transmission:
		from	to	from	to		
Chevrolet	Express	2018	2020	-	-	-	-
GMC	Savana

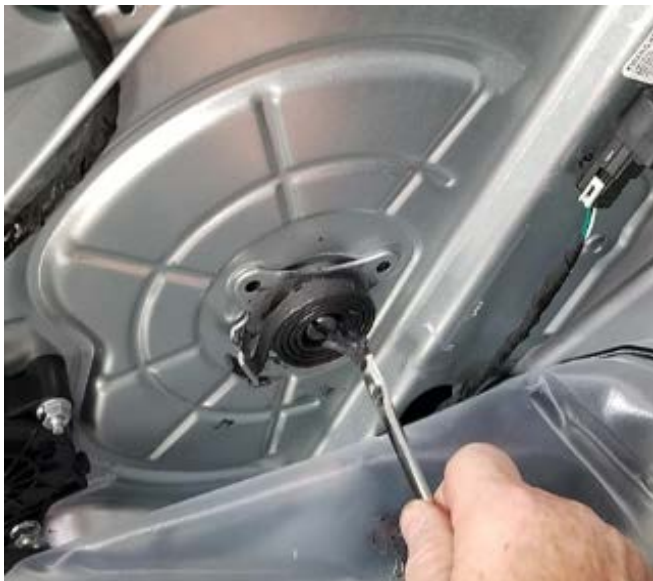
5422036

Involved Region or Country	North America, Middle East and Israel
Condition	Some customers may comment on a binding and/or clunking noise heard when operation the front door windows.
Cause	This condition may be caused by insufficient grease in the window regulator clock spring.
Correction	Apply M-77 Paste to the clock spring windings following the procedure below.

2. Using an acid brush, apply M-77 Paste to the clock spring windings, as shown in the pictures above.

Note: It may be necessary to apply pressure to one side of the spring to open a gap for paste.
