Service Bulletin

Bulletin No.: 12-08-51-002K

Subject: Spray-in Bed Liner General Information and Repair Procedures

Models: 2013-2014 Chevrolet Silverado HD 2500/3500 Series
2014 Chevrolet Silverado 1500
2015-2020 Chevrolet Colorado, Silverado
2013-2014 GMC Sierra HD 2500/3500 Series
2014 GMC Sierra 1500
2015-2020 GMC Canyon, Sierra
2020 Holden Colorado
Equipped with Spray-in Bed Liner (RPO CGN, PDL)

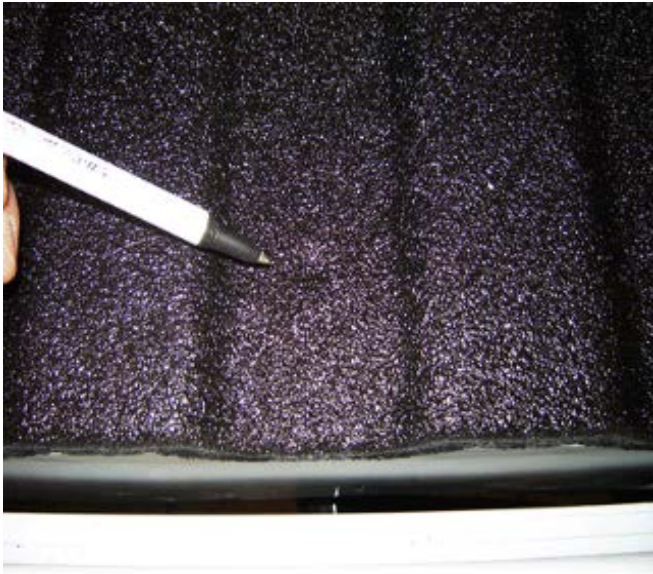
2968675

Because the bed liner material is sprayed on evenly, any variation in the bed such as seam sealer or spot welds in the sheet metal will show underneath the spray on coating. This is an expected condition. The coating does not completely fill in these variations.

Spot weld under bed liner example
