**THIS IS A TECH TIP, NOT A TECHNICAL BULLETIN.  
TECH TIPS ARE NOT ASSOCIATED WITH WARRANTY CLAIMING.**

Model(s)	Year	Eng. Code	Trans. Code	VIN Range From	VIN Range To
Passat, Golf, Jetta, Beetle	2015	2.0L TDI (CVCA, CRUA)	All	All	All

Instance Number	Published Date	Version Number	Reason For Update
2057752/2	11/22/19	26-19-03TT	Update to work instruction.
2057752/1	11/15/19	26-19-03TT	Original publication.

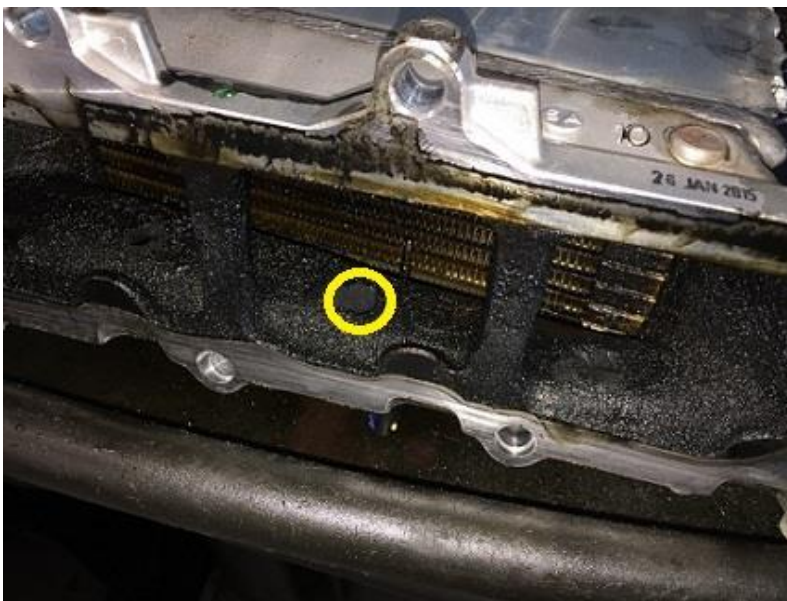
Figure 1

For customer concerns of MIL on with fault P0401/P2002. Inspect the EGR passage in cylinder head for casting irregularities or carbon build up (figure 1). Also inspect the EGR ports on the intake valve side of the intake manifold/intercooler (figure 2).

If the ports internal to the intake manifold are found restricted and faults P2002 and/or P0401 are set, replace the intake manifold. **For the cylinder head ports, clean with an appropriate diameter pick and/or brush.**
