NUMBER: 08-019-19 REV. B

UGQ Radio Enhancements

This bulletin involves inspecting and if required, updating the radio software level to ****2.5****.

2018 (WK) Jeep Grand Cherokee

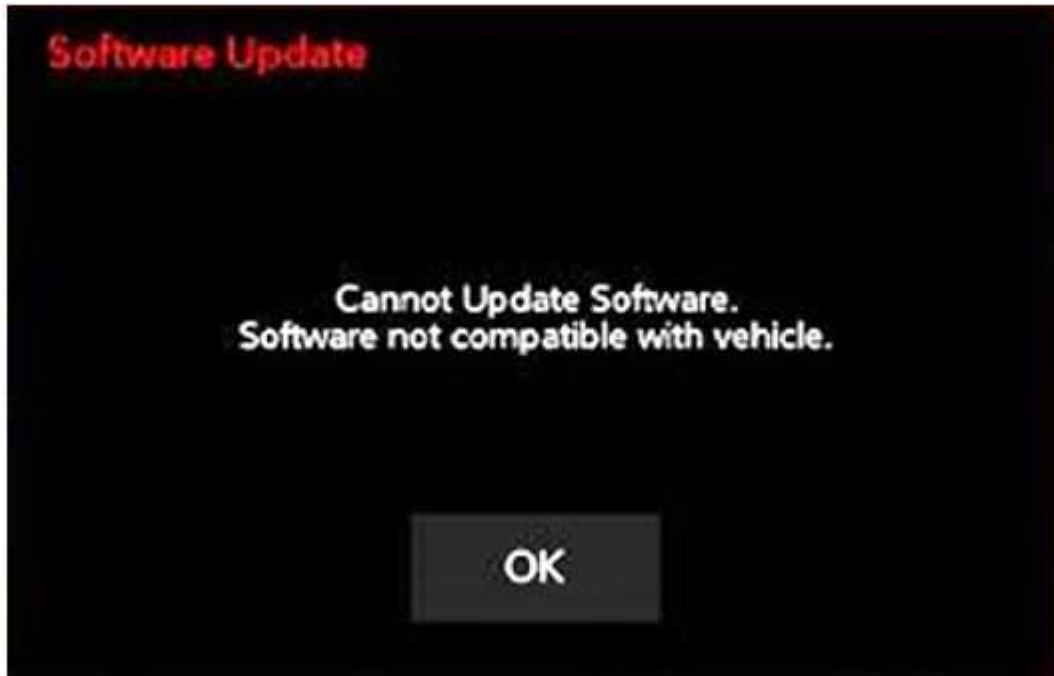
10. If the screen in (Fig. 4) is displayed, the USB flash drive was not set up correctly. Use a top name brand USB flash drive and create a new USB flash drive. Start the update again.

Fig. 4
Software Not Compatible
