TECHNICAL INSTRUCTIONS
FOR
LIMITED SERVICE CAMPAIGN K0P
CUSTOMER SUPPORT PROGRAM 19TE12

SAFETY CONNECT SYSTEM – VEHICLE LOCATION INACCURATE

CERTAIN
2013 – 2019 MODEL YEAR 4RUNNER
2011 – 2017 MODEL YEAR LAND CRUISER
2013 – 2017 MODEL YEAR PRIUS
2012 – 2017 MODEL YEAR PRIUS V
2016 – 2017 MODEL YEAR MIRAI

Updated 10/17/2019

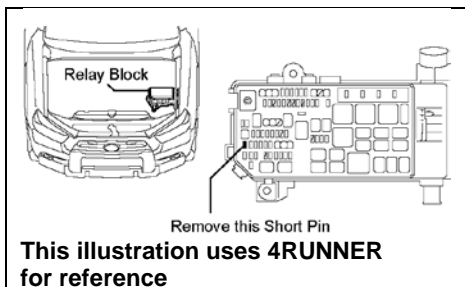
Remove this Short Pin

c) DISCONNECT "D/C CUT" OR "SHORT PIN"

- The reprogramming may fail if you perform it without disconnecting the "D/C CUT" or "SHORT PIN". Please make sure to disconnect the "D/C CUT" or "SHORT PIN" before performing the reprogramming.
- Refer to Section XIV for the location of "D/C CUT" and "SHORT PIN" of each vehicle model.

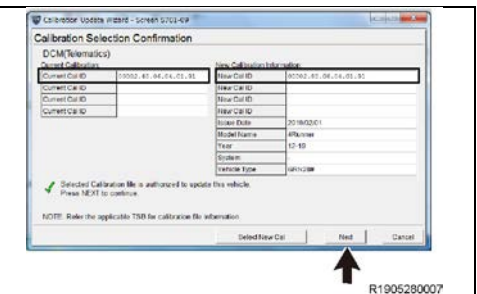
d) Confirm that "Current Cal ID" and "New Cal ID" are correct, and then click on "Next".

NOTE: The calibration IDs will be displayed as shown on the left. Please make sure you *DO NOT* mistake where to check to confirm the IDs.

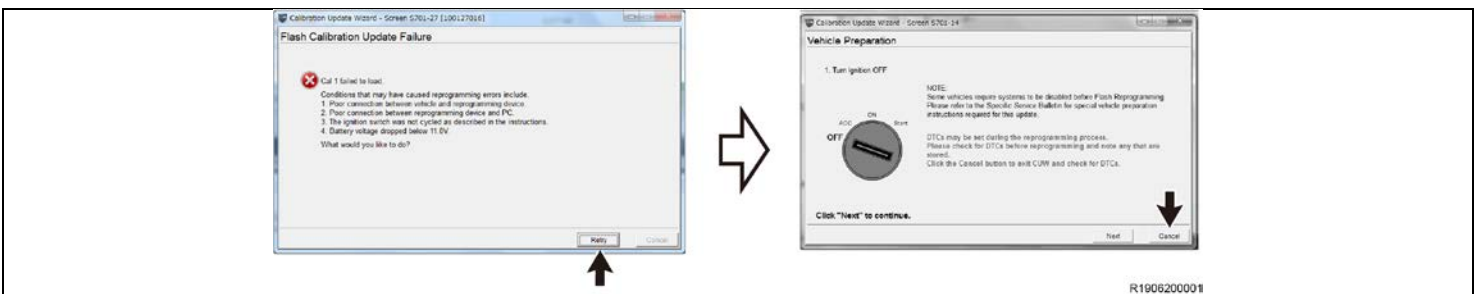
STOP If the following window is displayed and the reprogramming has failed, click on "Retry" and then "Cancel" to finish the reprogramming process. Remove the DCM (telematics transceiver) from the vehicle and perform the reprogramming procedure again only to the DCM (telematics transceiver). Refer to Section XIII

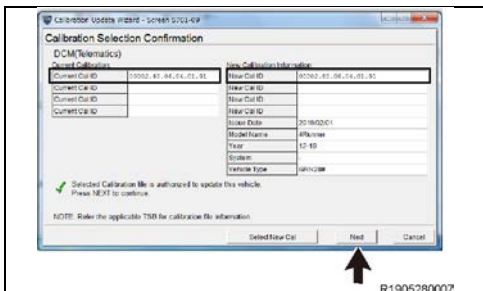
d) Confirm that "Current Cal ID" and "New Cal ID" are correct, and then click on "Next".

NOTE: The calibration IDs will be displayed as shown on the left. Please make sure you **DO NOT** mistake where to check to confirm the IDs.

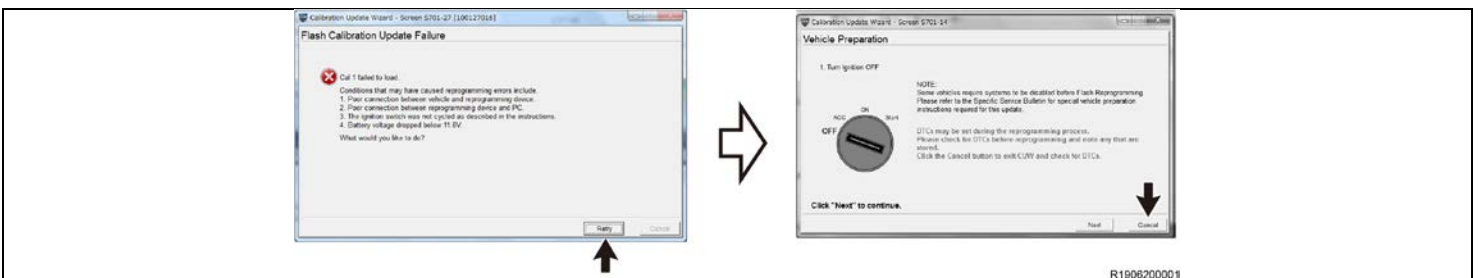
STOP If the following window is displayed and the reprogramming has failed, click on "Retry" and then "Cancel" to finish the reprogramming process. Remove the DCM (telematics transceiver) from the vehicle and perform the reprogramming procedure again only to the DCM (telematics transceiver). Refer to Section XIII
