PRODUCT CAMPAIGN BULLETIN

APPLICABILITY: 2018 Model Year Legacy and Outback Vehicles **NUMBER:** **WTW-82R**
SUBJECT: Combination Meter Reprogramming **NHTSA ID:** 18V-773
DATE: 12/11/18
REVISED: 11/08/19

Subaru of America, Inc. (Subaru) is recalling all 2018 model year Legacy and Outback vehicles to reprogram the combination meter software to correct an error in the driving range indicator calculation in the multi-information display. A total of 228,648 U.S. vehicles will be affected by this recall.

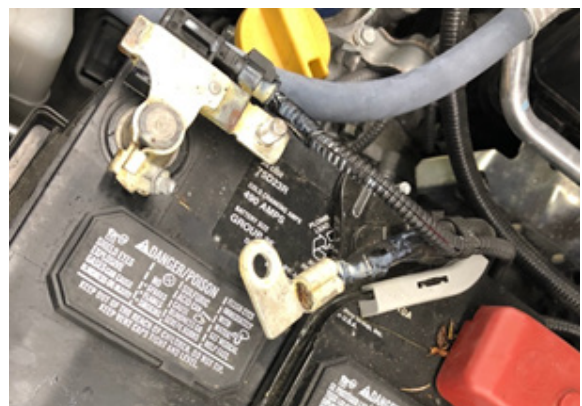
Step 3: While holding / supporting the battery sensor with 1 hand (to keep it from turning), use a 12mm socket to remove the negative battery cable. **DO NOT** remove the sensor from the battery post.

TIP: Put a rag over the sensor to help keep hands from getting greasy.

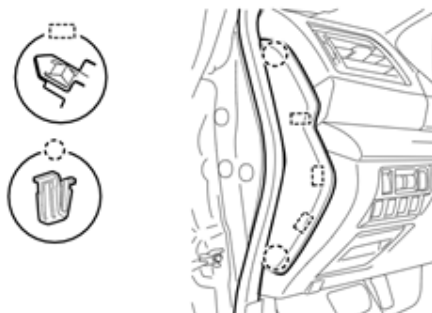
Step 4: CAREFULLY remove the IP end cover using the plastic trim stick. There is a retaining clip at the top and bottom with 3 locating pins in between.

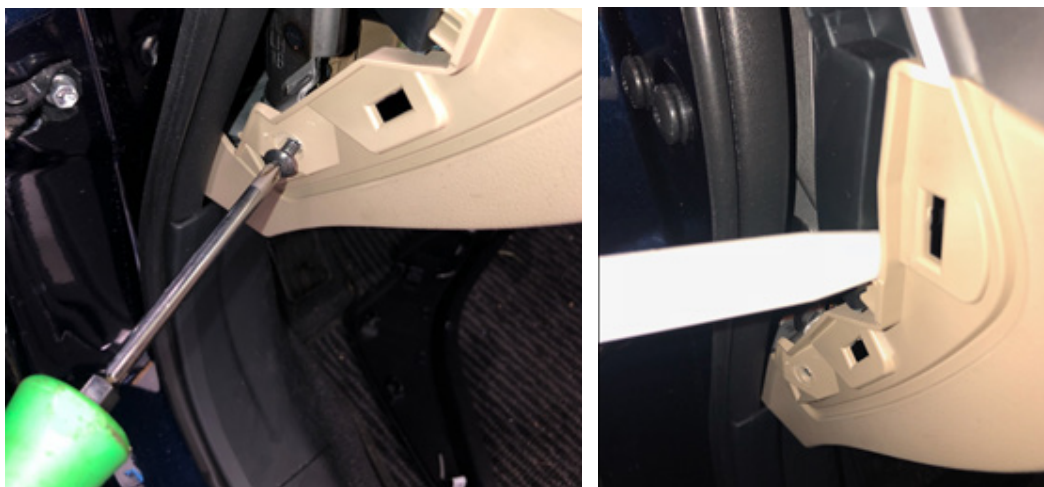
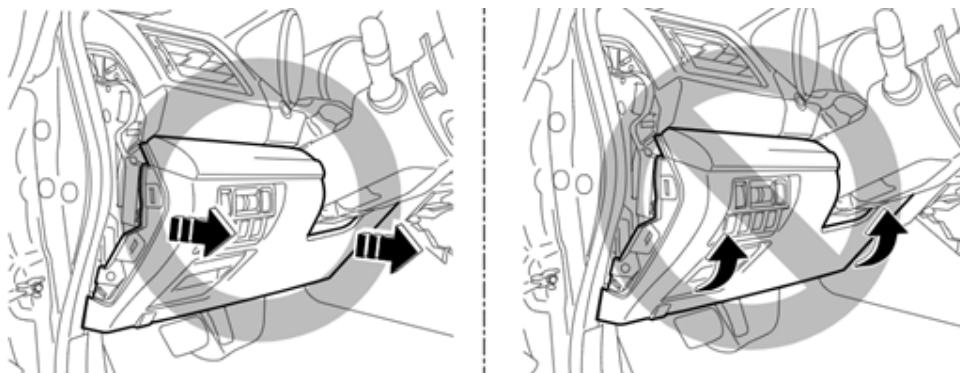
Step 5: Remove the philipps screw and release the 1 clip on the end portion of the trim shown in the photo. Then, CAREFULLY release and lower the lower IP trim panel by pulling it straight back toward you. **DO NOT** try to “peel” it up from the bottom. Leave all switches and the aspirator tube connected. Support the lower IP trim so there is no tension on the switch connections or harnesses.

TIP: The lower undercover does not need to be removed. Leave it attached to the lower IP trim panel.

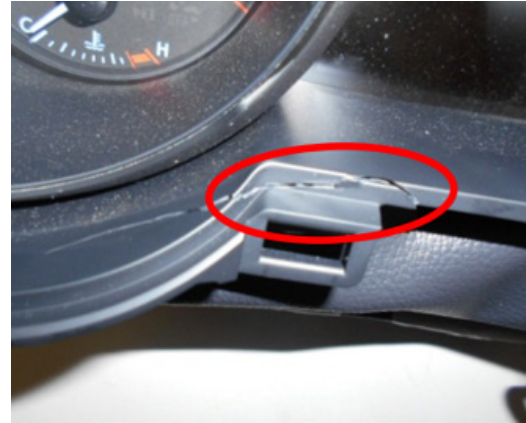
Reports of damaged meter housings as shown in the example photos below have necessitated revisions to this step.

Use the photos below for reference when **CAREFULLY** removing the combination meter lower trim bezel.

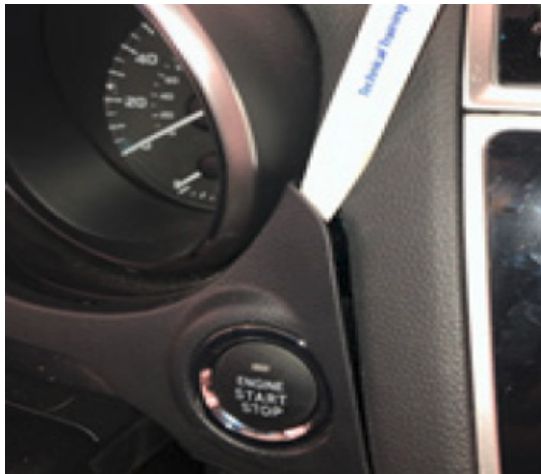
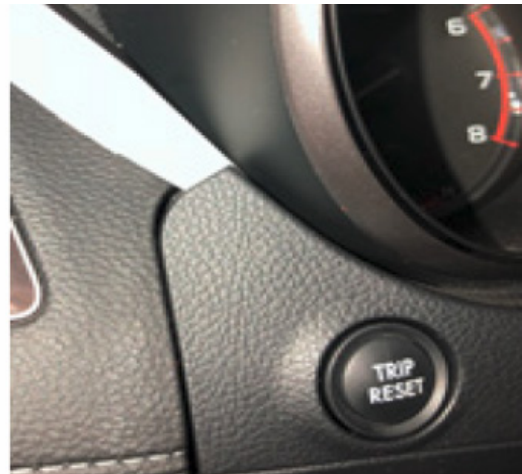
- Release the top claws on both sides using a trim stick as previously recommended.

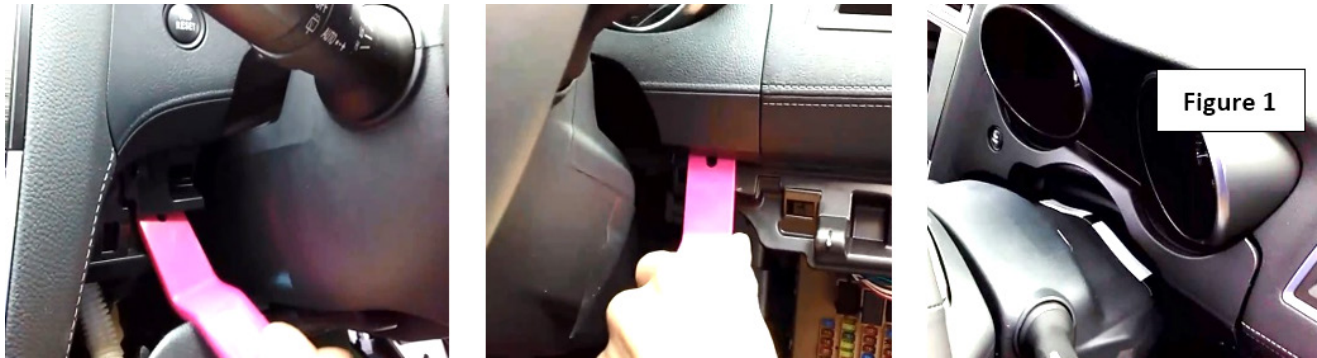
- Release the lower claws on both ends of the bezel using a trim clip removal tool as shown. When all four corners are released, the bezel will appear loose as shown in **Figure 1** below **BUT**, there are 2 more upper / center retaining clips which must be **CAREFULLY** released from underneath before the bezel can be removed.

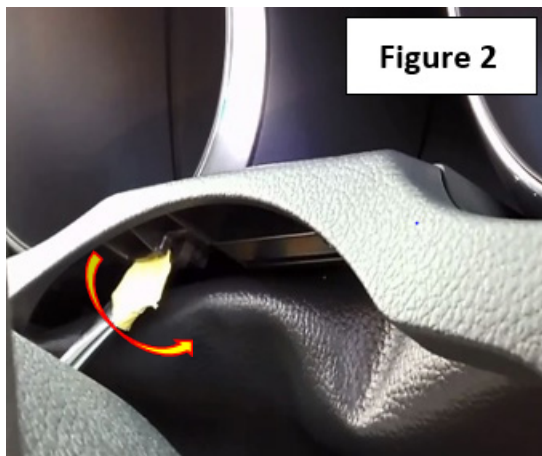
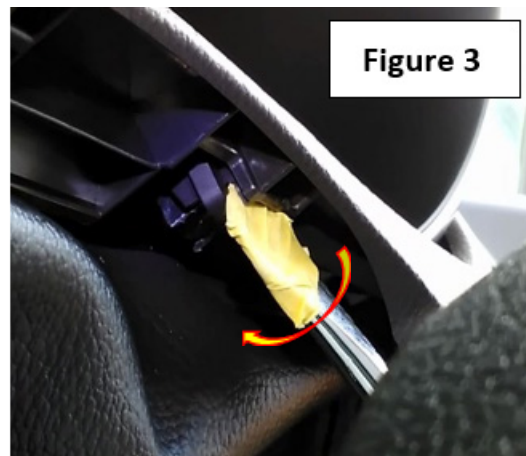
- Use a flat-blade screwdriver with protective tape added shown in **Figure 2** and **3** below works well. A **CAREFUL** twist of the tool will release the clips. **NOTE:** These 2 center clips will likely require more effort to release the first time than in the future if necessary.

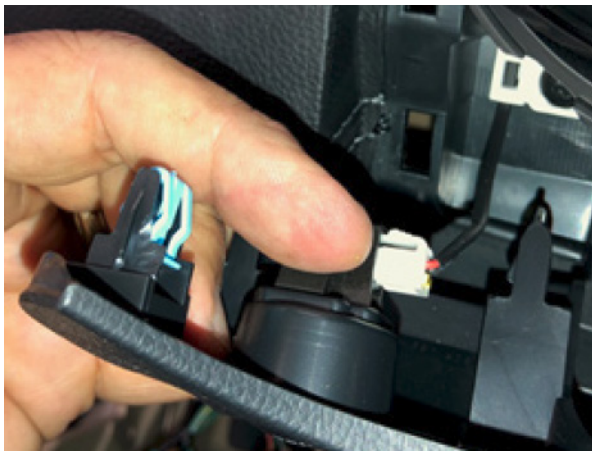
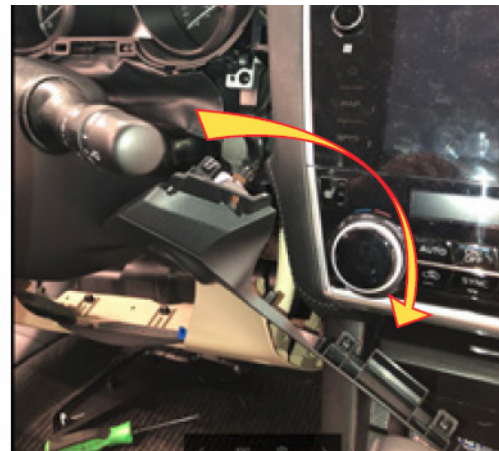
- Once the bezel is loose, disconnect the trip reset button harness connector and put the piece aside. On Push Start models, **LEAVE THE START SWITCH CONNECTED** and just flip the bezel over toward the radio. Cover the bezel with a clean shop cloth to make sure does not scratch the audio unit face or any surrounding trim.

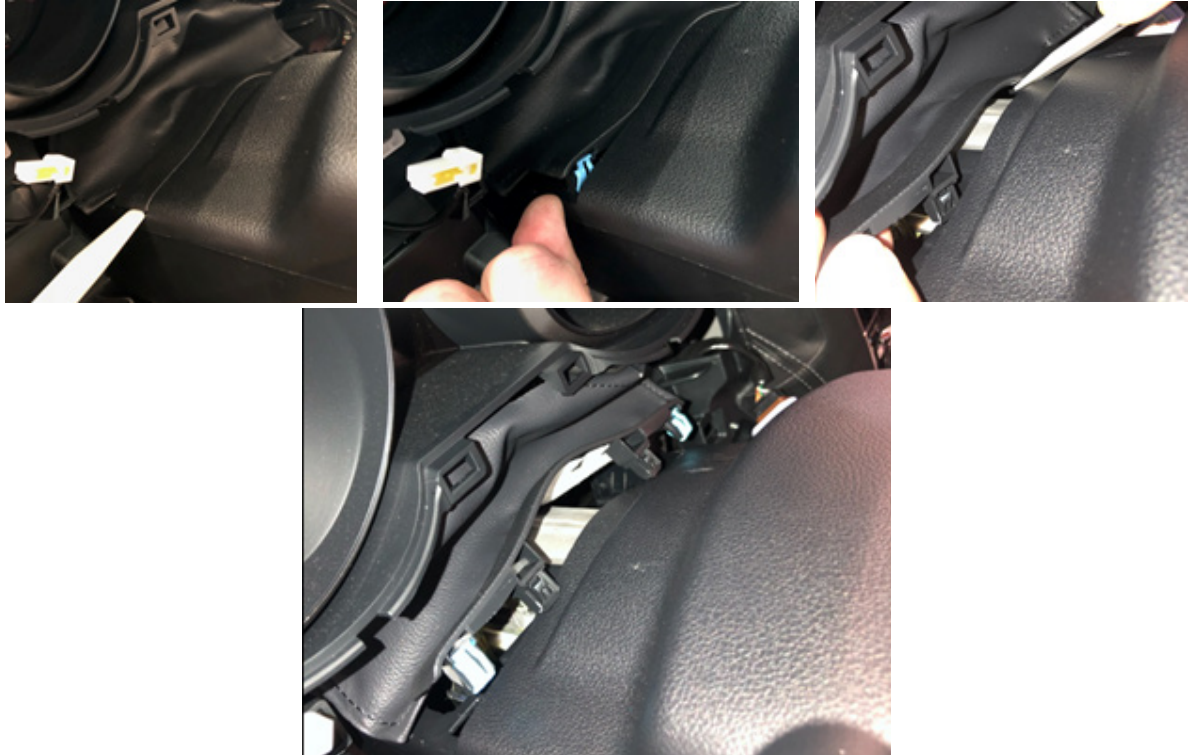
Step 7: Use a trim stick to release the 4 clips holding the fabric “gap cover” trim to the steering column cover. A good thumbnail works to create a gap for inserting the trim stick. Insert the trim stick and work across to remove the trim as shown in the photo sequence below. **NOTE:** The gap cover fabric is “attached” to a plastic reinforcement piece that clips onto the underside of the combination meter. Leave it attached to the combination meter. **NEVER** pull on the fabric as it is only lightly attached.

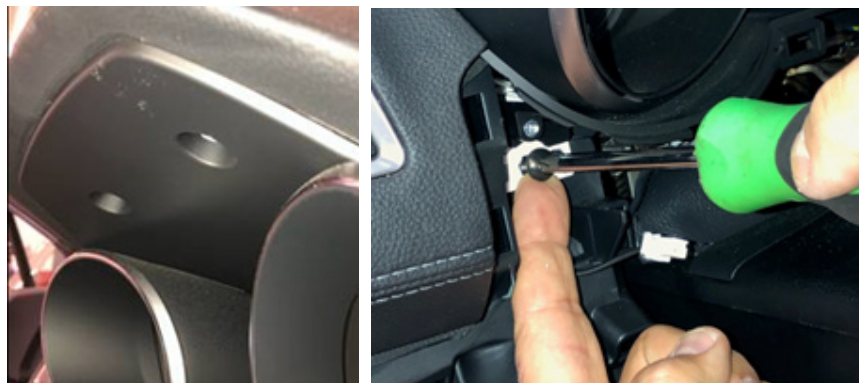
Step 8: Remove the 2- 10mm bolts from the underside of the visor and the 2 philipps screws on the bottom corners of the combination meter. **TIP:** Use a finger under the head of the screw to keep from dropping it inside the IP.

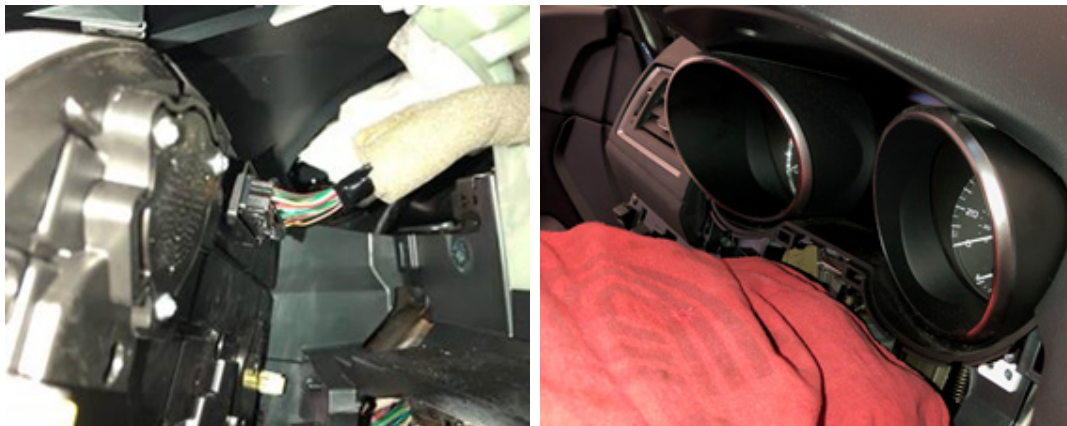
Step 9: Cover the steering column cover with a clean cloth or towel to protect it while removing and reinstalling the combination meter. **CAREFULLY** pull the meter toward you enough to get a hand behind it. Press the lock tab on the wiring harness connector and unplug it. There is only the one connector. Once unplugged, remove the combination meter from the IP toward the right of the steering wheel.

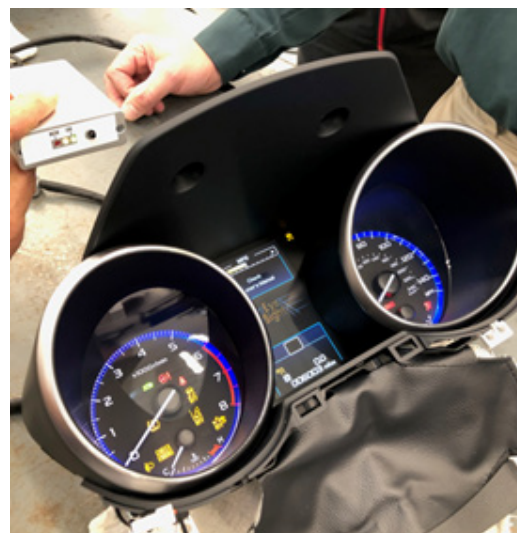
Step 10: Plug the AC adapter of the reprogramming tool into 120v AC “house current” and the combination meter harness connector into the meter. The meter will power up and illuminate completely. The tool’s Yellow LED will illuminate. Press the black button to start the update. It takes about 70 seconds to complete.

While the update is happening, the Yellow LED will blink on and off. When the update is complete, both the Green and Yellow LEDs will both come on solid. At this point, should the Red LED come on, repeat this (Step 10) again from the beginning. After successful completion, unplug the tool harness from the combination meter and the power supply from the wall outlet. This “resets” the tool.

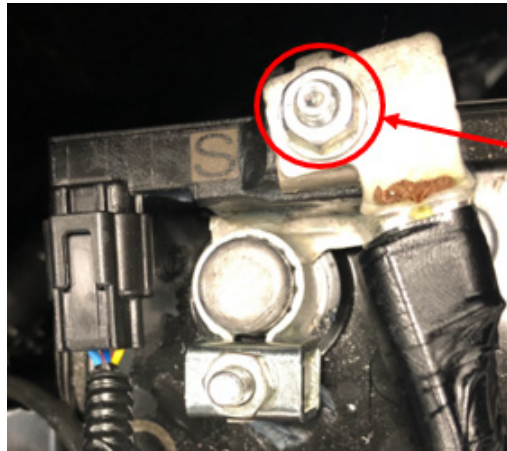
Step 12: Reconnect the battery cable while holding the battery sensor to support it with one hand and torque the 12mm nut to **5.5 ft. lbs.**

**(-) Ground Cable Nut
Torque to 7.5Nm
(5.5 ft.-lbs.)**

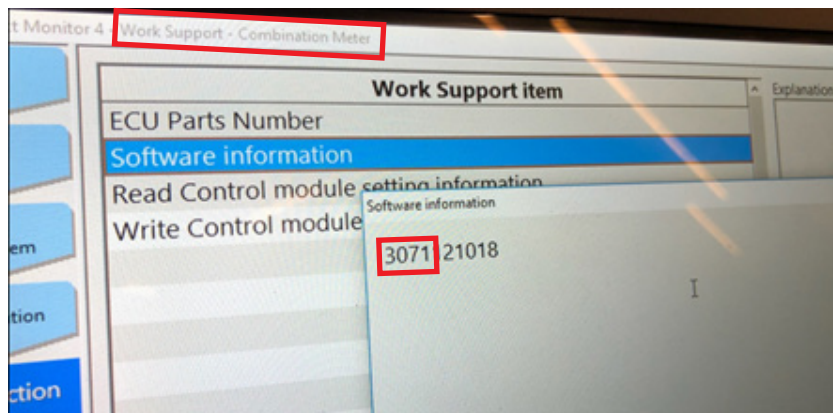
Step 14: Connect the SM4 and navigate to Work Support for the Combination Meter. Click on “Software information” and confirm the update was successful. Refer to the table below for the version information. The **first 4 digits** signify the version number. The photo shows a successful update of a 2018 Outback (3071). Once a successful update is confirmed, the process is complete.
