# Technical Service Bulletin

**20 MIL on or difficulty refueling, DTC P045100, P044100, P202500, and/or P045300 stored in the ECM**

20 19 23 2050276/3 November 15, 2019. Supersedes Technical Service Bulletin Group 20 number 18-99 dated February 20, 2018 for reasons listed below.

Model(s)	Year	VIN Range	Vehicle-Specific Equipment
A6, A7	2016 - 2018	All	3.0T

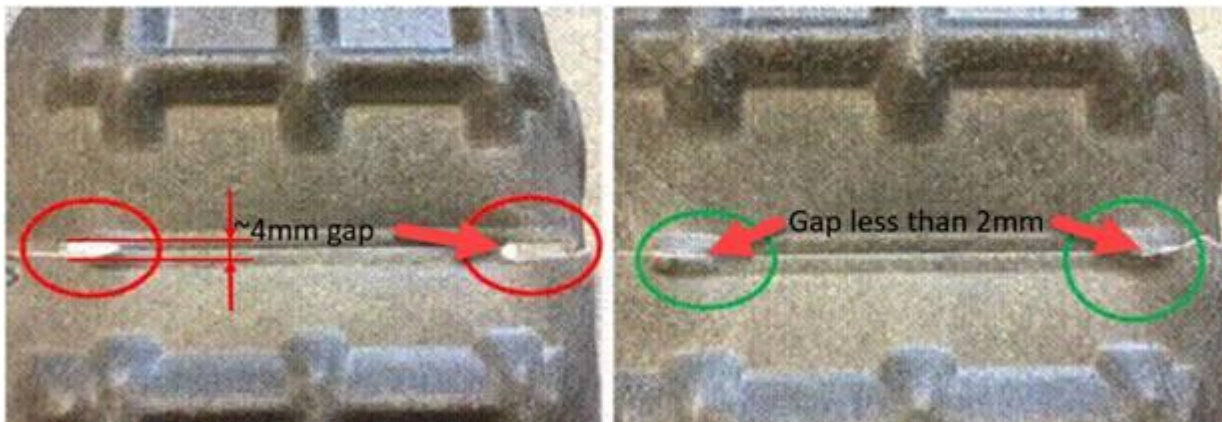
**Figure 1.** How to determine which steps to take Version 1 (~4mm gap) or Version 2 (gap less than 2mm).

1. If the updated wheel liner has not yet been installed. Then install the updated wheel liner, which has closed slots around the NVLD filter.
  - Remove the EVAP canister, ventilation tube, and NVLD pressure switch.
  - Remove all components mounted on the EVAP canister.

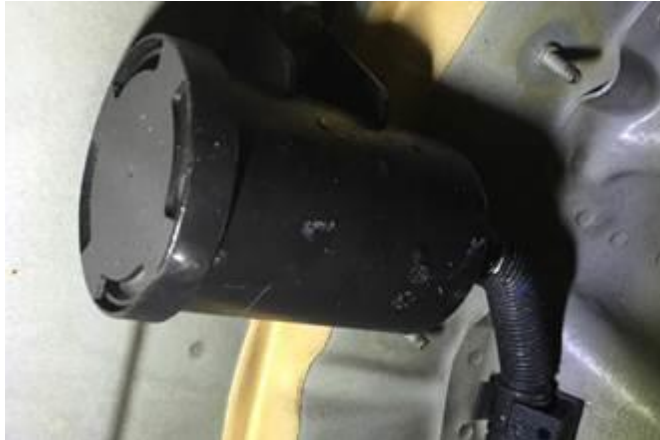
*Figure 2. Ventilation tube of the EVAP canister.*

- If it weighs more than 2650 grams, replace the EVAP canister + attached filter, ventilation tube (Figure 2), and NVLD pressure switch (J909).
- If it weighs less than 2650 grams, replace the ventilation tube, and the J909.

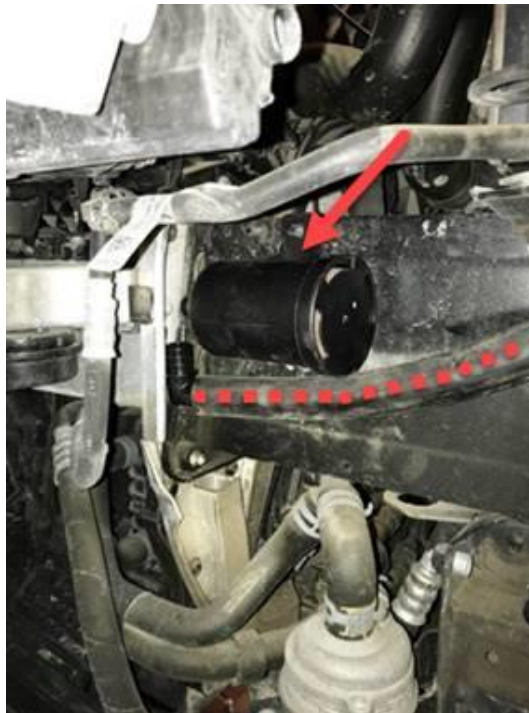
*Figure 3. Installing the new NLVD filter.*

1. Replace the EVAP canister only if weight is greater than 2650 grams.
  - Install a new J909.
  - Install the NVLD filter (new part number, Version 2) in the engine compartment on the left frame rail just in front of the ABS module, secure with M6 nut. (Figure 3).

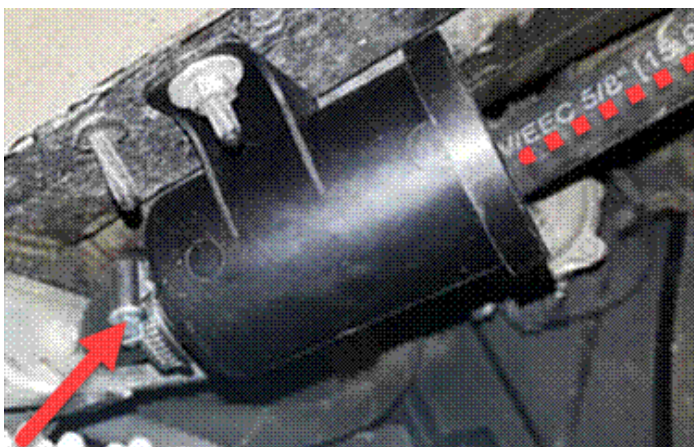
*Figure 4. Connecting the NLVD filter.*

2. Connect the filter to the 5/8" ID rubber hose via 1x plastic elbow and 1x rubber elbow (Figure 4).

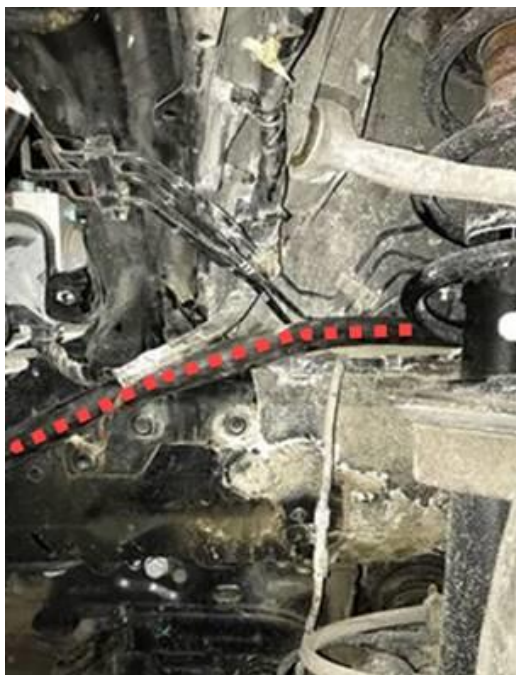
*Figure 5. Route the 5/8" ID rubber hose from new filter position to the J909.*

Route the 5/8" ID rubber hose behind the strut and brake lines from new filter position to the J909, along the orange battery cable (Figure 5 and 6). Then secure with zip ties.

5/8" ID rubber hose needs to be routed in a way that there are no sharp bends to prevent kinking.

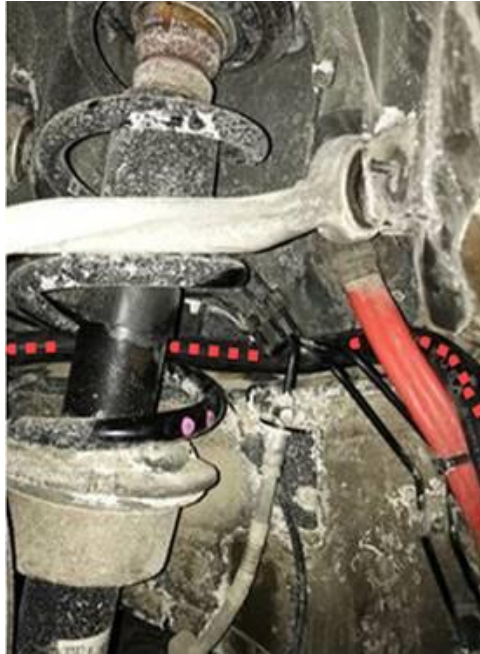
**Figure 6.** Routing the rubber hose.

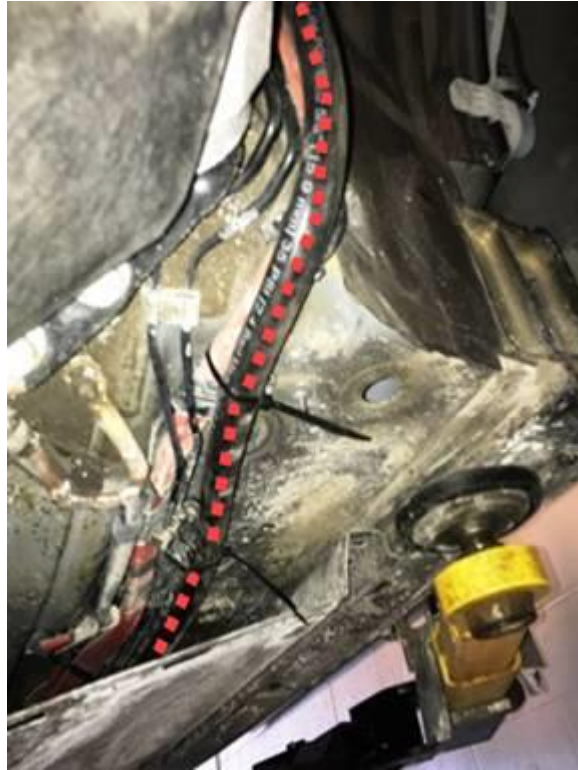
*Figure 7. Where to zip tie the rubber hose to the battery cable.*

4. Routing details to the J909, along the orange battery cable. Add zip-ties every 12 inches (Figure 7).

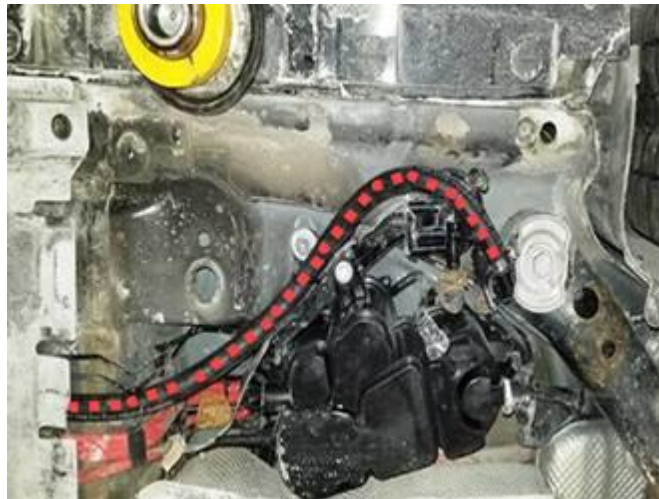
*Figure 8. Connecting to the J909.*

5. Before connecting 5/8" ID rubber hose to 90 degree connector, cut to length, as needed. Connection details to the J909 are shown in Figure 8 and 9.

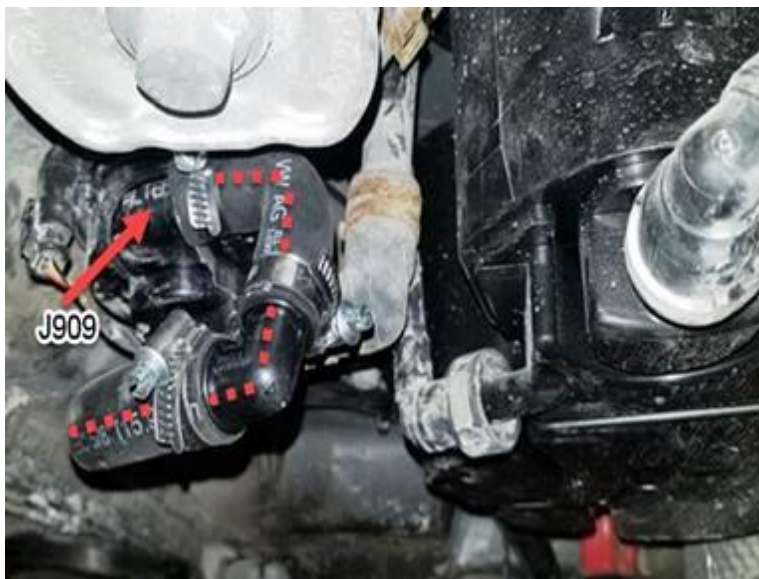
**Figure 9.** Closer look at the connections.

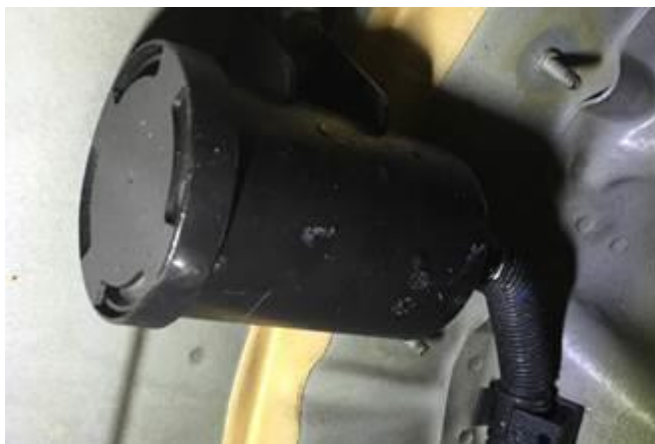
**Figure 10.** Remove original NVLD filter.

6. Remove original NVLD filter assembly. (Figure 10).
