11/20/1019
CAL WST 32-002

Subject: Airliner Welded Axle Seats

**Models Affected: 2019 and 2020 model year Western Star 4700,
5700XE, and 4900SB vehicles**

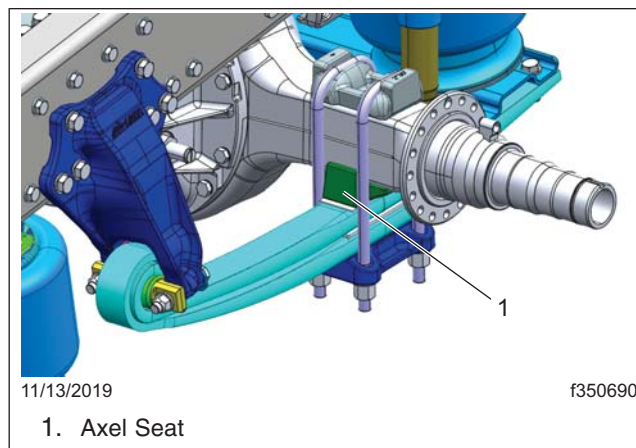
Fig. 1, Airliner Suspension Rear Rear Drive Axle

The Airliner rear suspension welded axle seats were installed incorrectly on the rear most drive axle on these vehicles, resulting in an incorrect axle pinion angle.

1. Park the vehicle, shut down the engine, and apply the parking brakes. Chock the steer axle tires and the rear rear drive axle tires.
2. Dump the air from the Airliner rear suspension air springs.
3. Raise the truck and support the back of the frame rails with appropriate support stands. Make sure the tires are still touching the ground.
4. Remove both air springs on the rear rear drive axle. See **Section 32** in the *Western Star Workshop Manual* for instructions.
5. Disconnect the shock absorbers from the leaf springs on the rear rear drive axle.
6. Remove both of the Airliner leaf springs on the rear rear drive axle.
7. Locate the welded axles located on the bottom of the axle housing. See **Fig. 1**.

8. Cut off the existing left-hand and right-hand axle seats.

IMPORTANT: Remove the welds with minimal grinding on the axle housing.
