Condition

Model(s)	Year	Eng. Code	Trans. Code	VIN Range From	VIN Range To
Passat, Golf, Jetta, Beetle	2015	2.0L TDI (CVCA, CRUA)	All	All	All

Instance Number	Published Date	Version Number	Reason For Update
2057752/1	11/15/19	26-19-03TT	Original publication.

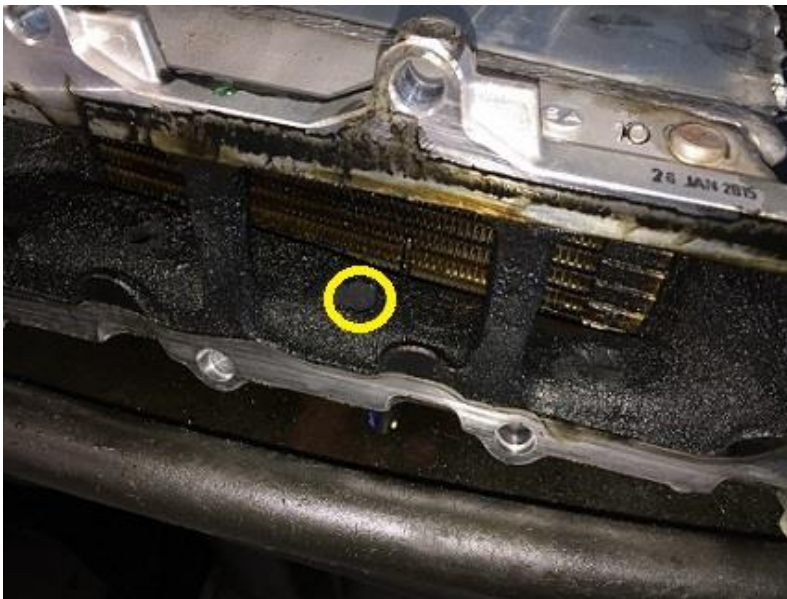
Figure 1

For customer concerns of MIL on with fault P0401/P2002. Inspect the EGR passage in cylinder head for casting irregularities or carbon build up (figure 1). Also inspect the EGR ports on the intake valve side of the intake manifold/intercooler (figure 2).
