Technical product information

Topic	Bentayga roof rail - Protective tape - Removal
Market area	Bentley: worldwide (2WBE),Hongkong-Macau (5HK)
Brand	Bentley
Transaction No.	2057130/1
Level	EH
Status	Approval
Release date

Bentayaga

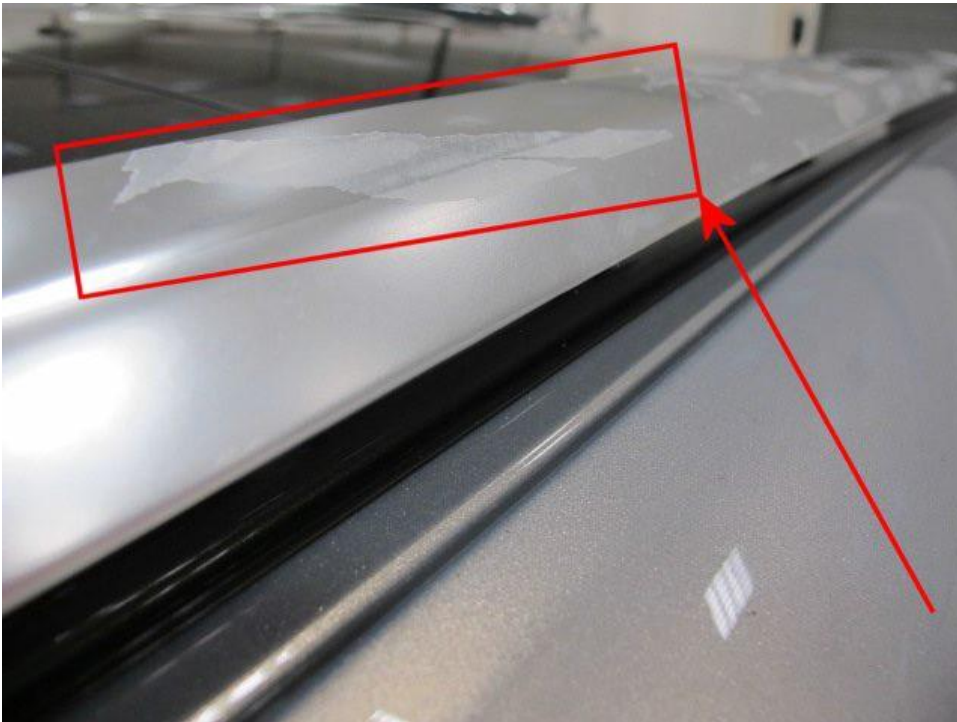
Figure 1

Roof rail protective tape difficult to peel/remove at PDI (Figure 1)

In some cases the roof rail protective tape cannot be easily peeled/removed from the roof rails, Refer to the instructions within the Measure section for removal instructions
