Field campaign

Topic	V8 Kovomo - Engine control module (SC19/25)
Market area	United States E05 Bentley USA and rest America (6E05)
Brand	Bentley
Transaction No.	2056414/2
Campaign number	EB39
Note	
Type	
US code

Software update required to the engine control module

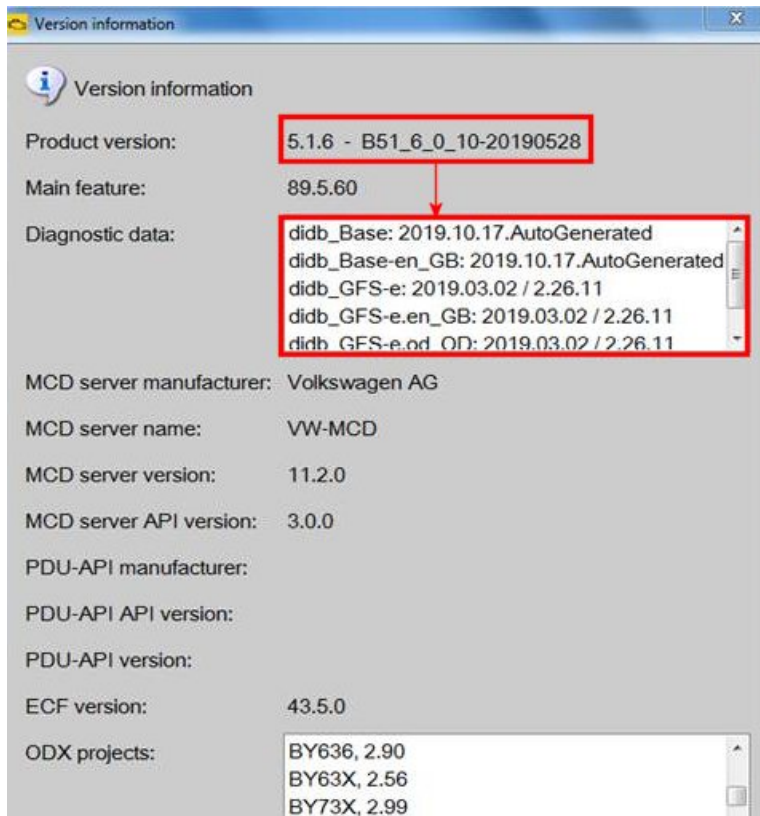
Figure 1

IMPORTANT NOTE: Please make sure you have installed the latest ODIS diagnostic software version (Figure 1) before carrying out the instructions within the

New ODIS version must be 5.1.6 / 2.26.11 or above

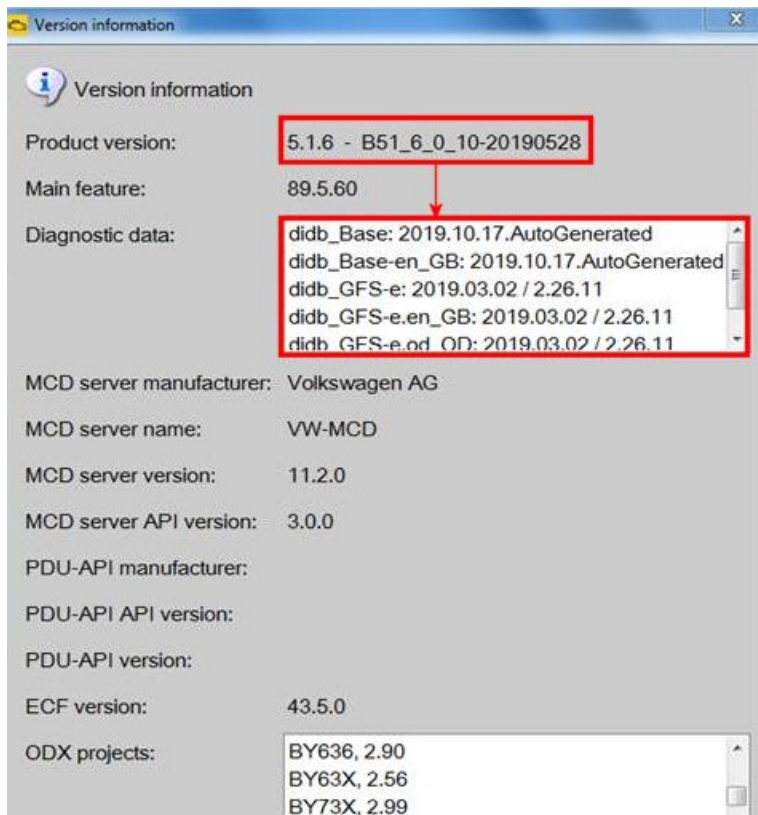
Figure 1

IMPORTANT NOTE: Please make sure you have installed the latest ODIS diagnostic software version (Figure 1) before carrying out the instructions within the

New ODIS version must be 5.1.6 / 2.26.11 or above
