WJ07 - Checking Plastic Rear Window and Replacing it if Necessary (Workshop Campaign)

Vehicle Type: **911 GT3 RS (991)/911 R (991)**

Model Year: **2016**

Subject: **Plastic rear window (polycarbonate)**

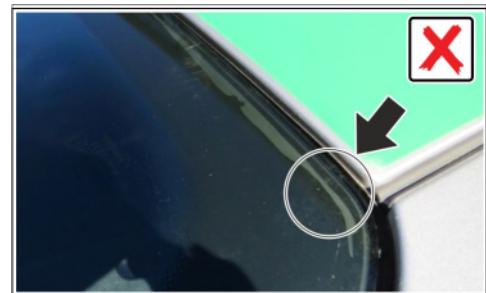
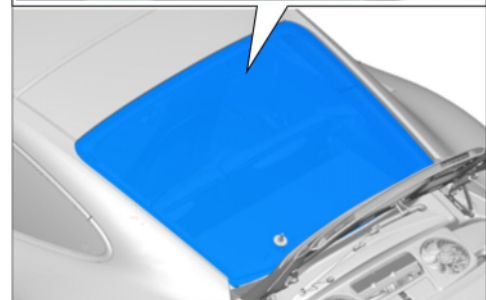
- 1.1 Press lightly against the window all around the edge of the rear window from inside the vehicle using two fingers.
- If you feel the rear window lifting off in the bonding area ⇒ *Damaged screen print -arrow-*, the bonding has become detached.

Damaged screen print

If the **bonding is detached**, the **rear window must be replaced** (see Step 2).

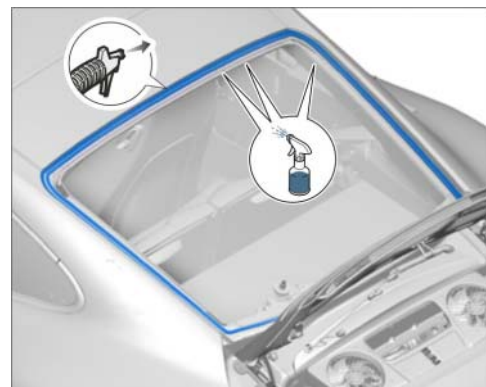
Checking rear window

- 1.2 If the rear window cannot be lifted off with your fingers, also spray the area with soapy water from the outside and then apply compressed air from inside the vehicle.
- If bubbles form, the bonding has become detached.

If the rear window has not become detached and you do not see any bubbles, no further action is required ⇒ **End of test measure and continue with Step 3 (Invoicing - Scope 1)**.
