EL19-067

ITB19-041

2020 Q50; BOTH CENTER DISPLAY SCREENS ARE BLANK

APPLIED VEHICLE: 2020 Q50 (V37)

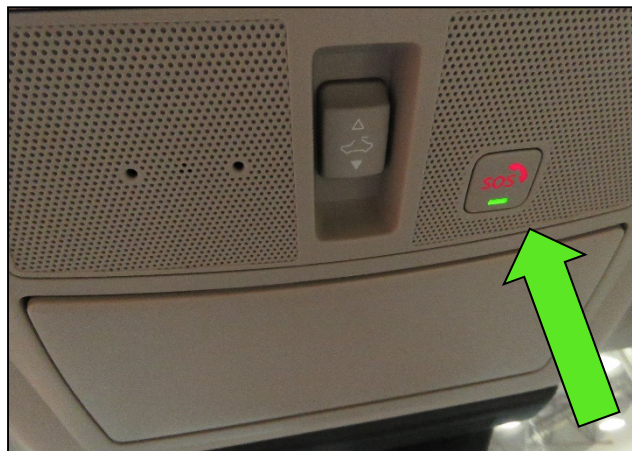
Figure 1

APPLIED SYSTEM: Vehicles equipped with factory navigation system (Vehicles equipped with navigation will have an SOS button in the overhead console assembly).

Both the upper and the lower center display screens are blank.

Perform the **SERVICE PROCEDURE** starting on the next page to configure the TCU.
