SERVICE BULLETIN

Classification: BT19-015	Reference: NTB19-102	Date: November 14, 2019
-----------------------------	-------------------------	----------------------------

2017-2019 TITAN/TITAN XD KING CAB; WIND NOISE AT 40 MPH AND ABOVE

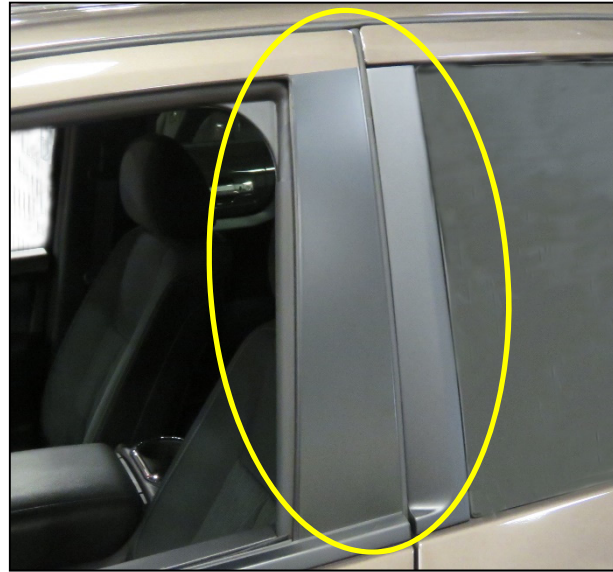
Figure 1

1. Verify the wind noise is originating from the area circled in Figure 1.
 - Left side is shown, right side is a mirror image.

The wind noise may be present on one side or both sides of the vehicle.
