Title Diagnostic Trouble Code (DTC) P20EE - SCR NOx Catalyst Efficiency Below Threshold (Bank 1) - **US17+OBD2019 Emissions, Model Year 2020 ONLY**

**Mack Model** AN - Anthem , CHU - Pinnacle, Axle back , CXU - Pinnacle, Axle front , GR - Granite , GU - Granite , PI - Pinnacle

**Volvo Model** VN , VNL , VNR , VNX , VAH , VHD

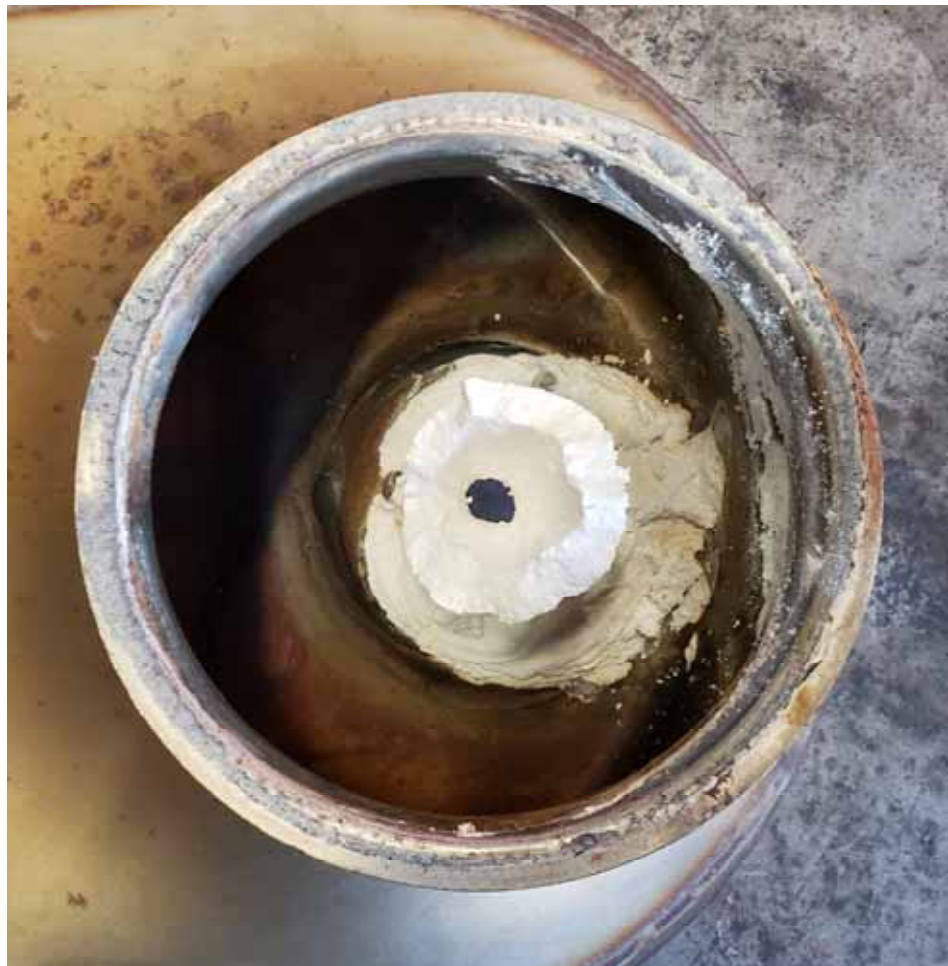
Affected vehicles have been observed having large urea crystal buildup starting from the DEF dosing valve. When applicable SCR mufflers are evaluated following removal of the DEF crystals, the SCR functions as good as a new component.

## 2. Remove the DEF dosing valve and inspect for crystal buildup.

An example of expected crystal buildup can be seen below:

2.1. If crystal buildup is similar to that shown in the picture above: Continue to Step 3.

**3. Remove the DPF (Tear Drop) cover and clean the crystal accumulation out of the pipes.**

**3.1. With a damp cloth, wipe off the DEF dosing valve and mixing vanes.**

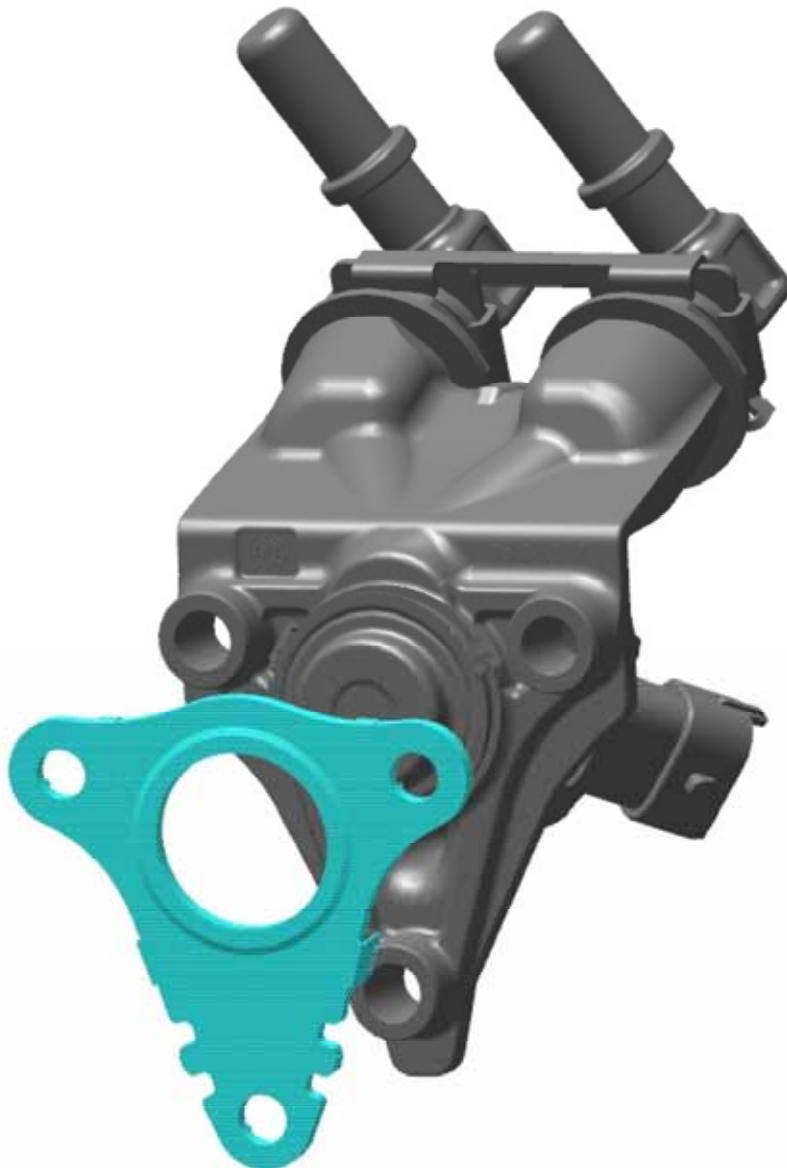
**6. Remove and discard the insulator (gasket) from the dosing valve.** The part is highlighted in the picture below.

**7. Re-install the DEF dosing valve WITHOUT a new insulator.** Make sure to use a new sealing plate and new mounting screws (one time use parts).
